Deir El-Bahari, Tuthmosis III Temple

DEIR EL-BAHARI, TUTHMOSIS III TEMPLE

Jadwiga Lipińska

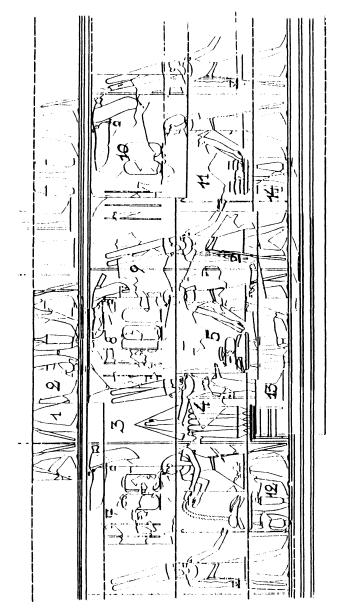
(Fig. 1) and from the niche opening on the other side of this wall (Fig. 2). In 1987-89 five blocks from the middle part of the wall were restored, and five from the niche. In 1993 another block from the wall was fully restored as well as one block from the niche. The former, 78 cm long and 62 cm high, was reconstructed of 66 fragments; the latter, 96.5 cm long and 70 cm high, consists now of 160 fragments. Its restoration was extremely difficult as some of the pieces were paper-thin and fixing them together was a complicated technical task.

Fragments of both blocks, being of very fragile limestone with salt efflorescence and peeling polychromy, were first reinforced with a stone hardener Keim-Silex OH. Fragments of polychrome reliefs, originating from four further blocks were also hardened and prepared to be joined together in the 1994 season (blocks 8, 8a, 9, 10 and 11 on figs 1 and 2).

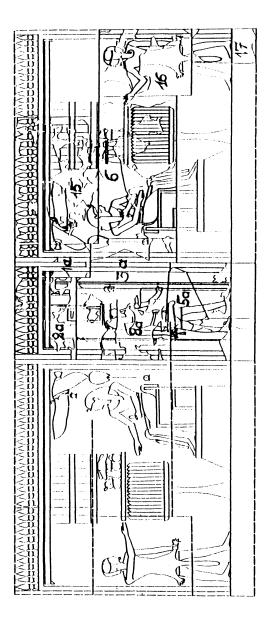
Tuthmosis III temple at Deir el-Bahari. The niche in the western wall of the sanctuary. Blocks 1-5 were restored in 1987-89, block no. 7 in 1993, blocks 8-10 are prepared for reconstruction in 1994. Fig. 2.
