**Marina El-Alamein: Polish-Egyptian
Restoration Mission : Conservation
Work in 2008**

MARINA EL-ALAMEIN POLISH-EGYPTIAN RESTORATION MISSION: CONSERVATION WORK IN 2008

RESEARCH, BUILDING, CONSERVATION AND RECONSTRUCTION IN THE 2008 SEASON

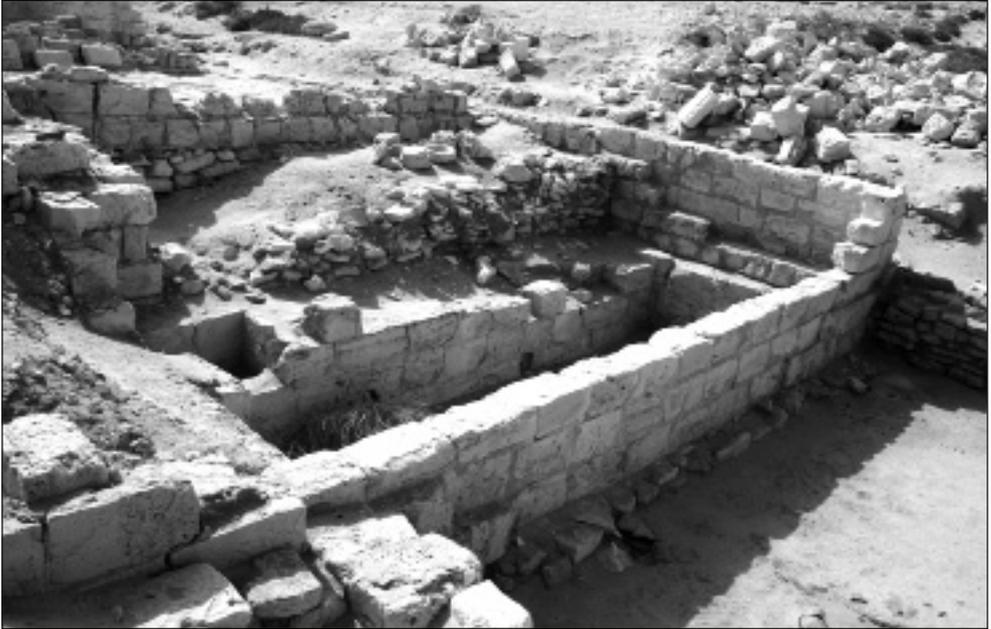
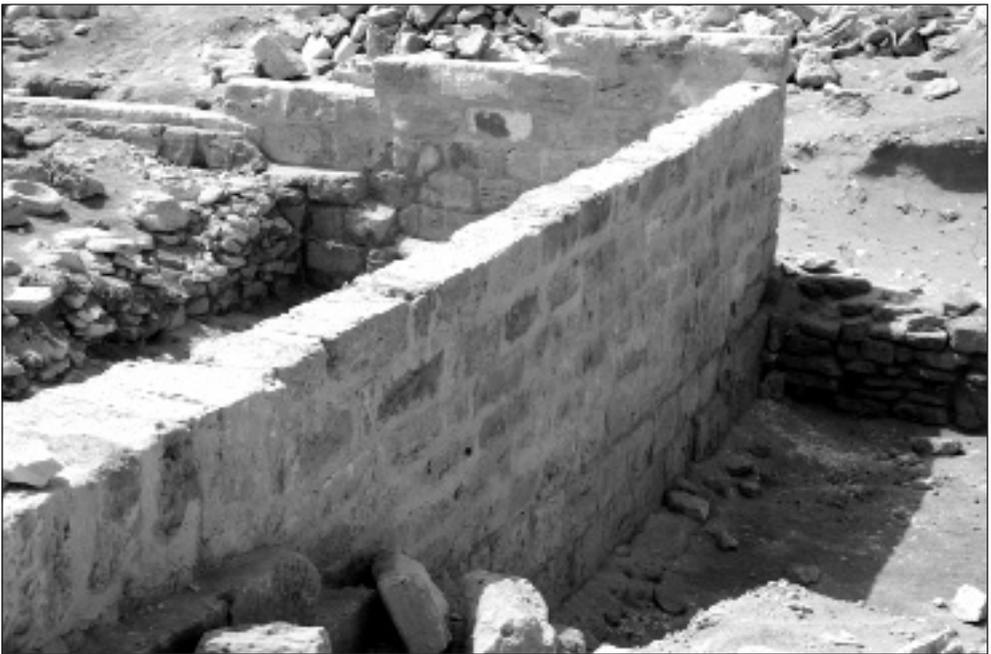
The southwestern part of the enclosure wall, encompassing the south and west walls of Room 27, which are at the same time the outer walls of the house [*Fig. 1*], continued to be reconstructed, building up now on the foundations and lower courses laid already in 2006 and 2007 — three courses in the south and five in the west (using blocks 0.30 m wide). By the same, the corner of the house has finally been raised high enough to become visible in the surrounding area [*Fig. 2*].

Fig. 2. House 1, southwestern corner before (top) and after conservation in 2008, view from the north-west (Photo P. Zambrzycki)

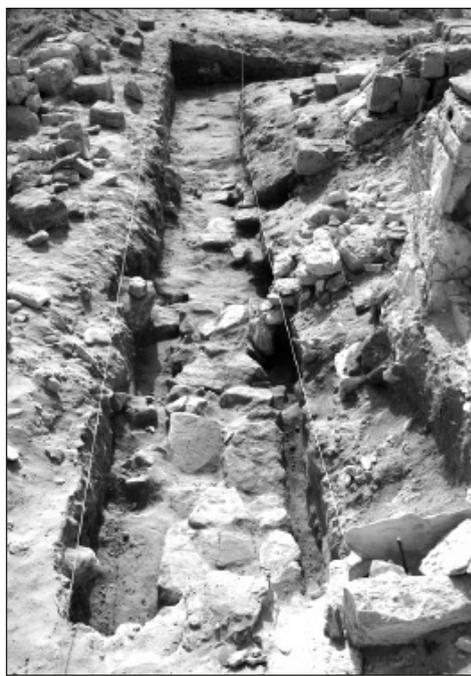
The reconstruction of the foundation of the northeastern corner proceeded in preparation for the restoration in the future of the north wall, which was presumably the main house facade. Both the northern and eastern facades have been recognized in the record, and only this corner had been lost during the original building works in 1986 when the site was discovered. The building technology of the foundations was also clear, consisting of a broken-stone wall in mud mortar laid in a narrow trench [*Fig. 3*] and the space between the stones and trench wall (approx. 0.15 m) packed with mud (possibly also mud-brick) and

Fig. 3. Foundation of the northeastern corner of House 1 after clearing for conservation, view from the west (Photo P. Zambrzycki)

The foundation of the northeastern corner was rebuilt of broken stone but bonded in lime-cement mortar (not mud mortar as originally) to a height of 0.30 m and on top of this two courses of transversely laid stone blocks were introduced [Fig. 4]. At the western end of the reconstructed section of the north

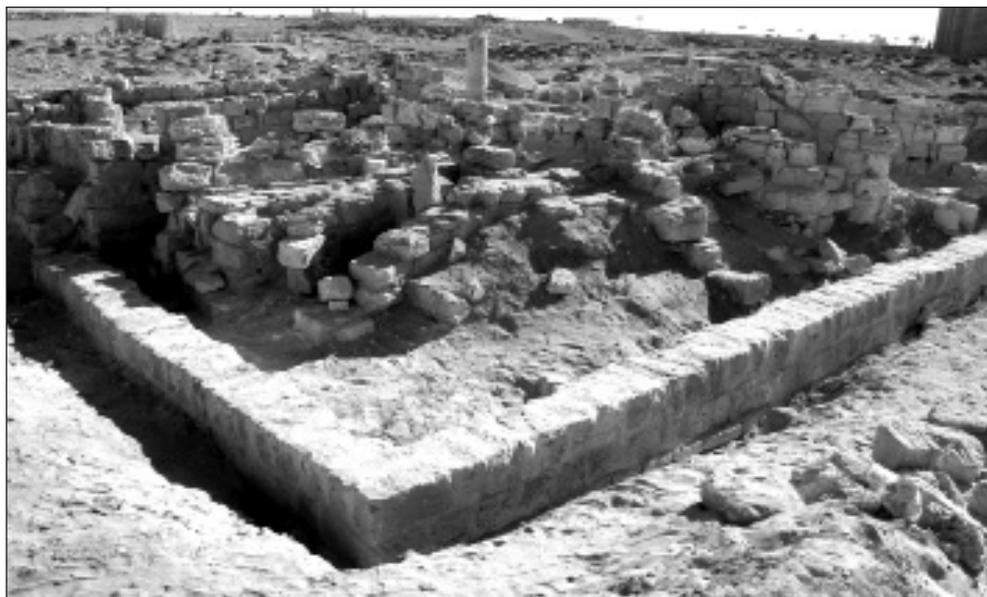
Fig. 4. House 1, northeastern corner after restoration in 2008, view from the northeast (Photo P. Zambrzycki)

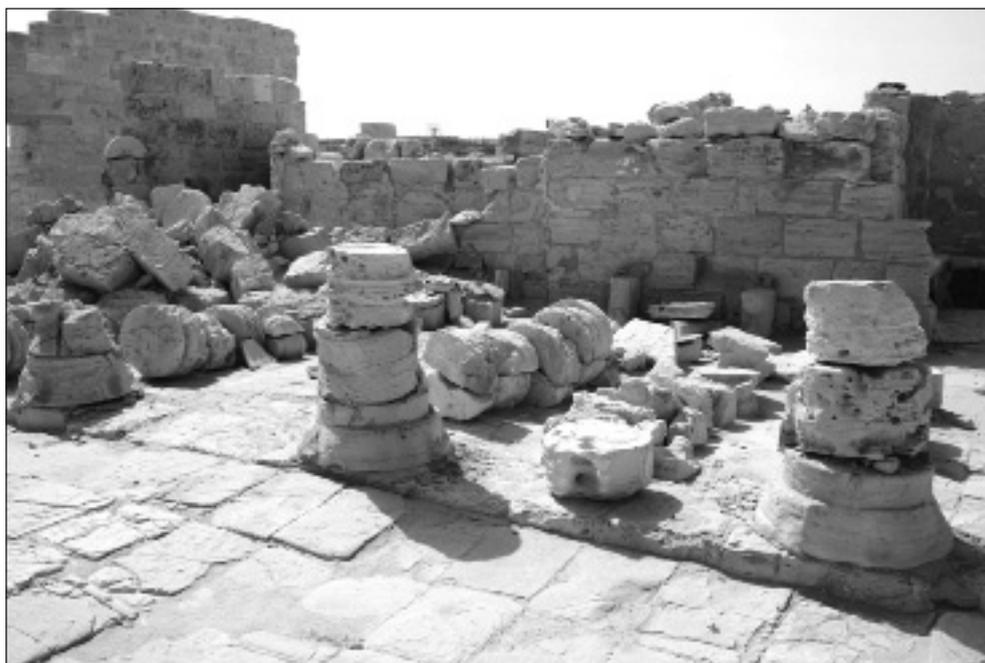
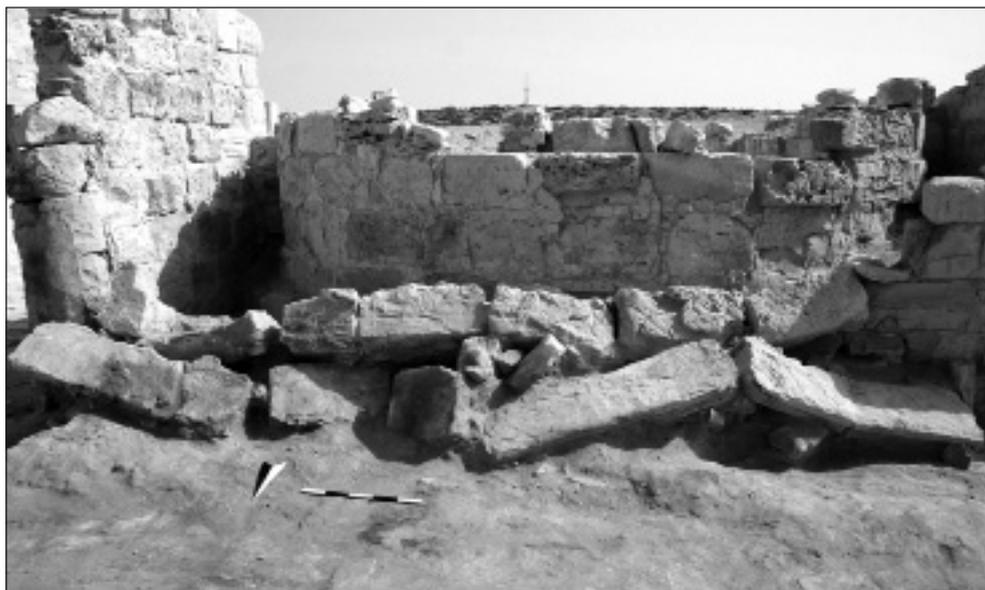
The collapsed wall in the eastern end of the portico was cleared under archaeological supervision, particular elements marked and the original arrangement reconstructed [Figs 6, 7]. Two building phases were recognized in the process. The western section of the wall, which was 3.49 m long, was erected first, followed by the section further away from the exedra, only 0.95 m long, built to adjoin the southeastern corner column of the portico. This narrower section of the wall must have once contained a slab, possibly decorated or inscribed, set into a carelessly cut niche on the back, that is, southern,

Fig. 6. Back wall of the south portico in the main town square, state before preservation with arranged elements of the collapsed columns (top) and close-up of the eastern end of this wall and the bench during clearing of debris (Photos P. Zambrzycki)

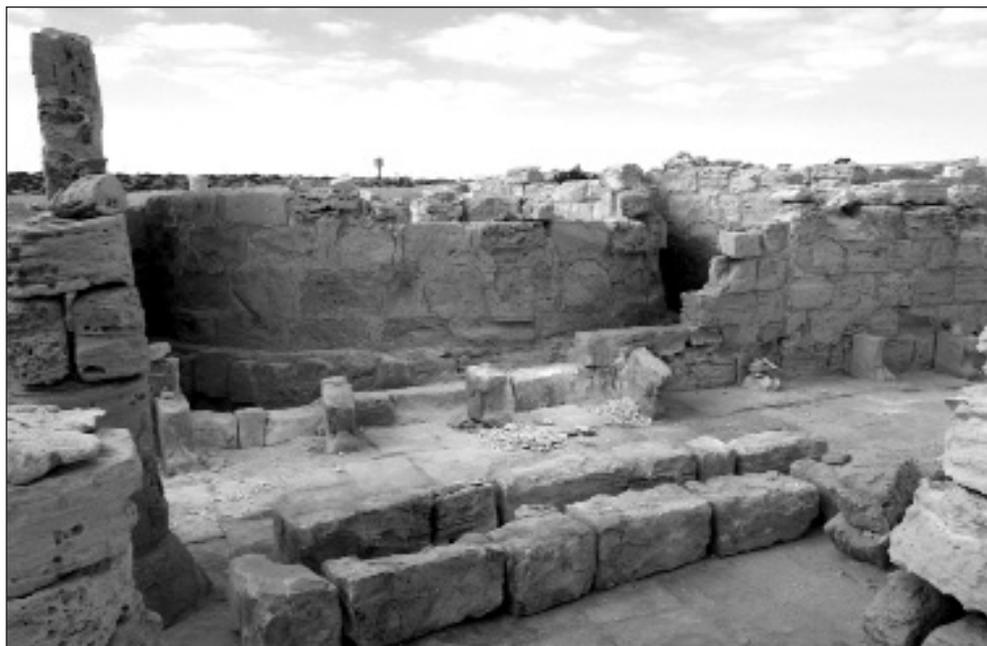
Fig. 7. Back wall of the south portico in the main town square after clearing of rubble and sand (Photo P. Zambrzycki)

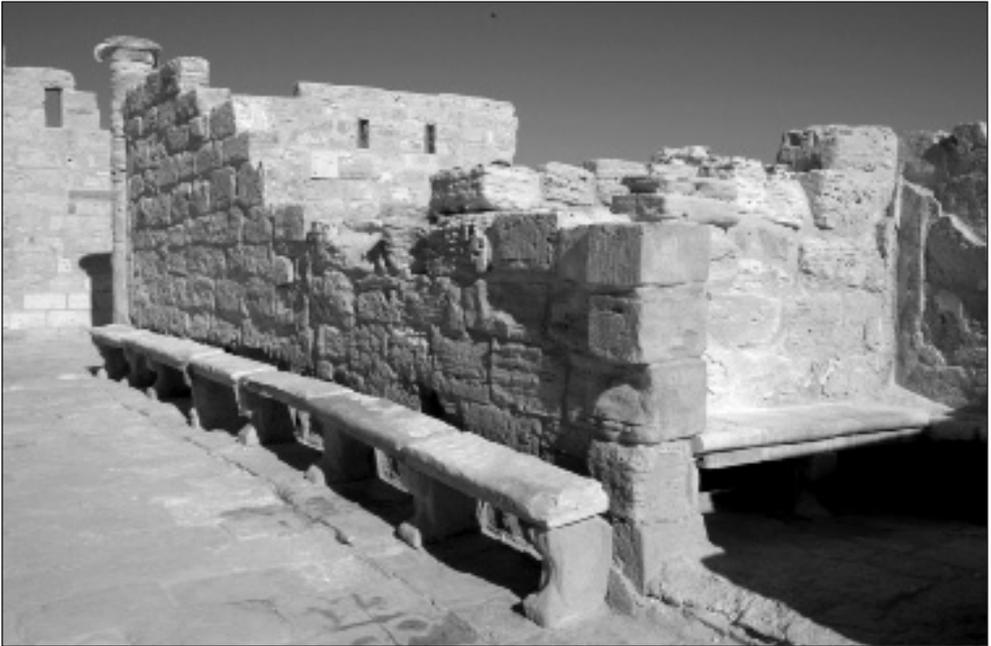
The relics were studied and restored in position, the arrangement reconstructed in the course of raising this section of the portico back wall [Fig. 8]. Original elements were replaced in position with only sporadic additions of blocks that

Fig. 8. South portico of the main town square with the back bench, after restoration in 2008 (Photo P. Zambrzycki)

With regard to the wall bench, once the slab seating and lion-paw supports were conserved (see below), they were rebuilt in position. The one missing seat (second counting west from the exedra) was reconstructed. Two of the supports, which were the most eroded, were also replaced. Fortunately, all of the supports had been found in place, leaving no doubt as to

All of the said rebuilding and restoration was carried out using a sand, lime and cement (parts 3:2:1) mortar.

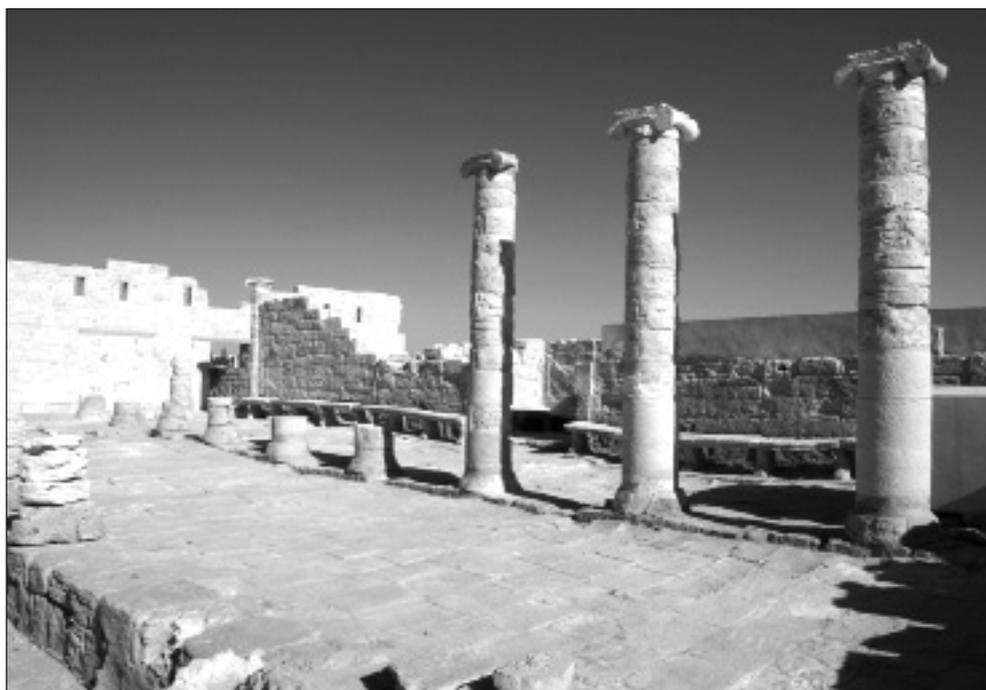
Fig. 10. Columns of the south portico restored, view from the northwest (Photo P. Zambrzycki)

in the pseudo-Ionian order common in the Marina el-Alamein region [Figs 9, 10]. Column height, according to a study by the discoverer Wiktor A. Daszewski, was about 3.60 m (Daszewski 2005: 86; 2007: 88–90), composed as a rule of a base, eight to nine drums from 0.28 m to 0.35 m high, and a capital in a style resembling the Ionian order. A soft limestone was used for these pieces of the architectural order. The bottom drums were usually made up of two half-drums joined vertically. The bottom drums were 0.50 m in diameter, the upper ones 0.43 m. The columns were all coated with lime mortar render and plaster with relief fluting.

ancient procedure for the lower parts of column shafts. Usually only one half of the lowermost drums needed replacement. The bases were all original, preserved in good condition and requiring only consolidation and strengthening of the substructure. Four drums (about a third of the height, that is, 1.51 m) of the easternmost column in the middle row were thus put together to await anastylosis, as were two drums (0.78 m in height) of the easternmost column in the northern front row (fifth counting from the corner).

Since only the bottom parts of columns, that is, bases and lowermost drums have been found, the broken elements, even though they have been preserved, had to be replaced with new, reconstructed elements. The upper parts of the columns were reconstructed of mostly original elements preserved in fair condition, as follows:

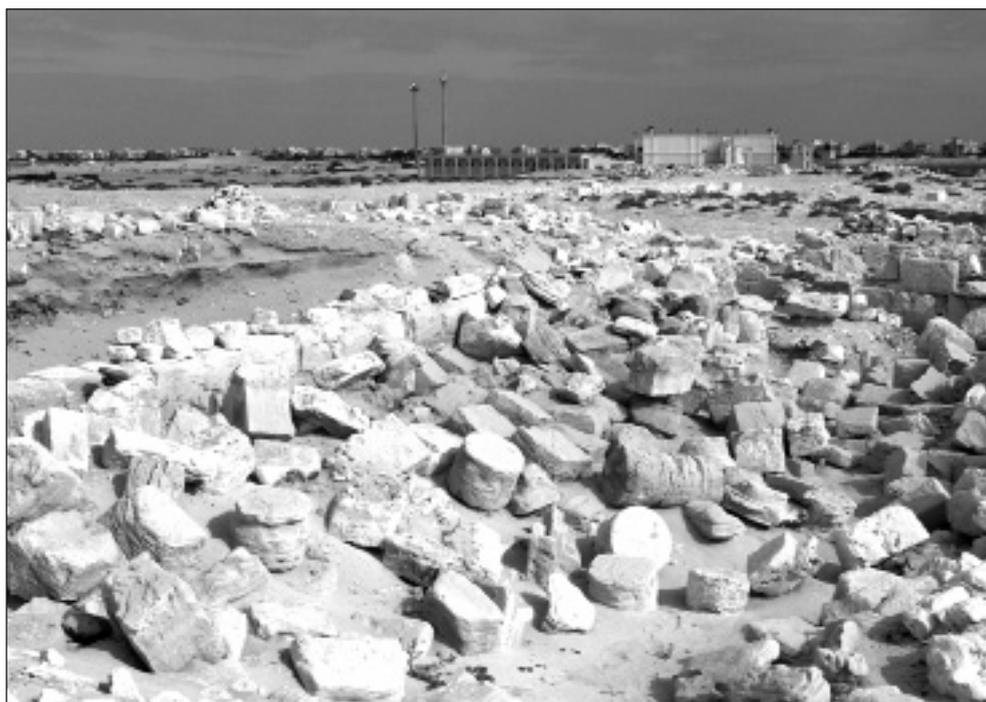
*Fig. 11. General view of the south bath portico (unit no. 4) before conservation
(Photo P. Zambrzycki)*

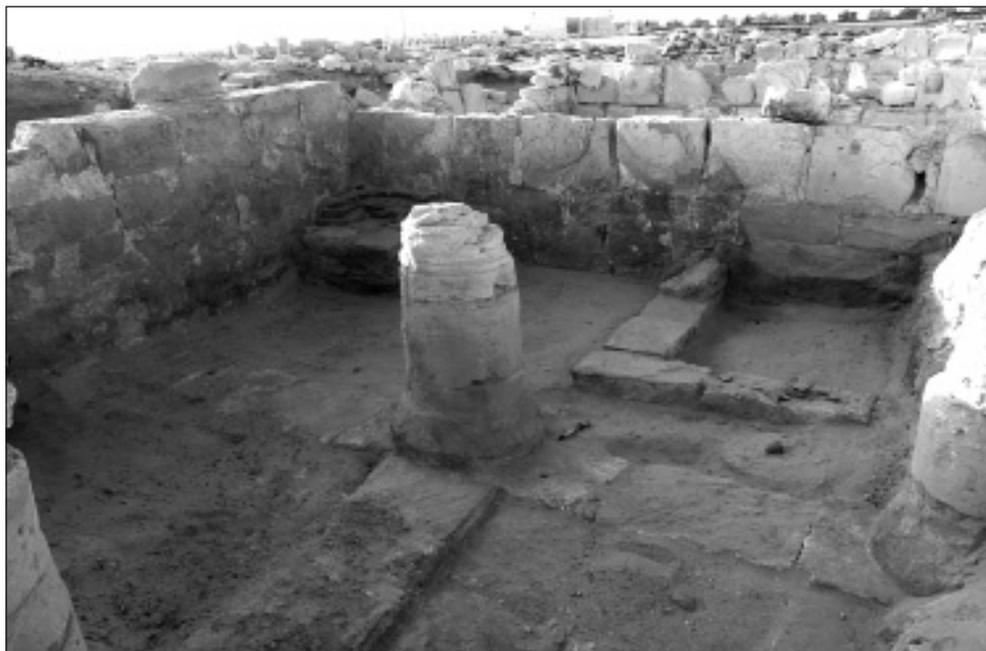
The cleaning and conservation–preservation program started from the north-western corner of the portico [Fig. 12]. The positioning of columns in this part was determined as composed of three columns along the north wall. Two building phases were distinguished. Conservation objectives called for protecting the crest of the west wall in its northern half. The three most eroded blocks from the topmost preserved course were replaced and two more courses added in the northern

Fig. 12. Northwestern corner of unit no. 4 of the south bath portico after clearing in 2008
(Photo P. Zambrzycki)

section, consisting of five original blocks found nearby. Three of the column drums from the northwestern corner column of the portico were also rebuilt in position.
