Kom El-Dikka: Preservation Work, 1997

Polish Archaeology in the Mediterranean 11, 21-28

KOM EL-DIKKA

PRESERVATION WORK, 1997/98

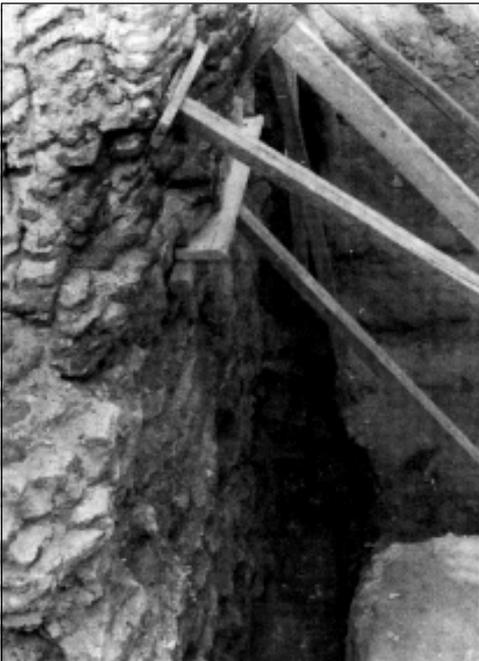
Fig. 2. Cisterns. Western wall of the corridor before restoration (Photo W. Kolqataj)

Top priority was accorded the work in the area of the cisterns lying immediately adjacent to the access route to the projected mosaics pavilion. The western wall of the corridor-ramp, 26 m² (Figs 1, 2, 3), as well as the south drawing wells (Figs 4, 5) were protected and restored where necessary. The restoration of the crown of the wall separating the Cisterns from street R4 was completed and a staircase was constructed

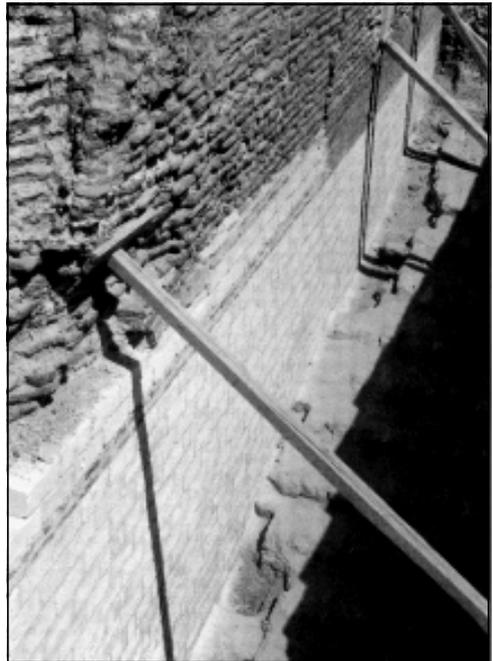
Fig. 3. Cisterns. Western wall of the corridor after restoration (Photo W. Kolqataj)

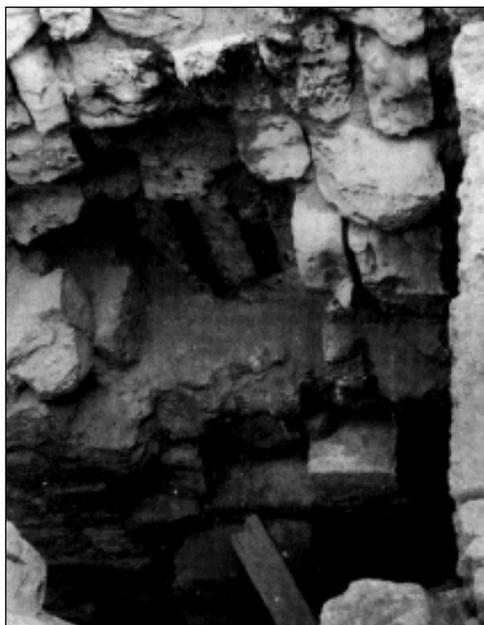
Fig. 4. Cisterns. South double wall before restoration (Photo W. Kołtątaj)

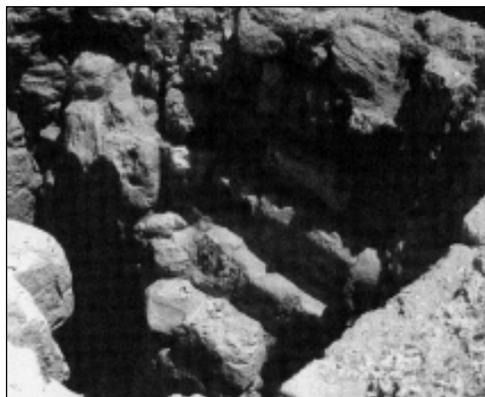
Fig. 5. Cisterns. South double wall after restoration (Photo W. Kołtątaj)

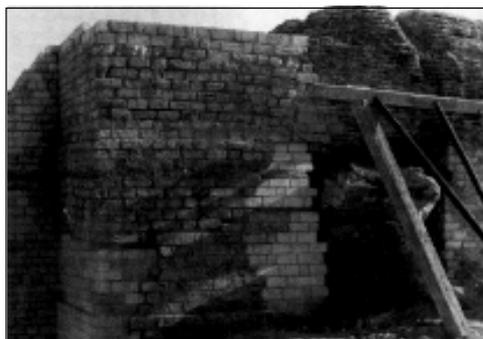
Fig. 8. Cisterns. Northeastern corner before restoration
(Photo W. Kołtąj)

along its southern edges. The consolidation of the cavities under the Cisterns was completed (Fig. 6) and a fragment of the wall fallen from the northern facade of the structure was put back in place (Figs 1, 8, 9).

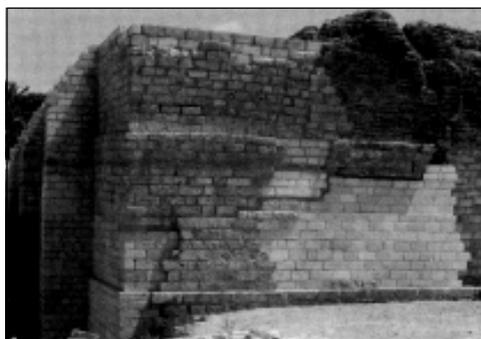
Fig. 9. Cisterns. Northeastern corner after restoration
(Photo W. Kołtąj)

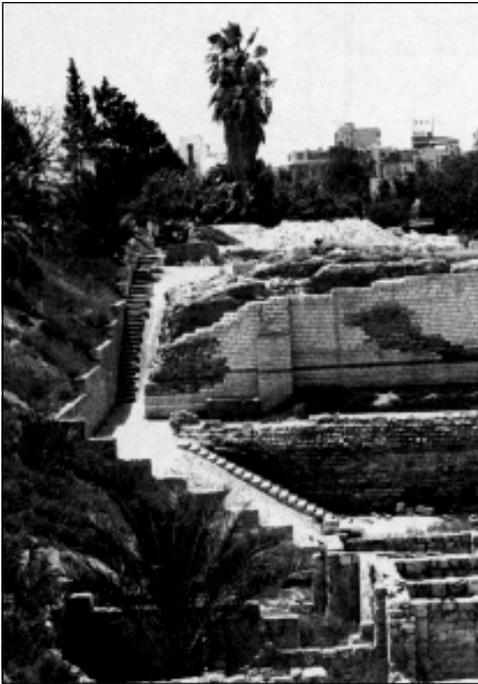
Fig. 11. Tourist path along the southern limits of the site (Photo W. Kołtątaj)

The tourist walkway along the southern limits of the site, from the Theater to street R4 and the mosaics shelter (120 m), was completed, including pavement, steps, casing walls and sloping work (Fig. 11).

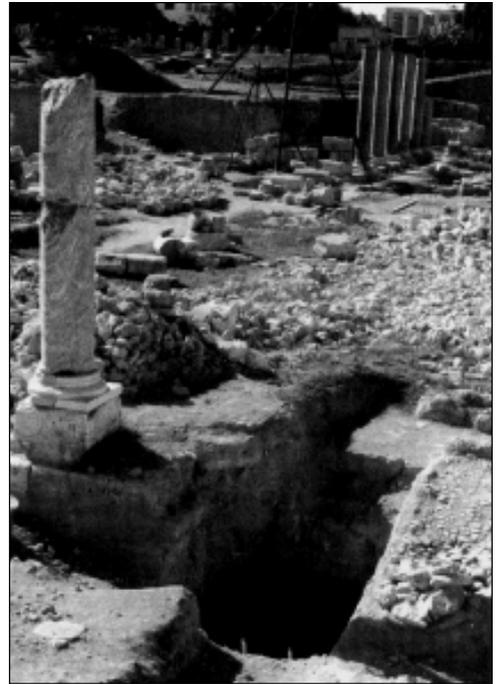
Fig. 12. Baths. Southeastern corner of the frigidarium after cleaning (Photo W. Kołtątaj)

portico passage of the Baths have been designed. The plundered foundations and floors of the frigidarium on this side were cleared, preparing ground for work in the future season (Figs 10:B; 12).
