Marina El-Alamein: Conservation Work in 2004

MARINA EL-ALAMEIN

CONSERVATION WORK IN 2004

Stanisław Medeksza et al.

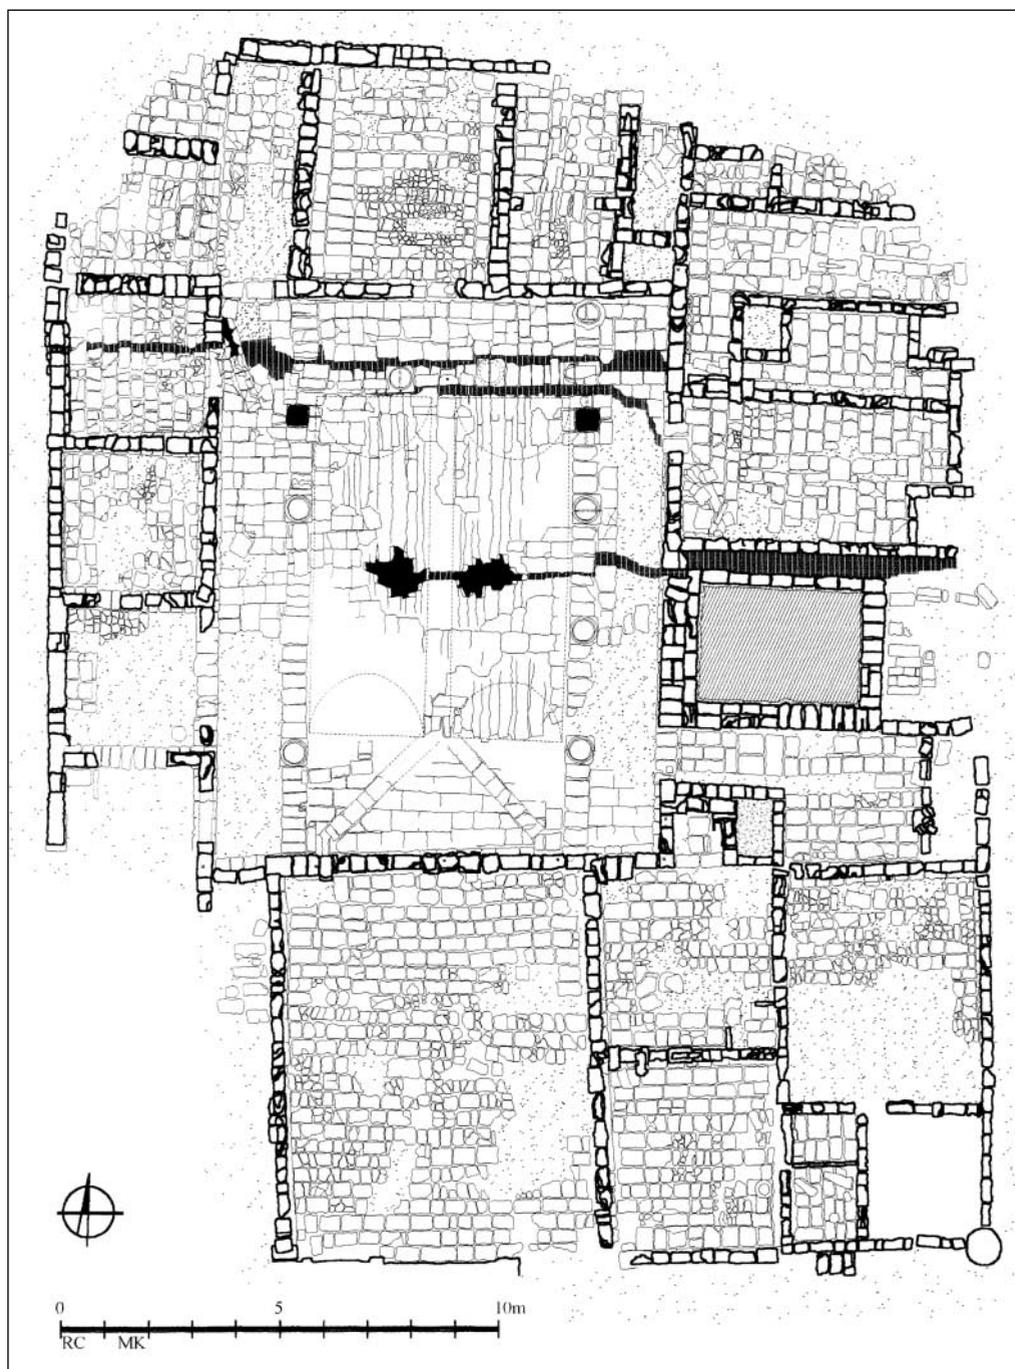
Fig. 1. Inventory plan of House H1, following clearing work in 2004
(Drawing R. Czerner, M. Krawczyk)

Work began with routine clearing and maintenance assessment of previously conserved structures.² Concurrently, an architectural inventory was taken and the documentation of House H1 completed [Fig. 1], revising earlier plans and descriptions, which had not had the benefit of a thorough clearing of the structure during the original rescue excavations by inspectors from the Egyptian Antiquities Organization in 1986-1987.

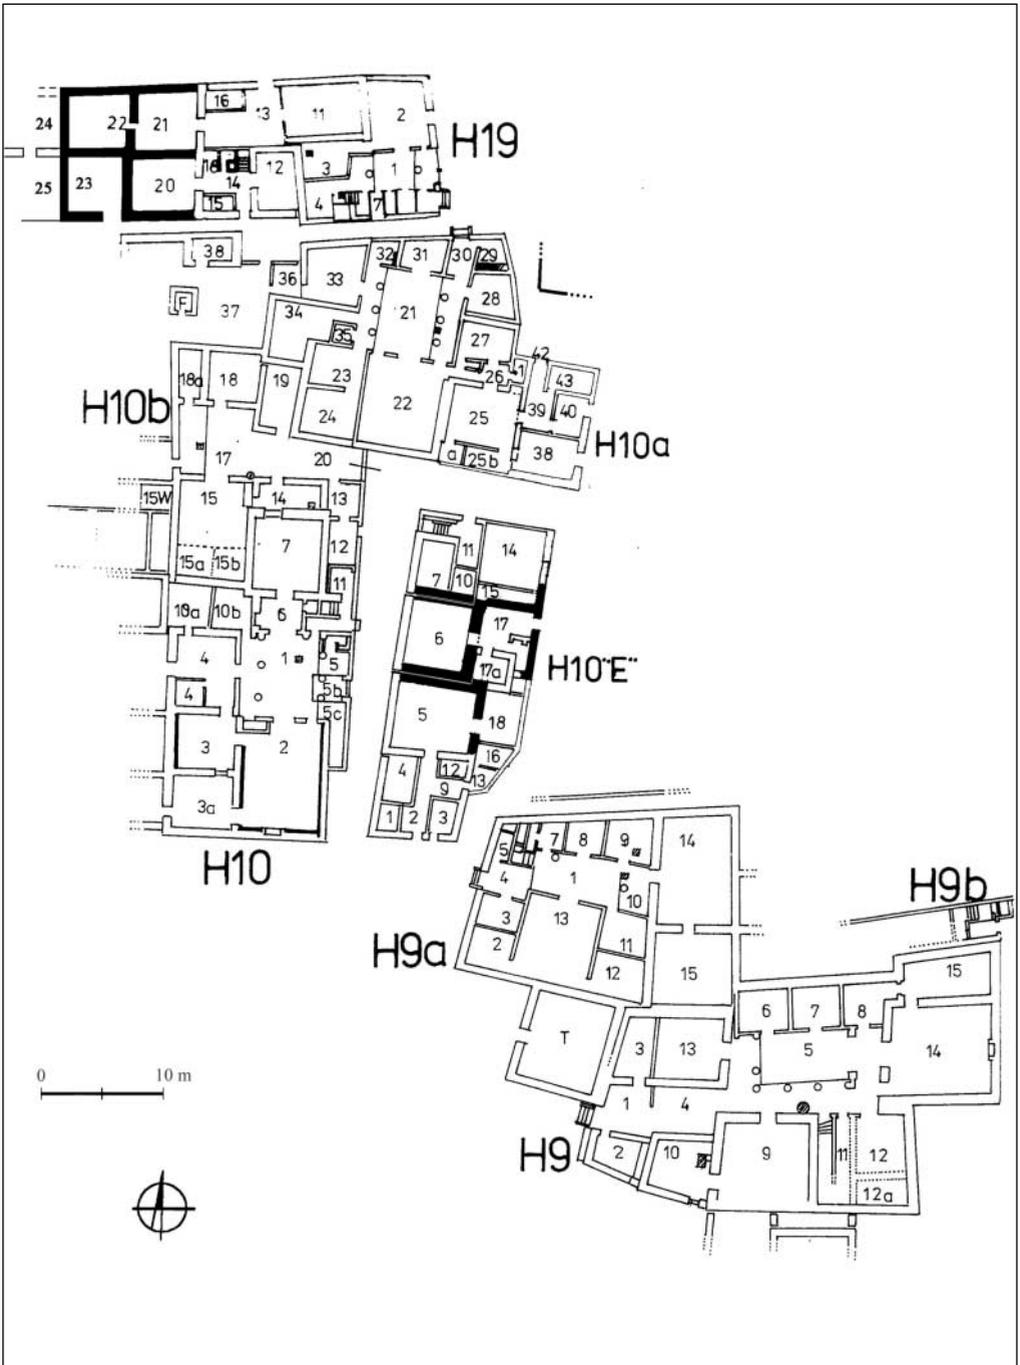
Fig. 2. Plan of complex of houses in the southern part of the ancient town
(Drawing S. Medeksza)

In the area of House H10"E" [Fig. 2], where work has been ongoing since 1998, especially with regard to reconstructing the street arrangement in an effort to enhance the display potential of the houses in this district, walls were built up to an average height of 1.20 m. Architectural phasing was emphasized by varying the height of walls, pointing work and finishing touches on the bondwork in the central part of the house, in rooms 5, 6, 15, 17 and 17a. Building-conservation work was completed on the eastern outer wall separating rooms 15, 17 and 17a from the eastern N-S street.

Continued clearing work conducted under archaeological supervision in House H19 made it evident that all rooms numbered from 11 up were part of the next house in this insula [cf. Fig. 2], which was bounded on the north by a 2.00 m wide alley similar to the one on the south. Room 22, and parts of 23 and 24, as well as 25 were now investigated. It appears that rooms 21, 22 and 25 were added to the western wall of room 20, while 24 was added to 22, corrupting in many places the

original street grid. Preservation work on surviving walls was completed, replacing the clay mortar in the broken-stone bondwork with lime mortar in the accepted proportions (6:3:1) of sand, slaked lime and white Portland cement. Walls were built up to an average of 1.20-1.40 m (in rooms 20, 21 and 22, and the eastern wall of 23). Well-fitted stone chips in a lime-cement mortar forming a protective cap on the top of surviving walls will eliminate the danger of the clay being washed out by corrosive rains.

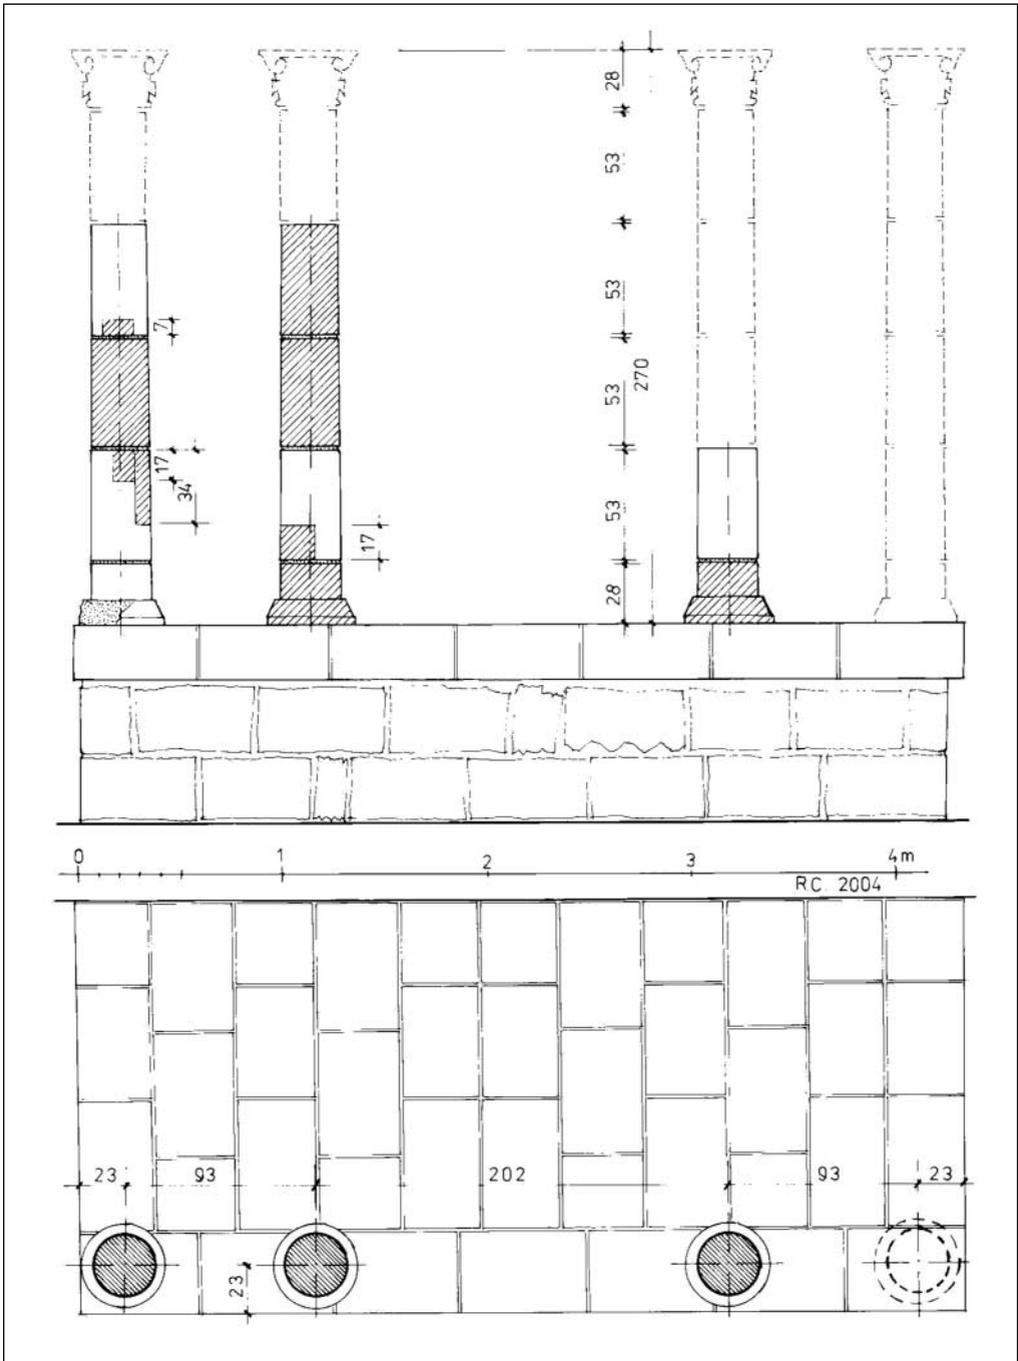
Fig. 3. Drawing reconstruction of the commemorative monument in House 21c
(Drawing R. Czerner)

Last year, the parapet of the commemorative monument connected with an inscription dedicated to Commodus, occupying the two square "cubicles" (2a and 2b, 4.40 x 2.00 m) in House 21c was reconstructed.³ Work continued this season on a partial reconstruction of this monument. Three of four columns which had once formed a portico together with the engaged pillars in the back wall were re-erected on the podium. The arrangement of the portico was reconstructed on the grounds of an analysis of preserved architectural elements and comparative studies [Fig. 3].

Each column had originally consisted of four drums, each 0.53 m high and from 0.31 to 0.29 m in diameter. One drum with painted plaster featuring a floral design was preserved in 2001-2002 (for future museum display).⁴ Four other drums have been preserved, plus a base 0.28 m high and one capital, also 0.28 m high. These elements were reinforced and

the losses filled in with limestone of parameters like the original.⁵ Four new drums and two new bases were made for the purposes of anastylosis, which should be completed in the coming season, using elements prepared this year.

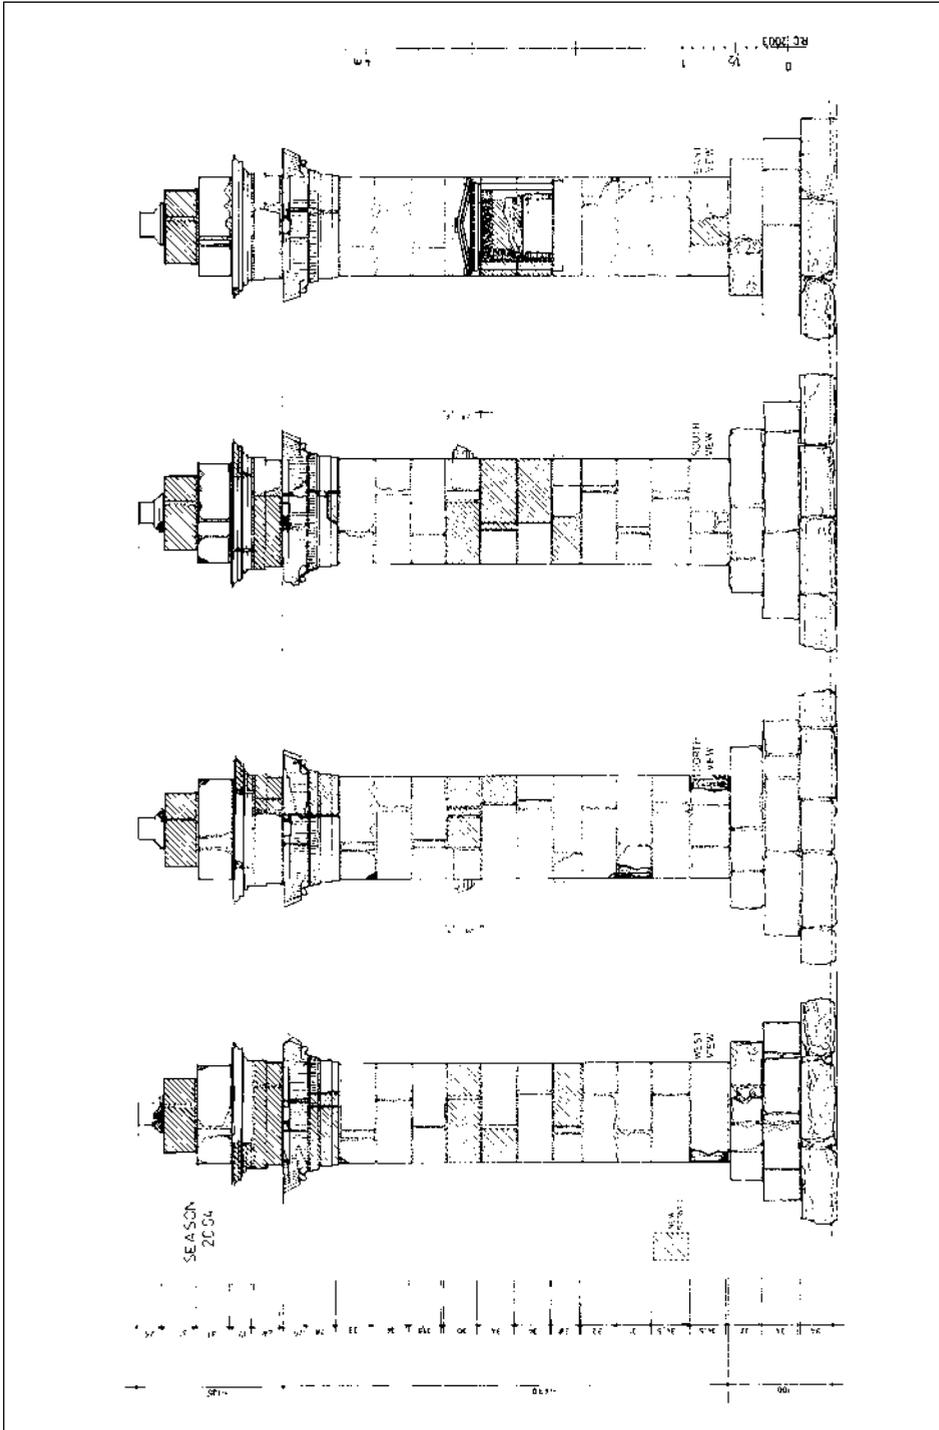
Fig. 4. Analysis of the pillar structure of Tomb T1K
(Drawing R. Czerner, based partly on earlier documentation by J. Dobrowolski)

The anastylosis of the pillar structure of Tomb T1K was completed largely in the past season. (The tomb had been excavated in 1994,⁶ and it was then that the inventory drawings were prepared and a drawing reconstruction of the superstructure proposed).⁷ This year an architrave was introduced crowning the cornice, two receding courses of blocks and the base of a small pillar topping the structure [Fig. 4].⁸ Most of the elements were original and were found toppled around the tomb. Only two of four architrave blocks and the blocks of the second course above the cornice had survived. The rest have now been reconstructed in new limestone. The corner fragment of one of the four blocks forming the full circumference of the cornice was broken off and lost. There were other losses as well, requiring full workshop conservation⁹ that included desalination. Epoxy resin (KEMAPOXY 150 by C.M.B., produced in Egypt) was used to fasten the corner piece made in new limestone, reinforced with two stainless steel rods. Larger losses were filled

in with new limestone, smaller ones with mineral putty (binder-to-filler ratio 1:3). The binder was a mixture of slaked lime with white Portland cement (1:1), the filler crushed lime. A small amount of 5% solution of acryl resin (PRIMAL AC 33) was added to the mortar.

Specialist conservation work on this tomb superstructure covered also a structural reinforcement of the carved elements of the tympanum above the small niche holding a sculptured stela in the middle of the east side. A silicon stone strengthener (OH by Remmers) was used for the purpose.

The anastylosis of all the elements was carried out using traditional methods with mortar in accepted proportions of sand, slaked lime and white Portland cement (6:3:1). The bigger losses were filled in with putty and a finishing chromatic unification was carried out using mineral pigments.

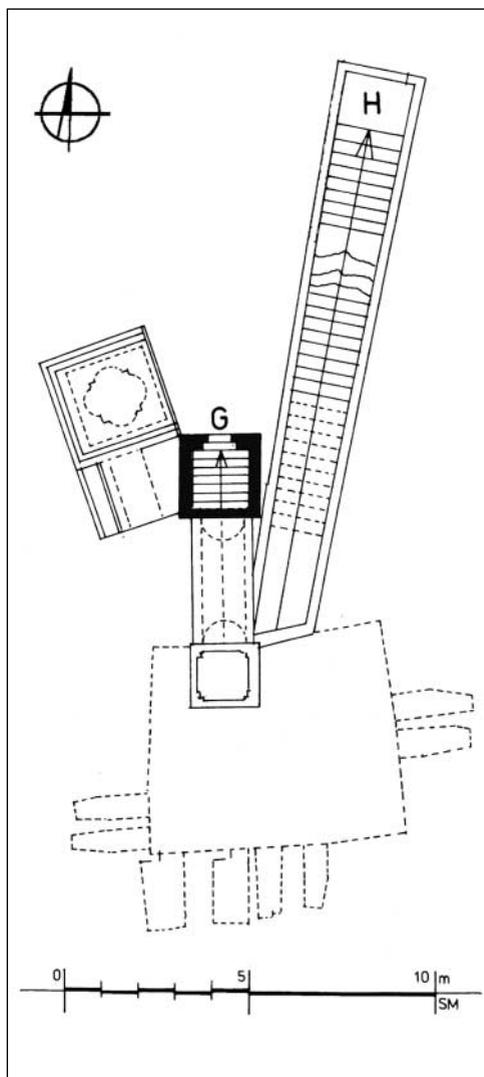
Fig. 5. Plan of hypogeum T1GH and neighboring pillar tomb T1D (Drawing S. Medeksza)

Following upon previous conservation work in this hypogeum,¹⁰ which included the restoration of dromos H and the decorated casing of the light shaft of the hypogeum in 2002-2003 [Fig. 5], the mission now proceeded with a partial reconstruction of the entrance kiosk to dromos G [Fig. 6].¹¹ Since it seems likely that the kiosk was destroyed already when the neighboring pillar tomb T1D was con-

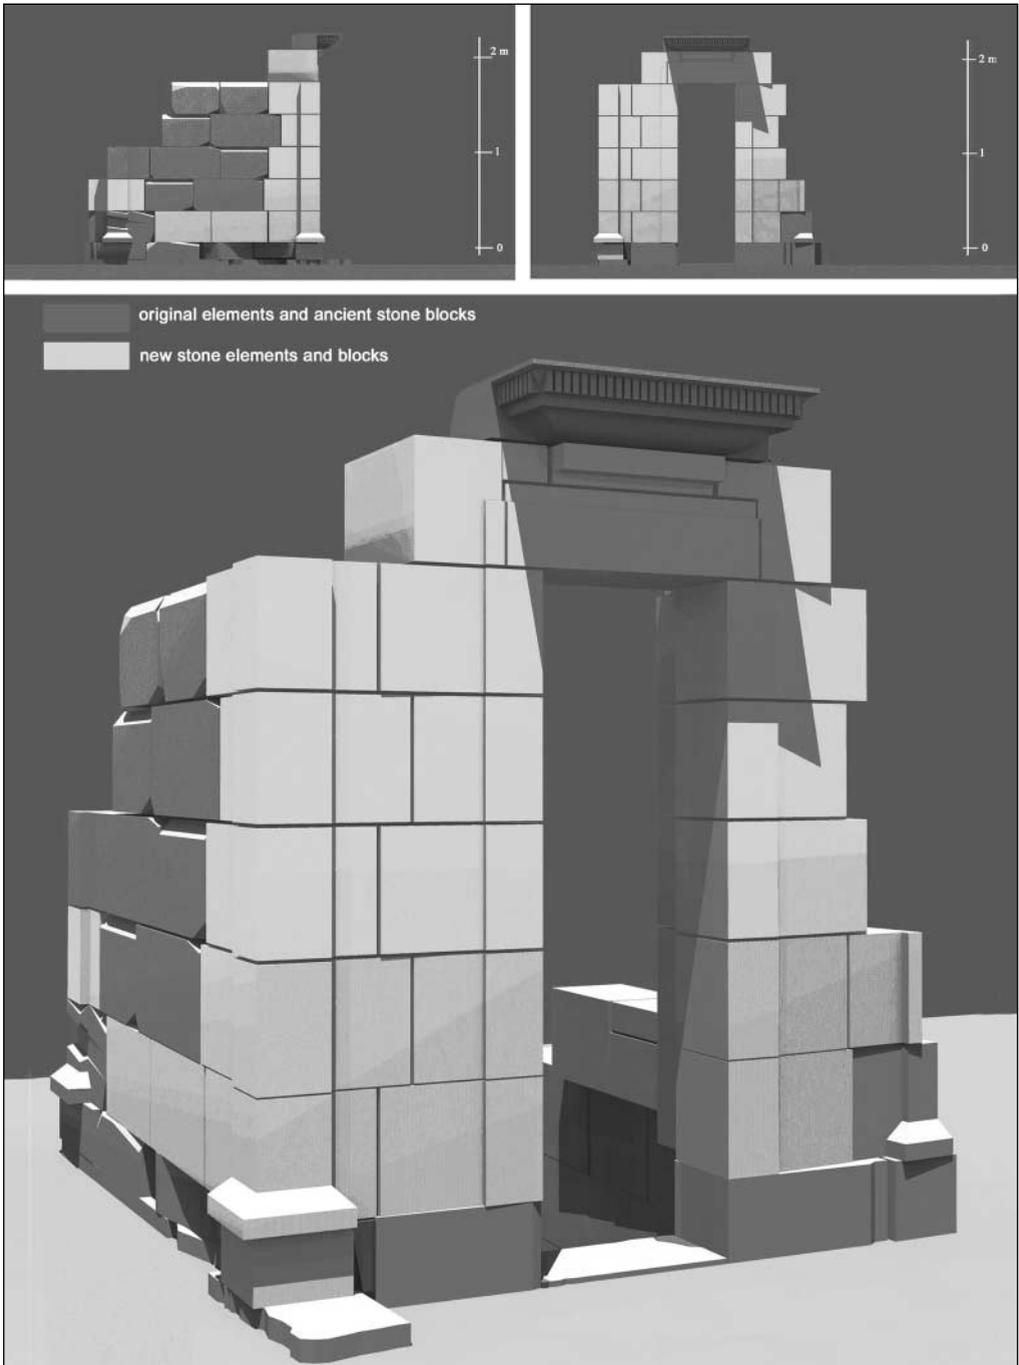
Fig. 6. Reconstruction of the kiosk of Tomb T1GH
(Drawing R. Czerner)

structed (its lower walls stand on the lower parts of the western wall of the kiosk), the reconstruction on this side was not carried out. Only parts of the eastern and northern (front) walls were restored, including the entrance with the original cornice (preserved in 1998).

In earlier seasons, the underground structure of the dromos (G) with its virtually complete vaulting had been consolidated. All the foundation walls were in place, rising 0.24 m above ground level, but built up with five courses of stone blocks to a height of c. 1.50 m. The foundation courses preserved incised lines tracing the plan of the kiosk; also, two blocks of the first course of the walls in the southeastern and northwestern corners had been preserved, including carved bases and lower parts of small pilasters. The two blocks were 0.33 m high, equal to the upper foundation course and of the same width: 0.40 m in the eastern wall and 0.52 m in the northern one. These dimensions were adopted for all the new blocks used in the reconstruction of the walls and jambs.

The eastern wall was largely built up of original limestone blocks recovered from the fill, while the northern one with the northeastern pilaster, entrance jambs and doorframe were made of new blocks, following the evidence of traced lines on the foundation course. The height of the doorway was reconstructed as three times the width, a common design evidenced in contemporaneous structures discovered in the area. It corresponds to five courses of wall blocks, each measuring 0.33 m in height. The original cornice was placed above the successive, sixth layer containing the lintel. Its presentation at the proper height is didactic. The front wall west of the doorway was given a jagged form to suggest its collapse and to remind of the partial destruction of the kiosk when neighboring

tomb T1D was built. Elements of the kiosk were mounted using traditional methods with mortar following accepted proportions (sand to slaked lime to white Portland cement 6:3:1). The new elements were unified chromatically with the original stones using mineral pigments.
