Kom El-Dikka: Excavation and Preservation Work, 2003

Polish Archaeology in the Mediterranean 16, 17-30

EXCAVATION AND PRESERVATION WORK, 2003/2004

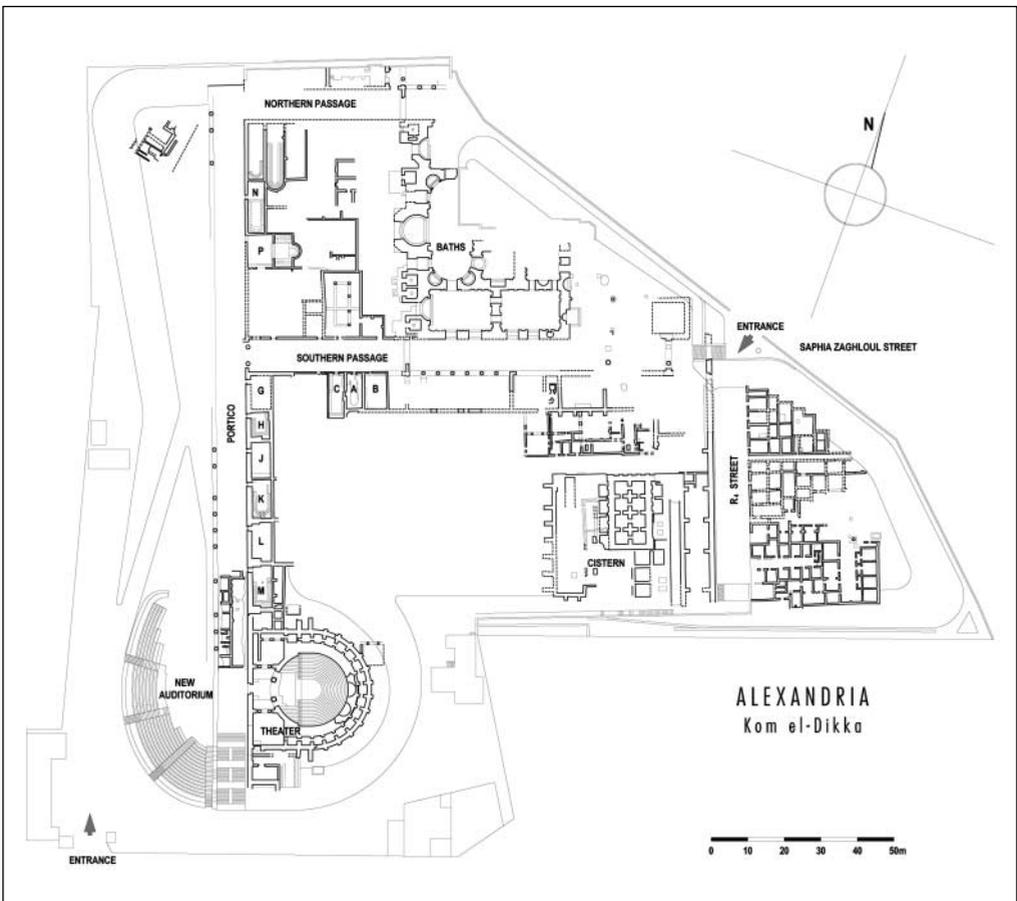
Fig. 1. General plan of the site
(Drawing W. Kotqtaj)

pected along the entire length of the portico and this initial assumption has now been fully confirmed as another three halls (H, J and N) were excavated this season [Fig. 1].

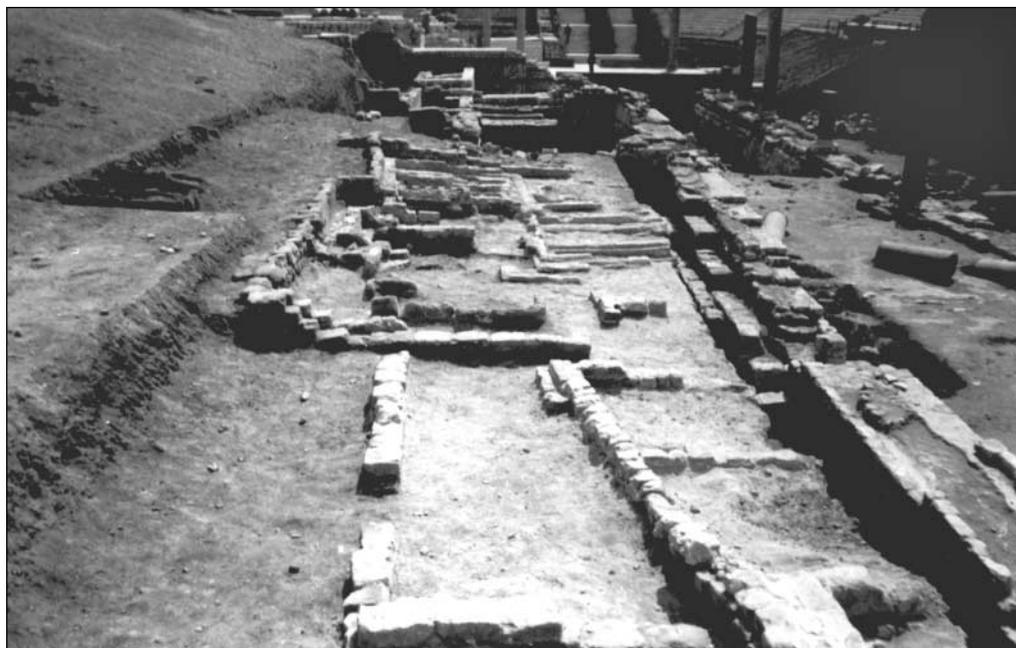
The upper strata in the area of planned work corresponded to a vast Moslem cemetery, which is known to cover virtually the entire site. Some twenty or so graves of the so-called Upper Necropolis (nos. H 10-17 and H 41-48) were cleared within the trench confines (8 x 20 m) [Fig. 2]. They were, however, largely damaged by later robbing activities. In some cases, the superstructures were utterly destroyed, exposing burial chambers underneath. In the southern part of the trench, an extension of the perimeter wall surrounding a group of previously excavated graves was cleared. The accompanying strata yielded the usual assortment of artifacts: medieval glazed pottery both Egyptian and imported, some lamps and glass finds, all dated to the 10th-12th century AD.³ Two fragmentar-

Fig. 2. Area H. Moslem Upper Necropolis looking south
(Photo G. Majcherek)

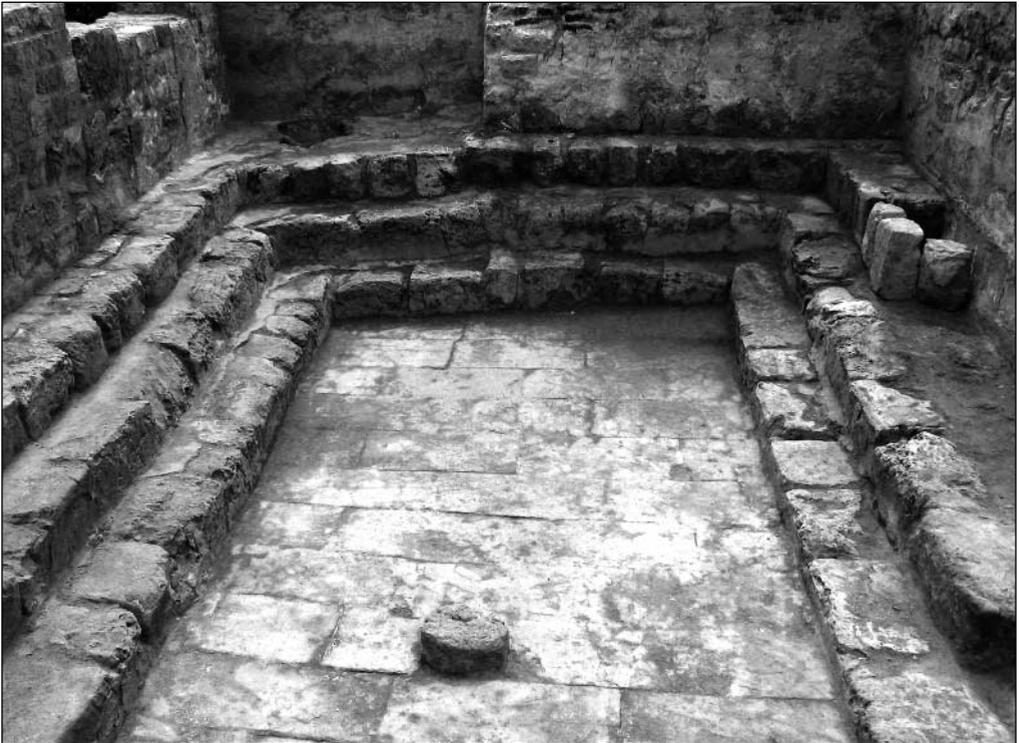
Fig. 3. Auditorium H. View from the north
(Photo G. Majcherek)

torium [Fig. 3]. It has proved the smallest of the excavated halls, measuring roughly 5.10 x 6.70 m. Three rows of benches ran straight along the three walls. The southern end was higher, accom-modating a seat for the lecturer. The benches (0.30-0.35 m high) survived almost intact in the southern and eastern part of the hall. Of those lining the western wall, the topmost row is gone, but the dismantled stones have left clearly visible imprints. The inner face of the southern wall was not aligned with the portico back wall buttress, which is recessed by 0.70 m. This irregularity caused some problems in planning the benches on the south. The resulting recess was filled with rubble and plastered, creating a kind of platform that ran even with the topmost

row of benches. The floor was made of regular, carefully laid limestone pavers. Nearer to the door, again almost in the middle of the hall, there was a small hexagonal limestone block rising conspicuously above floor level. As in the case of Hall J, it is likely to have something to do with the oratorical function of the room. Yet another puzzling installation was noted next to the north wall. It was a small, elongated basin (0.80 x 2.65 m), its walls lined with waterproof plaster. There was neither a solid bottom nor an outlet. The purpose of this basin remains enigmatic, especially in view of the assumed function of the hall.

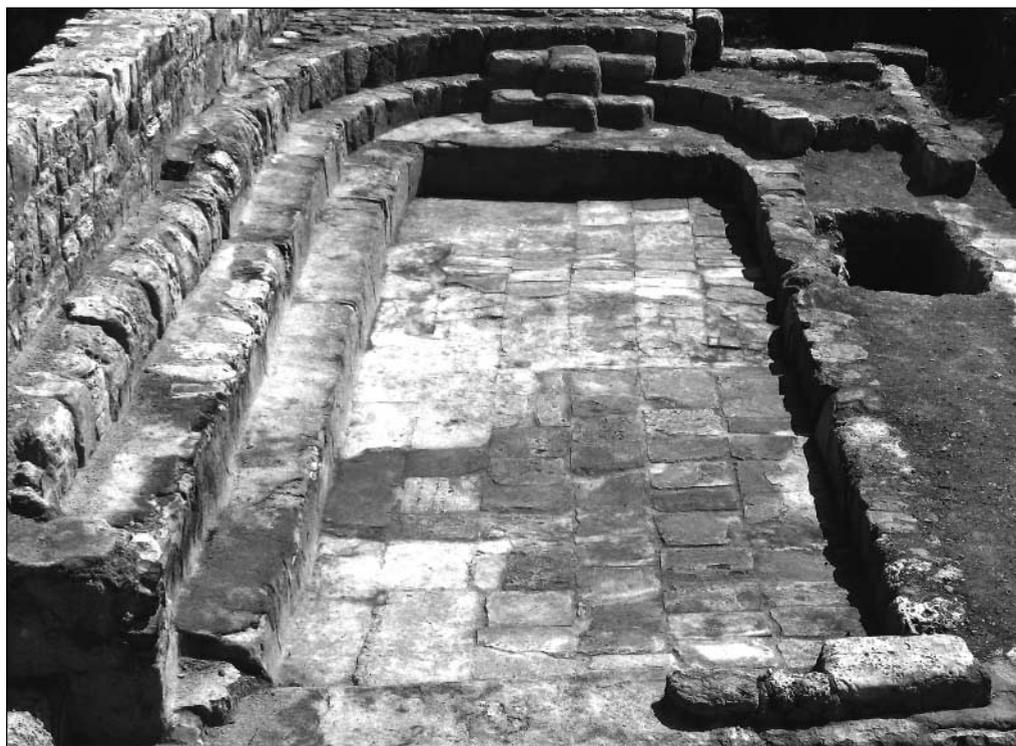
Fig. 4. Auditorium N. View from north
(Photo G. Majcherek)

Yet another auditorium (N) was cleared immediately below the medieval cemetery level. It was an elongated structure (approximately 14.25 m long), clearly divided into the auditorium proper and preceding anteroom. The latter almost square room (5.00 x 5.10 m), accessed from the Theatre Portico, opened into the auditorium through a wide doorway. The lecture hall (approx. 8.75 m long) was furnished with three built rows of stone benches placed along the walls and an apsidal ending on the south [*Fig. 4*]. Remnants of an elevated seat and the low steps leading to it occupied the center of the apse. The western stretch of benches was found almost totally dismantled. Remnants of a single bench were preserved also in the vestibule. The floor in both rooms, badly damaged by later burials, was paved with regular limestone slabs.

Its east wall, although heavily weathered, has been preserved to a height of

0.90-1.70 m above floor level. The west (back wall of the portico) and south walls were shaved off practically at ground level. The damages were apparently due to medieval plundering.

The newly uncovered auditorium N also received immediate attention. First, the missing facing of the eastern wall was repaired over a distance of some 14 m. The wall had suffered badly from weathering and damages caused by medieval burials. All the missing or eroded stones were replaced with new ones. The wall was rebuilt to a maximum height of some 1.60-1.80 m in places and the wall coping additionally reinforced to prevent water penetration. Some of the benches along the northern wall were found to be quite well preserved with only minor reparation needed, while the southern part of the auditorium had been almost entirely robbed out. The

necessity to rebuild also a huge adjoining facade wall excluded immediate restoration of the benches. Only the lowermost run of seats and a fragment of the southern apsidal ending could be restored.

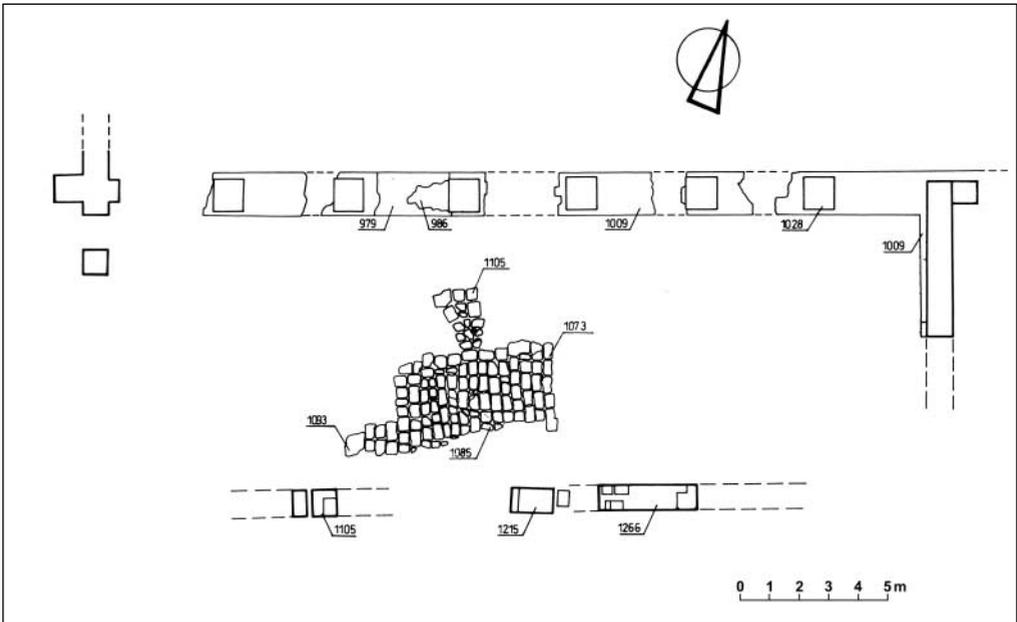
The layout of the palestra was thus marked out on the ground; the facility was found to measure approximately 9 x 27 m and to be surrounded with porticoes on the north, east and presumably also west (assuming a symmetry of design) [*Fig. 5*]. These rather modest dimensions, standing in telling opposition to the overall size of the bath complex, conform well to Late Roman practice and find numerous parallels in bathhouses excavated in the Eastern Mediterranean.

Fig. 5. Southern palestra of the bath
(Drawing M. Krawczyk)

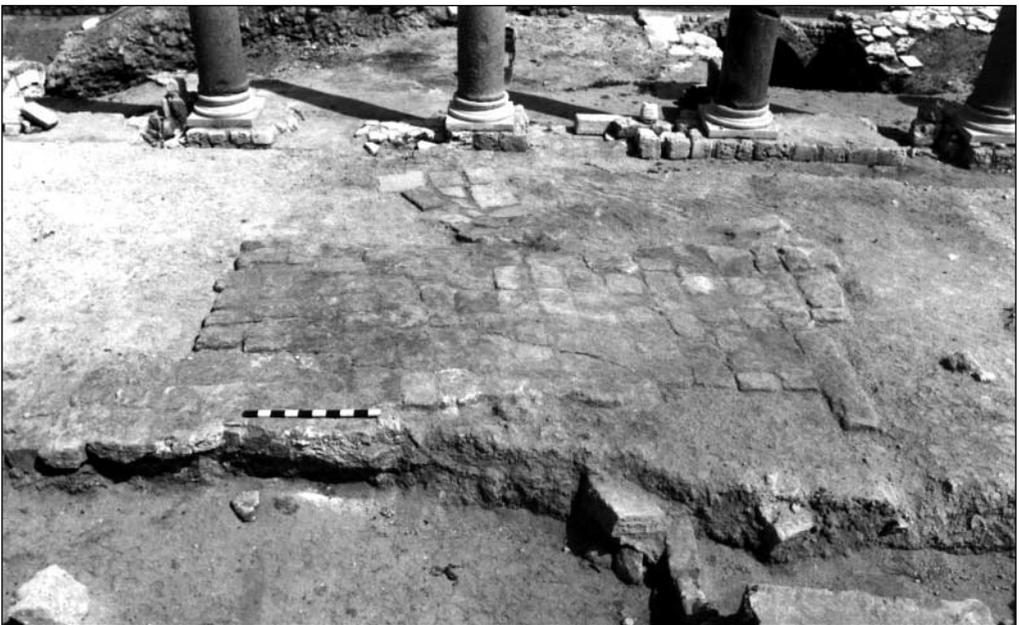
The work was halted temporarily at a level approximately 11.00 m above sea level, where a large stretch of flagstone paving was cleared [*Fig. 6*]. The paving is

Fig. 6. Flagstone paving of the southern palestra of the bath
(Photo G. Majcherek)

preserved only in the central part of the area, in other locations it had been apparently removed leaving a rubble substructure. The paving rises some 1.20 m above the level of the portico flagging and can hardly be linked to the latest phase of the bath. Pre-

liminary dating based on the available material (pottery and lamp fragments) collected from the layer lying directly on top of the paving, points to the 7th century. Detailed dating should be possible upon examination of the underlying strata.

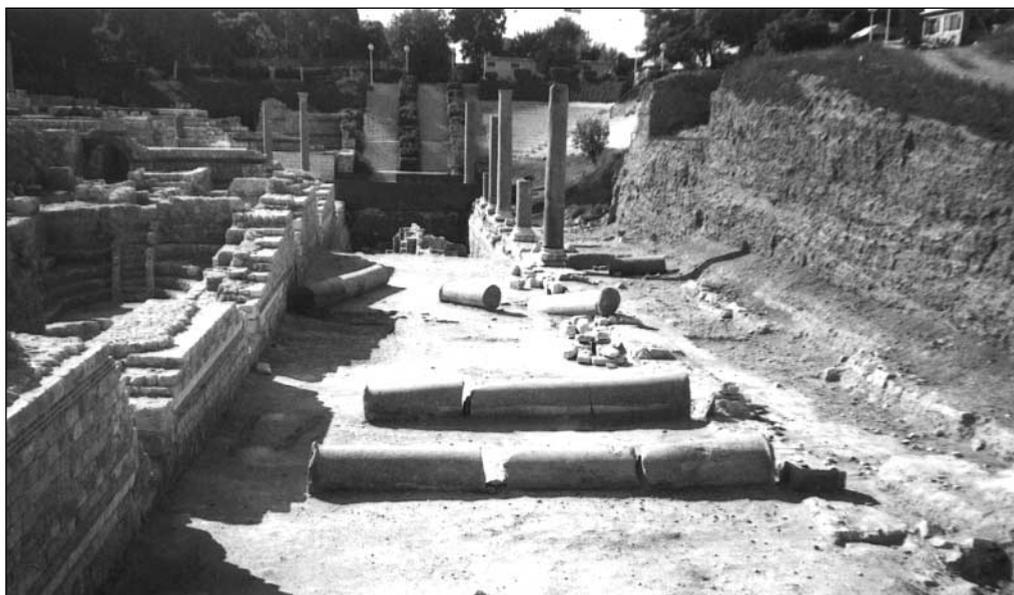
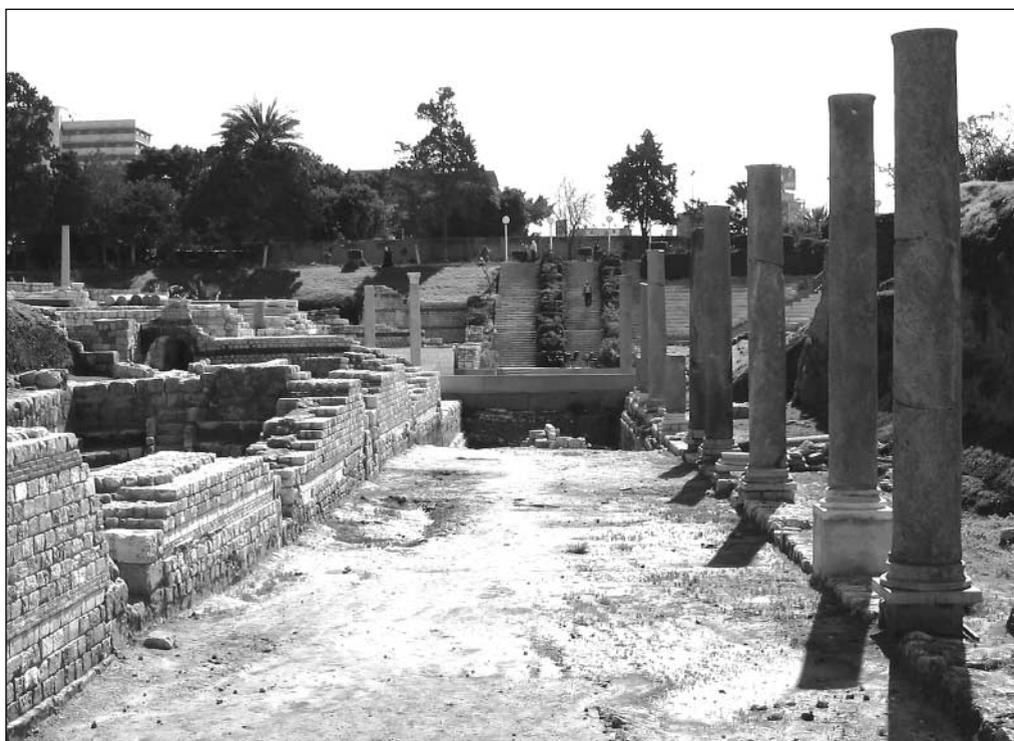
The anastylosis of the portico was the most important operation undertaken this season. Two recent field campaigns resulted in the clearing of c. 40 m of the portico.⁸ Four toppled and broken granite columns were found lying immediately on top of the extant pavement of the portico [Fig. 7 top]. Since the adjacent section of the portico stylobate was found to be quite well preserved with only some minor reparation needed, it was decided to proceed with the raising of the columns to their respective original positions [Fig. 7 bottom]. All the original marble bases were missing, so limestone replacements had to be manufactured. One of the columns, however, turned out to be shorter than the others; originally, it must have stood on a low pedestal to compensate for the missing height. A pedestal of two large blocks was constructed to accommodate it. The land configuration and easy access to the area in question allowed the lifting operation to be carried out using a crane instead of the traditional tripod and pulley device.⁹

*Fig. 7. Theatre Portico before (top) and after restoration, looking south
(Photo G. Majcherek)*

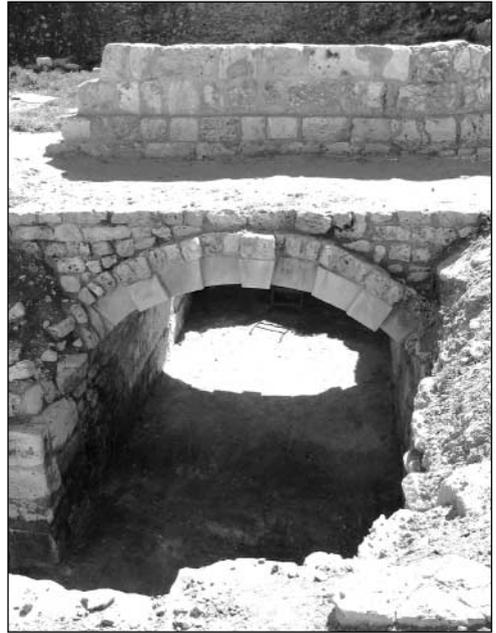
The operation that was technically perhaps the most demanding and certainly the most time consuming was the restructuring of the damaged vault over the southwestern entrance chamber of the subterranean service area. The vault had collapsed apparently under the heavy load of a Late Roman wall built across it and was found resting on a thick deposit of ashes and bath refuse. The wall itself had subsided and been deflected considerably. Following detailed recording in drawing and photo-

Fig. 8. Restored vault in the southern passage of the bath, looking south (Photo G. Majcherek)

graphy, this wall was dismantled, the fill cleared and the lateral walls of the chamber inspected for damages. Disintegrated blocks were replaced with new ones and the voids were filled with new mortar, making the construction structurally sound again. Since all the extant stone elements of the original vault were either heavily weathered or utterly destroyed, it proved necessary to rebuild the vault with new blocks cut to the required dimensions. The restored fragment

of the vault is approximately 4.50 m long. In the next stage of the operation, the dismantled wall was reassembled in its original position and the outer coating of the vault restored of smaller, randomly arranged stones [Fig. 8]. The restoration of this vault was essential in view of the planned visitors' route that is to run along the southern facade of the baths. The gap between the western and eastern part of the passage was thus bridged.

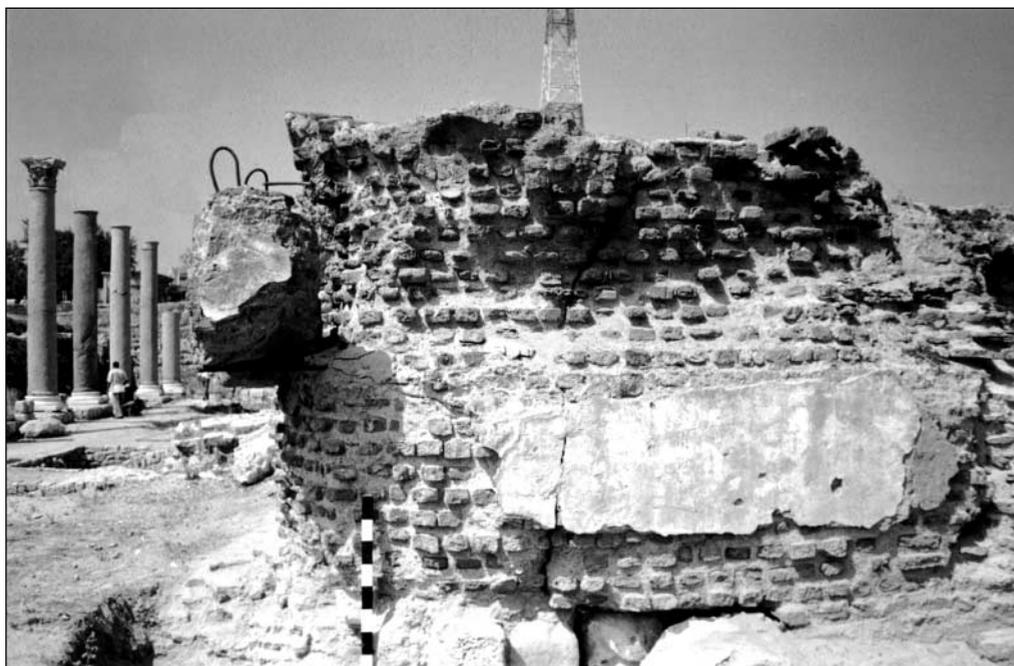
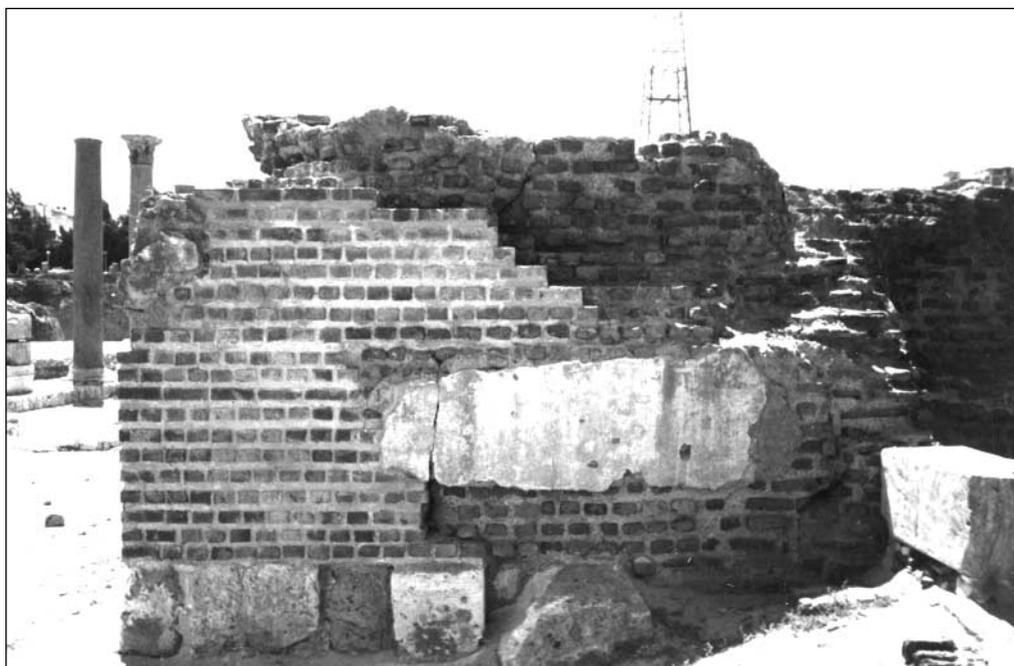
Fig. 9. *The southeastern corner of the bath before (top) and after restoration (Photo G. Majcherek)*

The already well advanced restoration program for the bath complex focused on the southern part of the complex. The southeastern corner of the edifice was restored in the manner of the original construction. The corner turned out to be severely damaged and the stone from the foundations robbed out sometime in medieval times [Fig. 9 top]. In the past, a large section of the original brick-made corner had been anchored with steel rods to the extant core of the wall.¹⁰ It was decided now to rebuild the entire corner, in an effort not only to restore its original appearance, but also to support this hanging fragment. A test pit revealed poorly preserved remains of stone foundations. They were rebuilt with large limestone blocks, whereupon the red-brick facing was carefully restored up to c. 2.50 m above the original occupation level [Fig. 9 bottom]. The hanging segment of the original wall now rested securely on the newly built structure, and the supporting steel rods were removed.

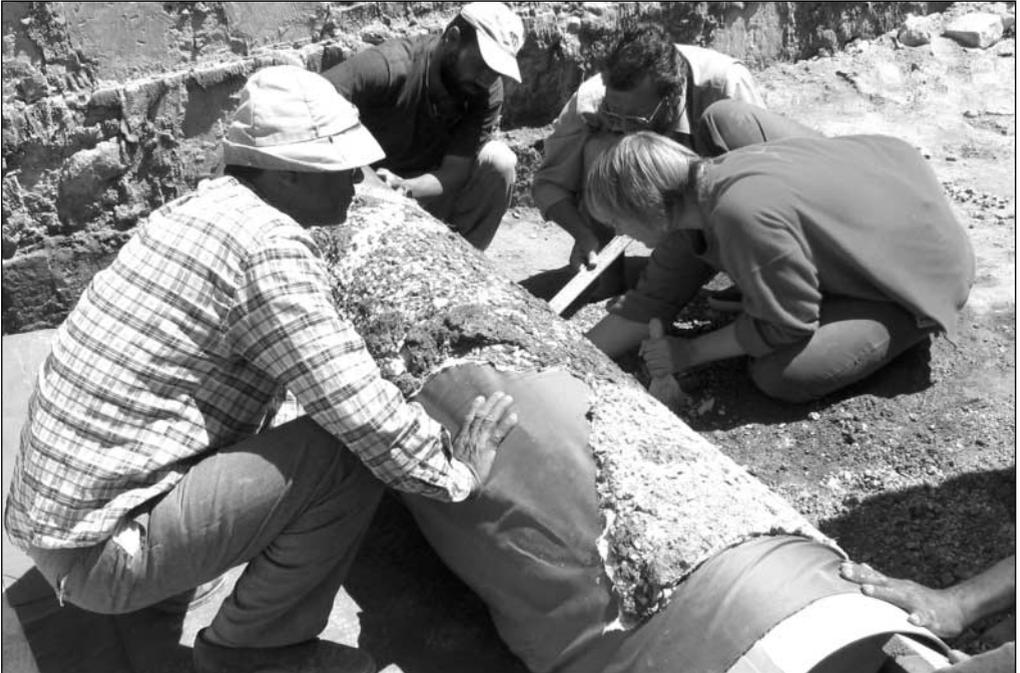
Fig. 10. *Transferring the mosaic*
(Photo A. Chabiera)

face.¹² In view of its size (3.90 x 1.90 m), the mosaic could not be removed in one piece. It was decided to cut it into two smaller sections, positioning the cutting lines to follow basic pattern designs.

Standard conservation procedures were applied during the operation.¹³ To facilitate the process, two rows of tesserae were removed along the dividing line. The surface of each section was cleaned and then rinsed with 5% ammonia water and acetone. The surface was then fixed with two layers of cotton gauze and reinforced with canvas, all soaked in PVA. Both sections were then

carefully detached from the bedding and gradually rolled onto a specially prepared wooden drum (c. 0.60 m in diameter) [Fig. 10]. The mosaic was then transferred to an on-site field laboratory where conservation treatment was continued. Remains of the bedding adhering to the underside were removed and the back of the mosaic was impregnated with a 7% solution of PRIMAL AC-33.
