Banganarti and Selib: Season 2010

Polish Archaeology in the Mediterranean 22, 273-294

BANGANARTI AND SELIB SEASON 2010

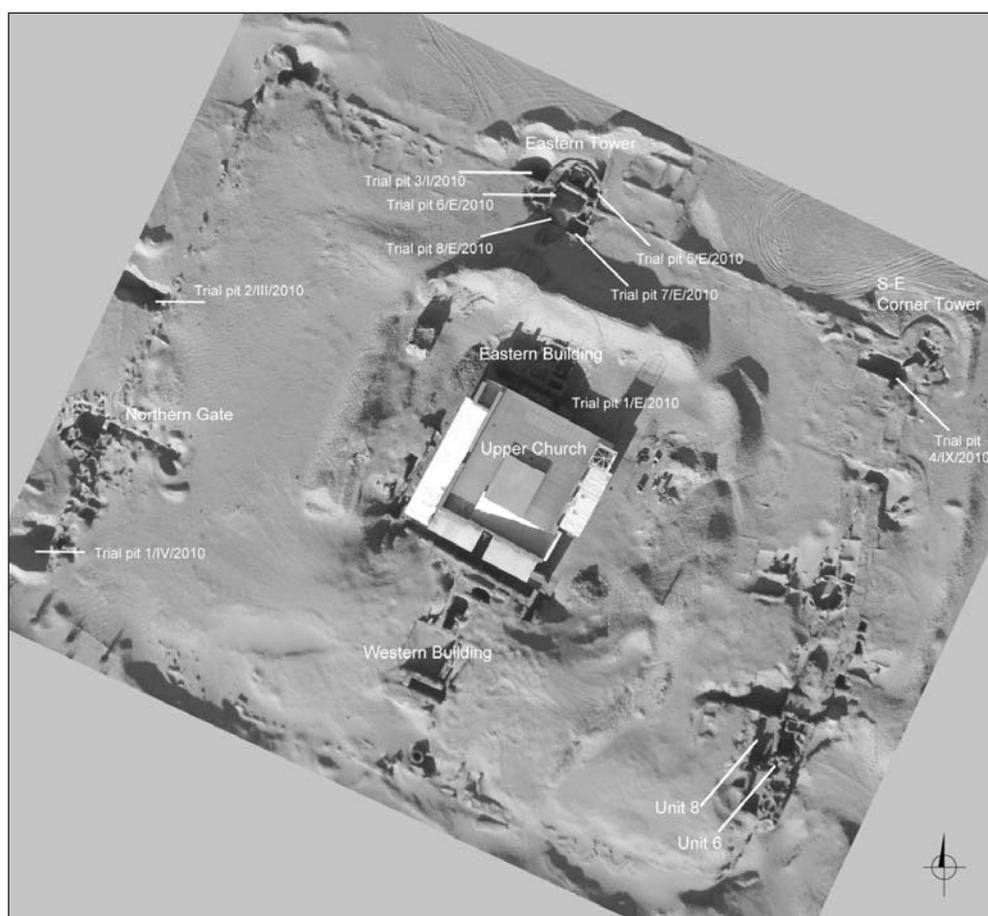
Fig. 1. Site of Banganarti 1 on 27 January 2010; marked trial pits and main structures on the kom; for a plan of the corresponding area, see below, Fig. 1 on page 296 (Kite photo B. Żurawski)

The excavations at Banganarti concentrated on the fortifications (for an in-depth review and discussion of the enceinte walls in Banganarti and Selib, see Drzewiecki 2013, in this volume). Two trial pits were traced on either side of the Northern Gate on the outside of the wall, 2/III/2010, 10 m by 14 m in size, 16 m to the east of the gate, and 1/IV/2010, 5 m by 3 m, 12 m to the west of it. The objective was to locate a cemetery (reportedly observed in this area by local residents planting palms in the late 1990s) [Fig. 1]. Culturally sterile sand was reached in both pits at a depth of

Exploration of the Southeastern Corner Tower [see Fig. 1] was continued from the previous season (see Żurawski 2011: 273–276). The topmost layers produced fragments of richly decorated, wheel-thrown plates and bowls dated to the 10th–12th century. Digging through the lower layers yielded a collection of mud jar sealings (part of a deposit first tested in 2001). Altogether 49 mud bungs and a couple of ceramic stamps, one decorated with the Raphael monogram [see Fig. 12

Another big trench (Unit 6, see *Fig. 1*) was opened in the western (riverward) part of the south wall. Excavations there brought to light a set of ceramic vessels from the 7th century, including a huge spouted jar decorated on the shoulders with a painted frieze of birds [*Fig. 2*].

Exploration of the area between the east wall of the Raphaelion and the Eastern Building (trial pit 1/E/2010, see *Fig. 1*) uncovered a red brick wall encircling the northeastern corner of the Lower Church and disappearing in the north trench wall. It was substructured with a deposit of unworked limestone and a layer of burnt soil set in pure sand in the northern part of the pit [see *Fig. 3*].

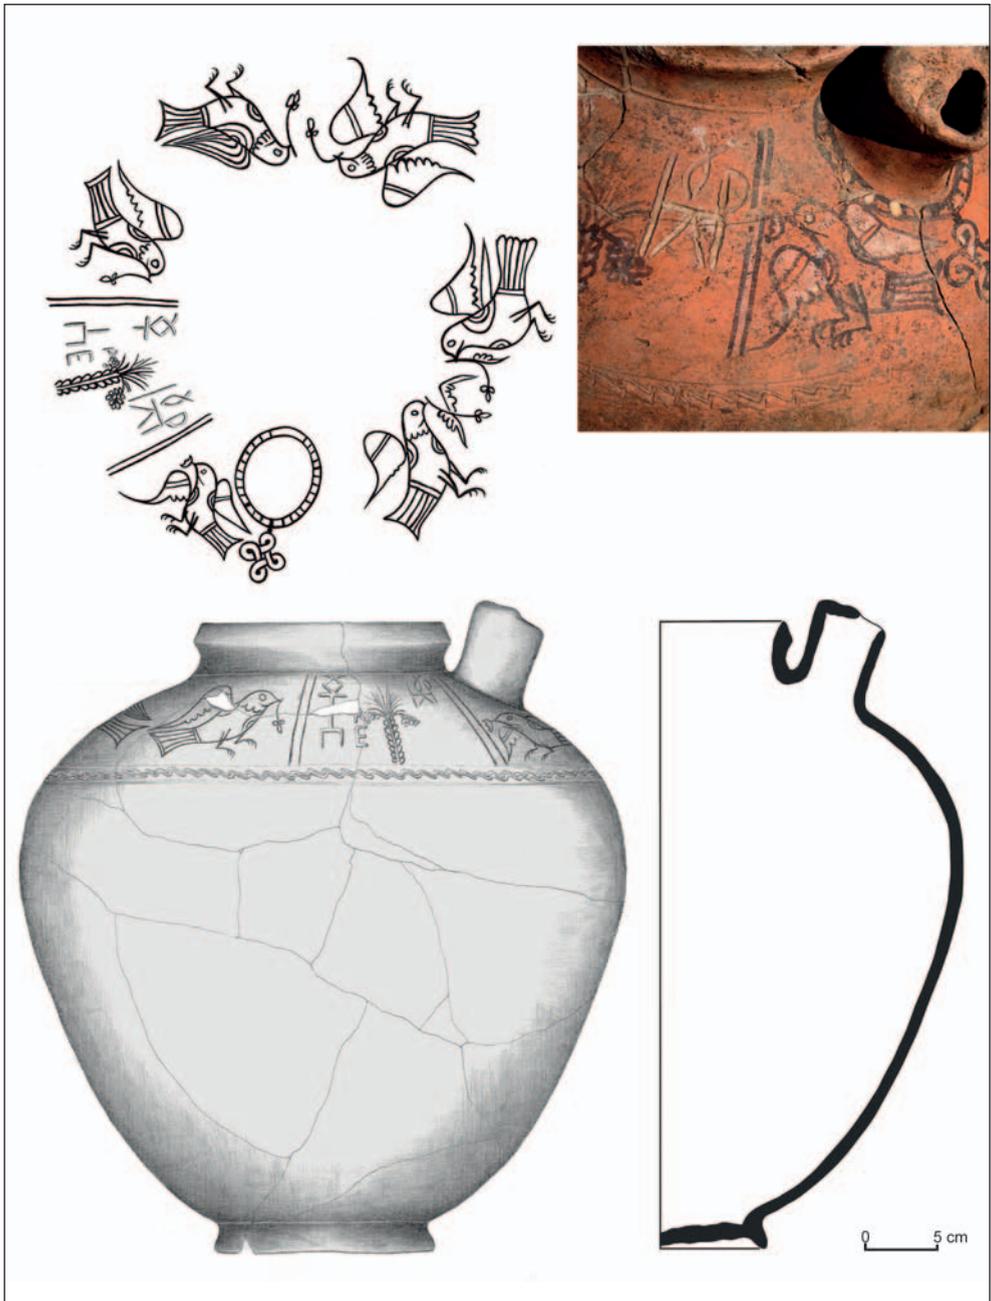
Fig. 2. Spouted jar with a painted frieze of birds on the shoulders
(Drawing A. Cedro; photo M. Drzewiecki)

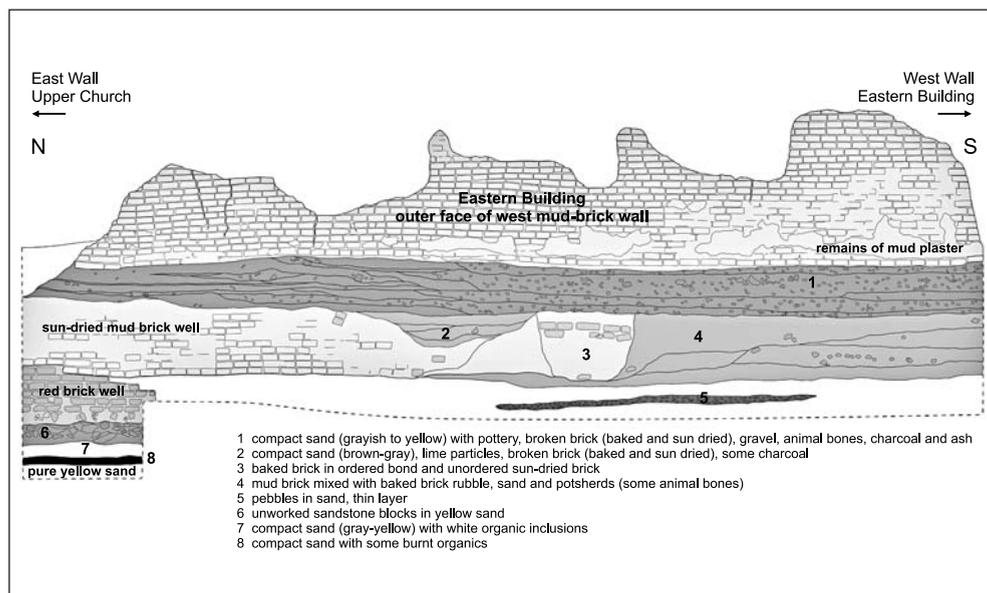
Fig. 3. Section through trial pit 1/E/2010, western face of the west wall of the Eastern Building (Drawing A. Cedro)

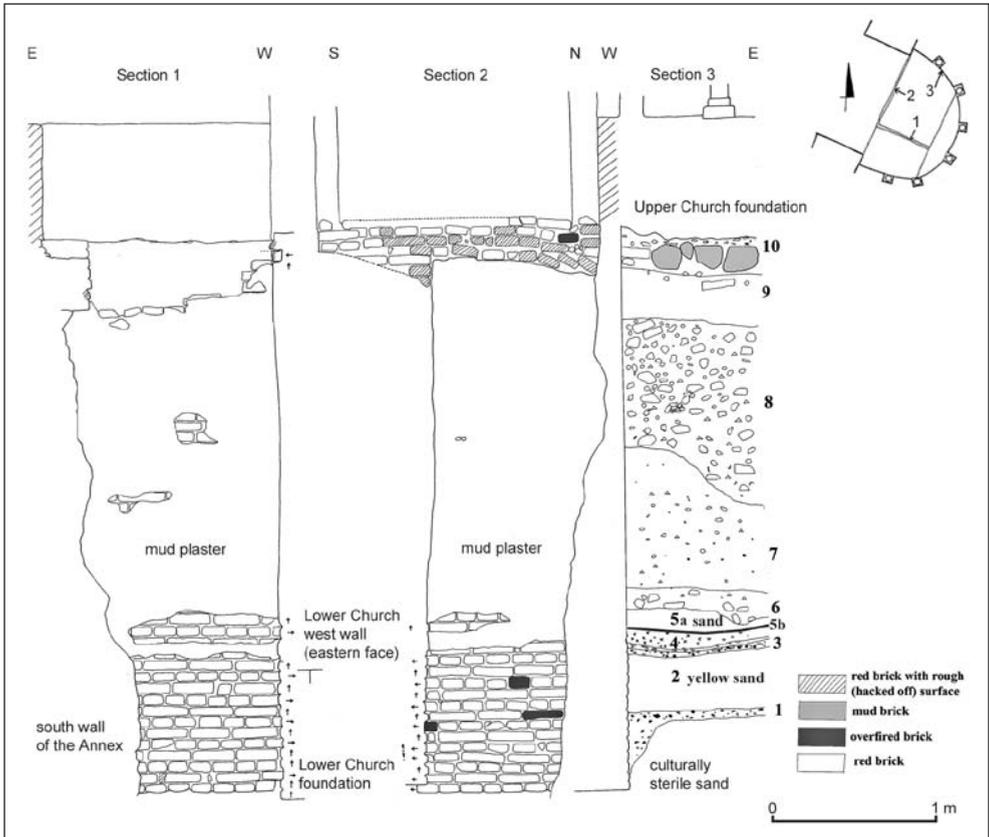
Fig. 4. Trial pit 1/2010 in Chapel 4 of the Raphaelion; for the legend, see accompanying text (Drawing T. Stepnik and B. Żurawski)

clear and regular (courses of alternating headers and stretchers). The foundation foot of the Lower Church wall was found at 4.20 m depth beneath the top of the wall [*Fig. 4*].

The occupancy preceding church construction was attested by a distinctive layer (1) starting 0.50 m above the foundation level (see trench section 3 in *Fig. 4*). The foundation trench for the Lower Church was dug into this layer. Layer 2 was composed of drifted yellow sand from the time when the foundations were laid and the wall was plastered. On both exposed walls the lower edge of the plaster, marked by a conspicuous set-off, appeared at a height of 1.10 m above the foundation foot. It coincides with clear evidence of a prolonged occupancy registered in the earth profile. Layers 3 and 4 coincided with the liturgical use of

the Lower Church. Considerable amounts of charcoal, small fragments of red brick and pieces of lime found in layer 5(a) were suggestive of a conflagration that consumed the Lower Church. Superimposed was a layer of clean drifted sand 5(b), which must have accumulated when the ruins stood useless. Layers 6, 7 and 8 constituted fill associated with the construction of the Upper Church that was raised partly on the walls of its predecessor. The foundation of the Upper Church (10) was laid in the topmost layer of fill (9).

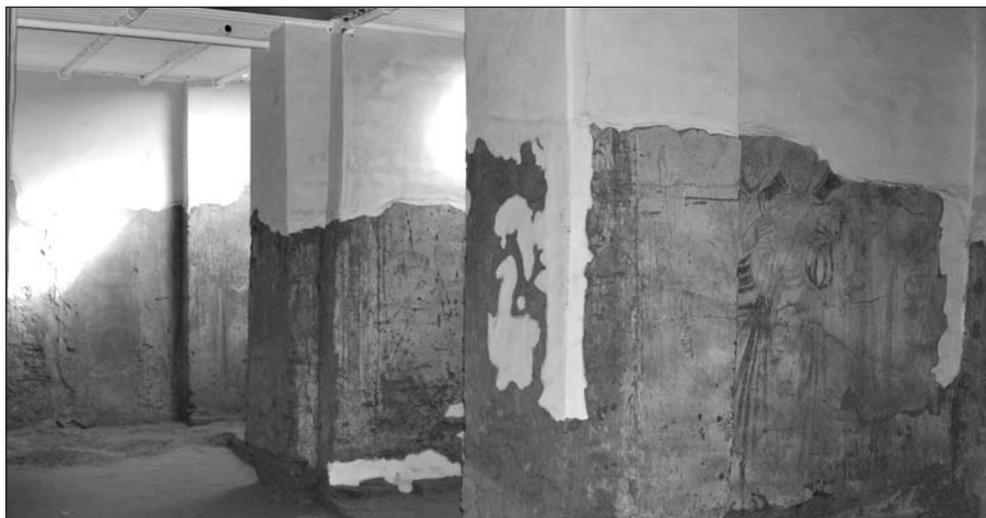
Fig. 5. Interior of the Raphaelion with plastered upper section of the walls in the northern part of the khurus (Photo B. Żurawski)

Last but not least, the new brick walls raised on top of standing ancient walls were rendered with lime plaster and whitened with lime wash [Fig. 5]. By the end of the season, seven of the eastern chapels had been plastered, as were also four rooms in the southern part and five in the western one. The illumination of the interior of the church was dramatically improved by the whitening, which contributed to better reflection and dispersion of light streaming in through the roof windows (which were made of corrugated Plexiglas).

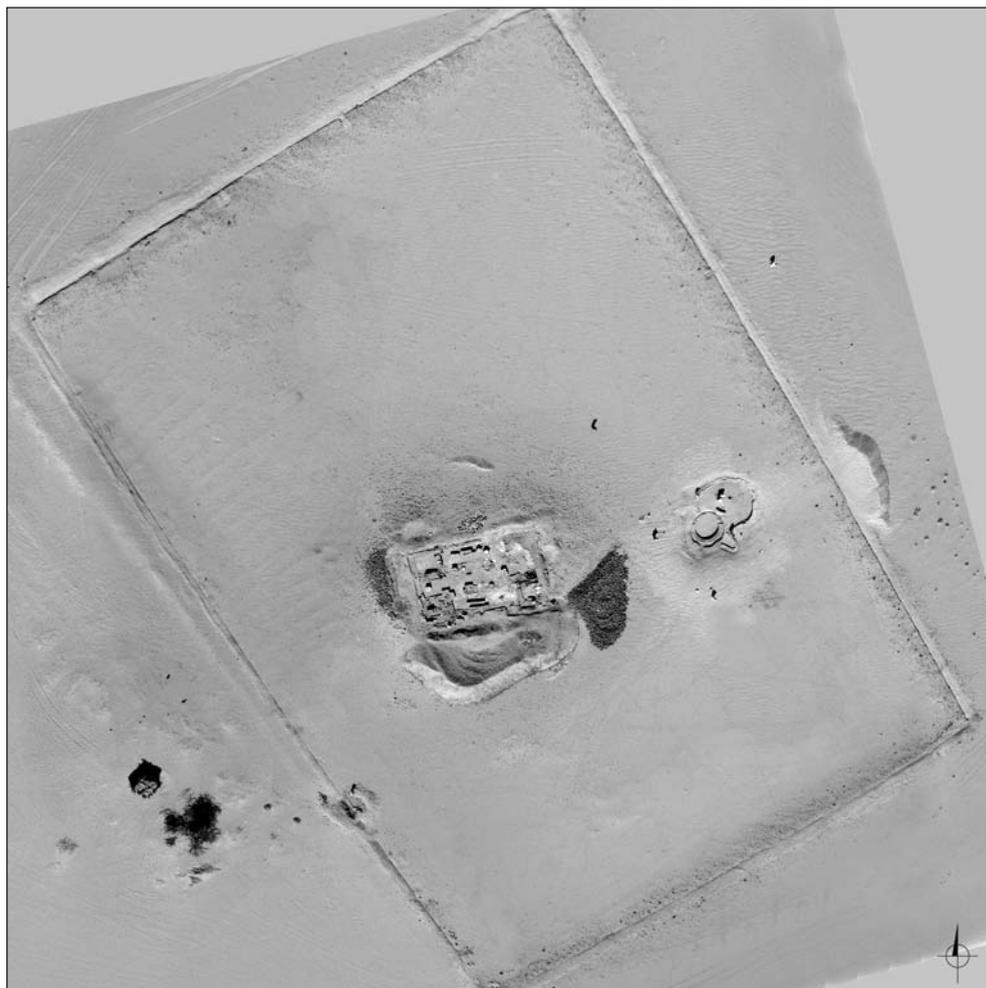
*Fig. 6. The site of Selib 1, aerial view following the season in 2010
(Kite photo B. Zurawski)*

The enclosure at Selib, known locally as *murabba kebir* (Arabic for "big square") despite its rectangular shape [Fig. 6; see also Fig. 2 on page 297], was now investigated (see also Drzewiecki 2013, in this volume).

In brief, it can be said that the wall is from 1.20 m to 1.50 m wide and its construction varied depending on the section. The oldest parts were raised as a core of smaller stones faced on both sides with bigger boulders

(rough and not dressed but laid in a way to produce a smooth surface). This mode of construction prevailed in the corner parts, whereas sections in between were made of mud brick (with some red brick) laid in different bondwork.

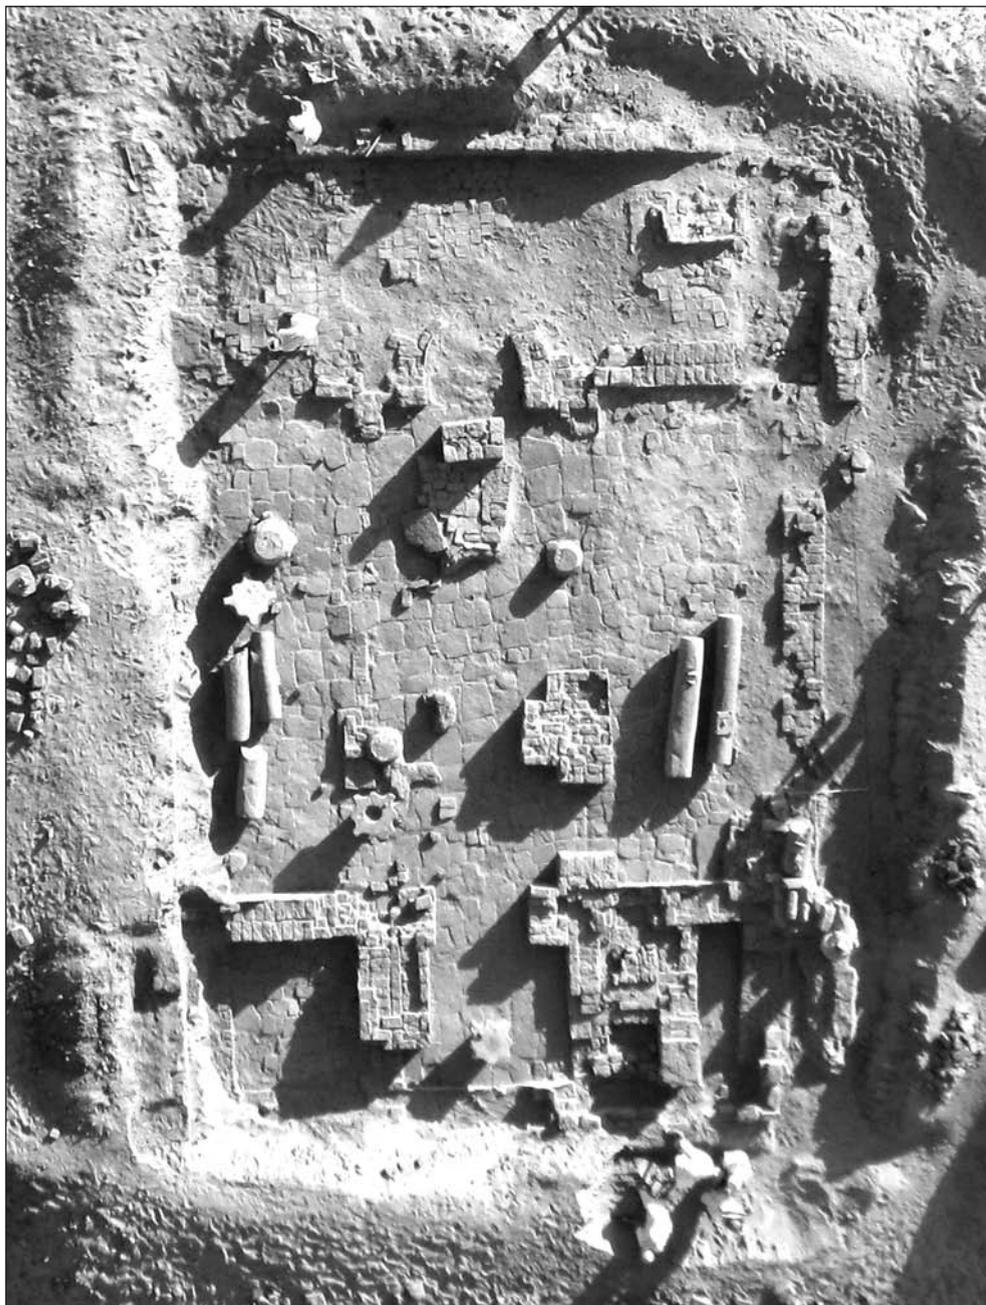
Fig. 7. Latest phase of the Selib church (=Red Brick Piers Church), view after clearing of the interior (Kite photo B. Żurawski)

clearing of the entire church interior from the latest phase (Red Brick Piers Church = RBC) [*Fig. 7*].

The uncovered, latest phase of the Selib church appeared to be raised on a basilical plan with an eastern passage behind the apse. The apse was uncovered and a stone altar was found next to it. The sacristies were paved with ceramic tiles (some decorated with geometric designs). Stone architectural elements lay on the pavement [Fig. 8]. The western part of the building was tripartite and a staircase was fitted into the northern unit. The gallery (if any) and vaulting were supported on massive piers that incorporated capitals from the previous phase of the church, reused as bases.

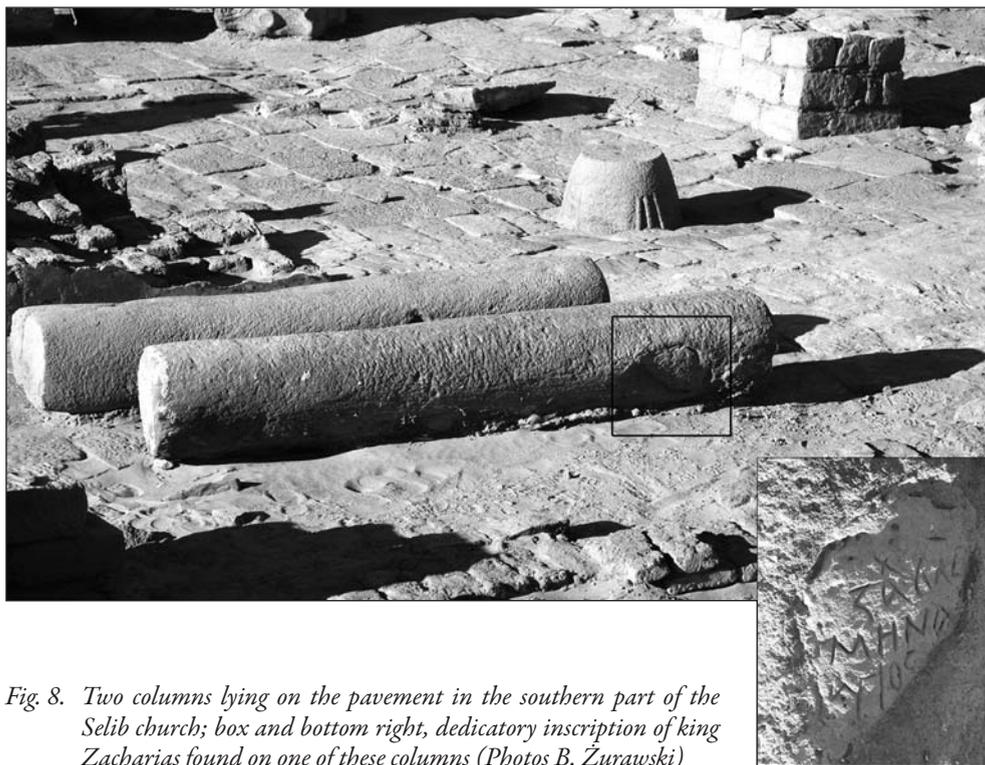
Fig. 8. Two columns lying on the pavement in the southern part of the Selib church; box and bottom right, dedicatory inscription of king Zacharias found on one of these columns (Photos B. Żurawski)

An inscription cut on one of the columns of ferruginous sandstone found lying on the pavement of the latest church [Fig. 8] tells of the building activity in the region of King Zacharias, who dedicated one of the Selib churches to St Menas. Whether the king in question is the Zacharias, father of King Georgios, of the 9th century has yet

to be confirmed. The column, however, fits the 6th/7th century capitals found inside the church. If the donor of the church really lived in the 9th century, then the distinctly early Christian columns and capitals found at Selib must have been brought from outside (presumably from an early Christian church destroyed in the 8th/9th century).

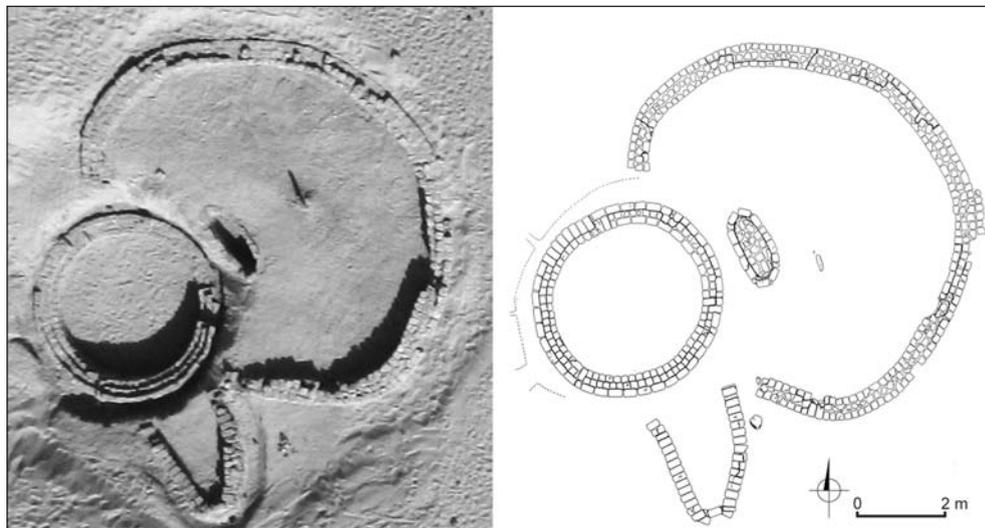
Fig. 9. *Saqiya at Selib: bird's eye view and plan of the well (matara)*
(Drawing A. Cedro; kite photo B. Żurawski)

Explorations began with tracing a structure observed on the magnetic map of the area. It proved to be a circular wall of red brick, about 0.50–0.60 m high. It was clumsily built of loosely bonded brick without foundations. An ellipsoidal hollowing lined with red brick in the southern part of this feature [Fig. 9]

looked like something that was designed to prevent people, who had come to draw water in buckets, from slipping into the well. Further digging led to the discovery of the well itself, which proved to be a couple of meters further to the south. The red brick masonry of this structure proved to be extremely well built. The inner diameter at the top was 5 m, while the depth could not be estimated for now.

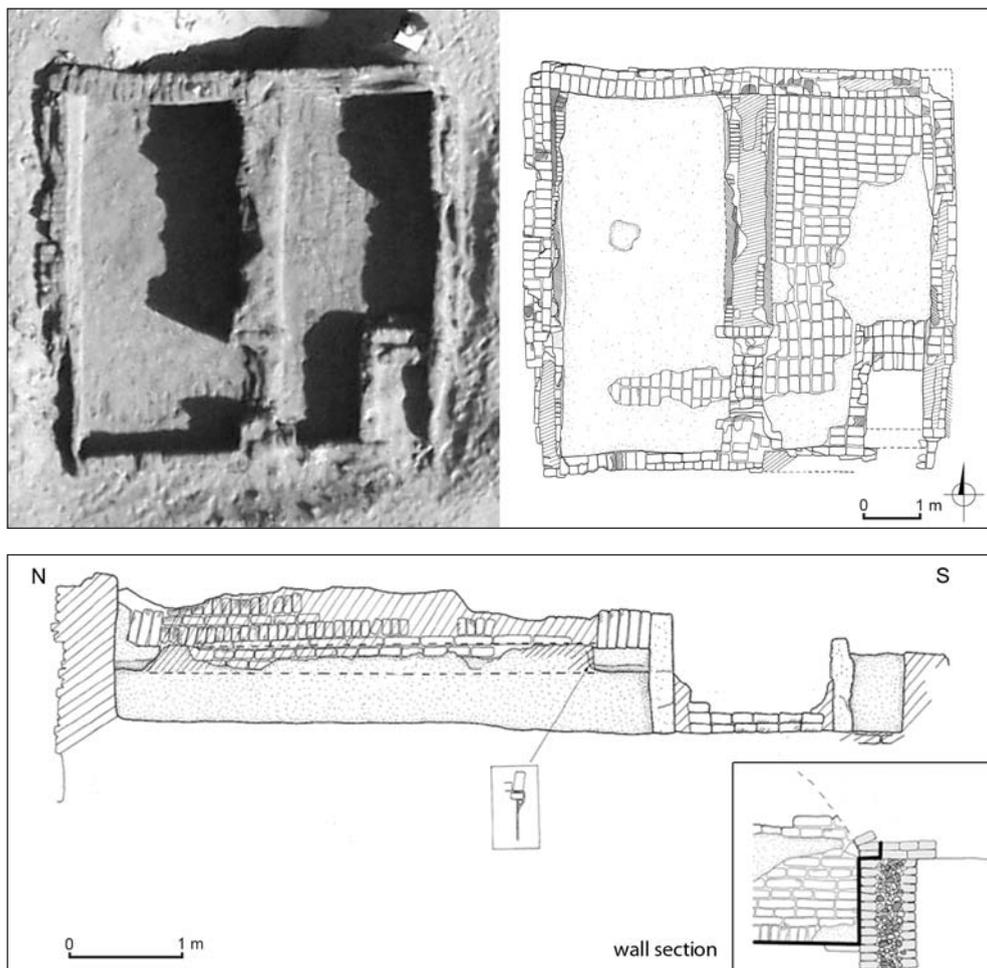
Fig. 10. Bird's eye view and plan of the early Christian house excavated at Selib 3 (top); N-S section (looking E); bottom right, section through an outer wall to show construction technique (Drawing K. Molga and B. Żurawski; kite photo B. Żurawski)

Testing of the mud-brick remains revealed a single-phase structure, composed of two rooms, one provided with steps leading to the (unpreserved) rooms upstairs [Fig. 10]. The outer dimensions of the building were 8 m by 7.70 m. Wall structure suggested the presence of an upper floor. The entrance was in the southeastern

corner, approximately 0.70 m above the pavement, and it led onto a platform filled with mud-brick debris, from which three steps descended to the pavement level. The rooms, which were similar in size, that is, 6.70 m by 3 m and 6.70 m by 2.50 m, were devoid of windows and were apparently entered from above. The walls were at least

1.80 m high and had barrel vaulting as indicated by the spring of the vault placed 0.70 m above floor level. The floors were paved with mud brick, laid in different arrangements and ultimately covered with mud mortar. The passage between the rooms (in the southern part of the divider) was provided with a threshold (three bricks high).

The outer walls were constructed in mixed technique, their subterranean part being built of a rubble core lined on both sides with brick, whereas the aboveground section was raised in typical brick bond [see *Fig. 10*, bottom right]. The top walls were wider than the lower parts (difference of a single brick) and projected from the outer face (a feature not observed from the outside as the lower part of the wall was concealed under sand).

A trial pit dug against the north wall of the structure indicated that the outer wall was founded approximately 0.30 m beneath the pavement level. The trial pit reached a level one meter beneath the wall foundation. The earth profiles recorded only loose, yellow sand with no traces of human activity (except for a few potsherds).

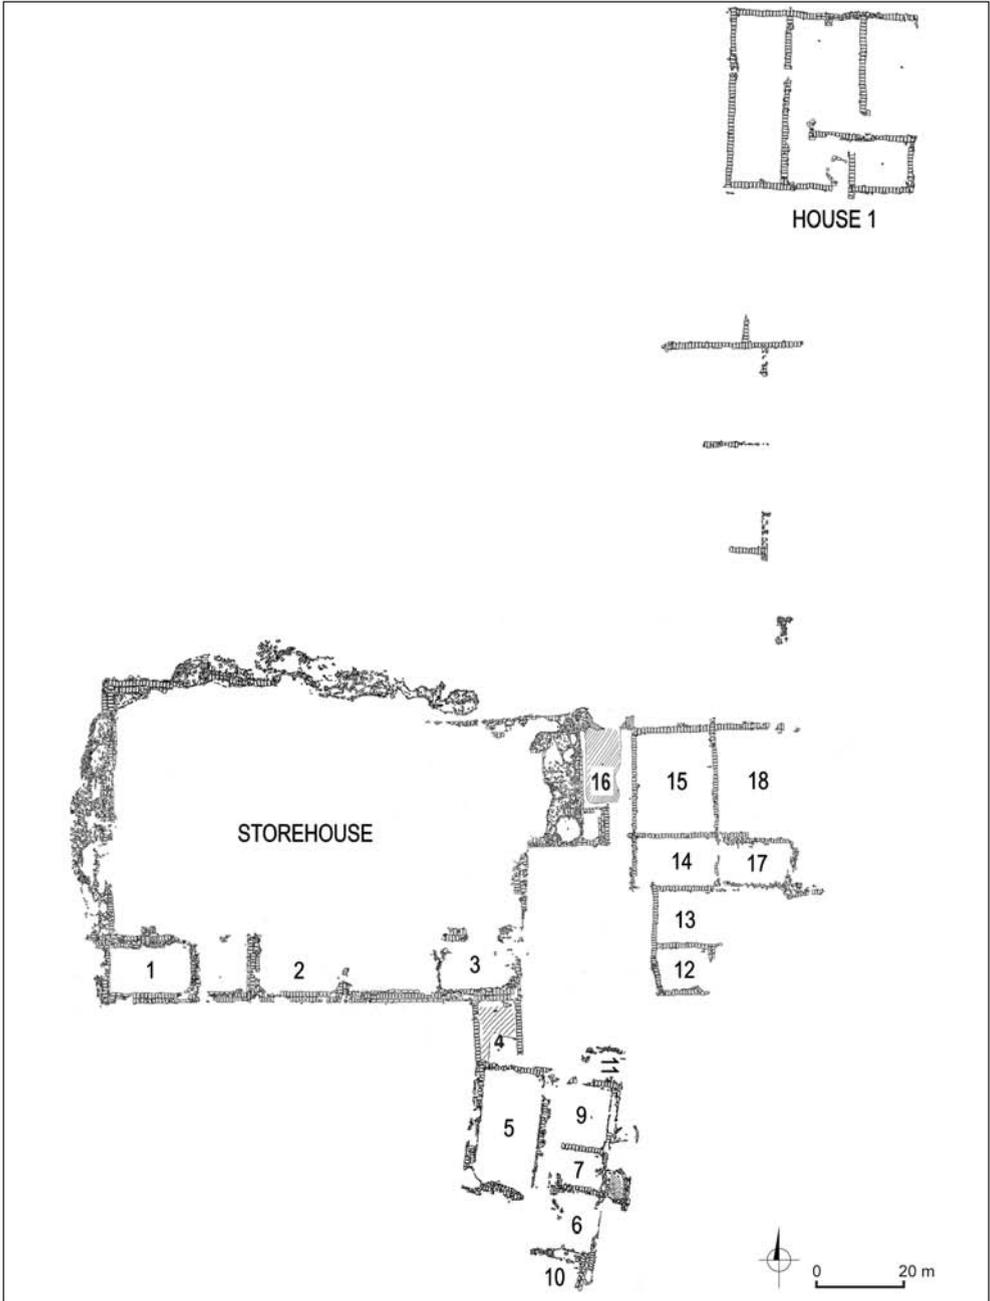
Fig. 11. General plan of Selib 2 following explorations in 2010

uncovered a large urban-type Meroitic settlement, which was coded Selib 2 [Fig. 11]. The stratigraphy and chronology of the site was established in effect of archaeological testing in 2010.

The architectural complex (approximately 900 m²), which was mapped, consisted of a large central structure surrounded by a cluster of dwelling houses. Surface clearing of wall tops revealed the plan of the building and its interior divisions [Fig. 11]. The walls were preserved only a few courses above the foundation. Nine rooms were explored, three (1–3) in the main complex and the remaining five (4–9) to the southeast of it. Room 4 was attached directly to the wall of the main complex, whereas the big rectangular room 5 and adjacent rooms to its east appeared to have a slightly skewed orientation. This unit, which was explored completely this season, yielded large quantities of pottery, as well as grinders, querns and a substantial set of animal bones.

A series of units was traced to the east of the complex as well. The houses appeared to be rectangular in plan, following a characteristic bicameral configuration, where the smaller room was accessed through the larger one. Of these, unit 16 with a floor of mud mixed with chaff appeared to be a kind of vestibule. A tumbled wall ran from the northwestern corner of this unit straight to the west, then turned to the south reaching room 1 in the main complex. Mud bricks measuring 34 cm by 17 cm were used in construction; the walls were preserved barely a few courses above the mud-brick foundations.

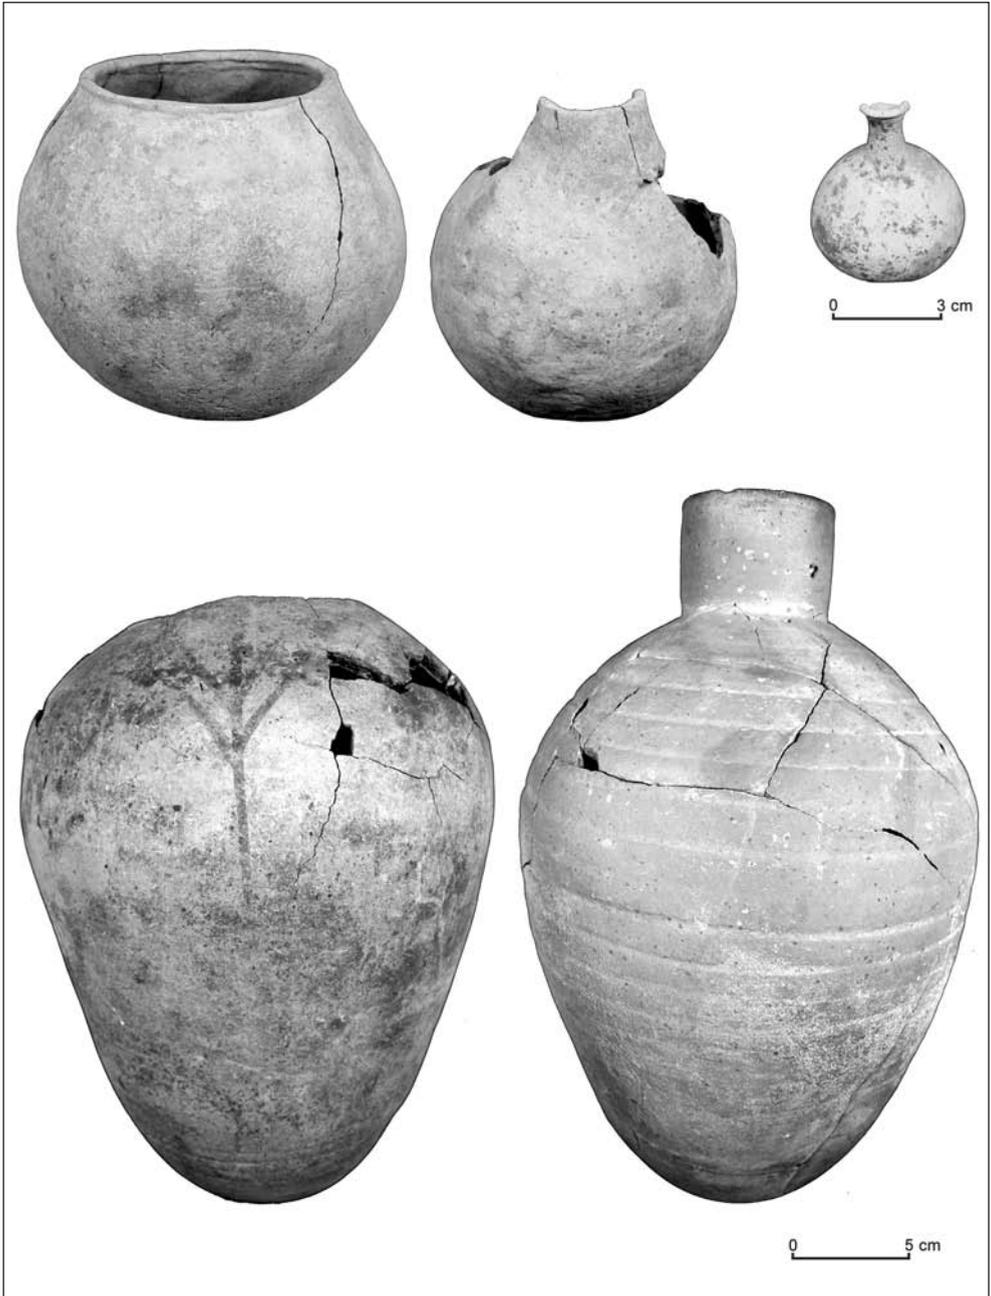
Fig. 12. Handmade kitchen vessels (top two from left), small bottle (top right, note the different scale) and storage jars (bottom) (Photo K. Molga)

encountered. This group also contained a significant number of small cups, bowls and bottles [Fig. 12, top right].

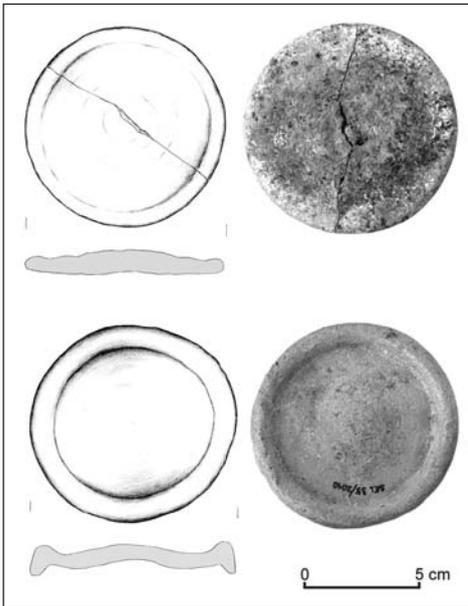
Fig. 13. Wheel-made lids for closing storage jars (Drawing R. Hajduga; photo K. Molga)

Two clay discs with red slip, identified as lids closing a pot before it was sealed with a mud stopper, were found in room 1 of the presumed warehouse and room 5 of the dwelling quarter adjoining it. Similar forms, made on the wheel, were found at Naga (Karla Kroeper, personal communication). Neither of the Selib lids had any signs of being used [Fig. 13]. Mud stoppers as such were found in quantity (15 pieces in room 1), but fragmentary. Seven bore stamps, including one of a walking man [Fig. 15, center].

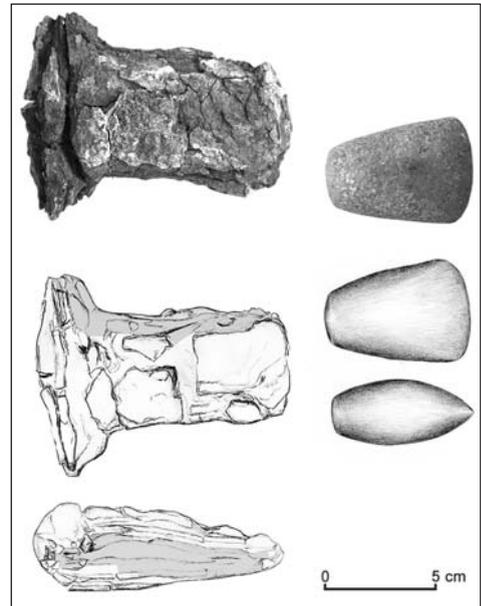
Fig. 14. Adzes: iron (left) and stone (Drawing R. Hajduga; photo K. Molga)

Remains of a blacksmith's workshop in the form of a ceramic tuyere and two iron objects were found. Two adzes came from unit 5, one of gray granite and the other one of iron. The stone adze is double-edged, 6.6 cm wide, with convex cheek and symmetrical blade about 5 cm long. It was found near a heavily corroded

iron adze also with a symmetrical blade approximately 5 cm long and raised helve that is 12 cm long [Fig. 14].

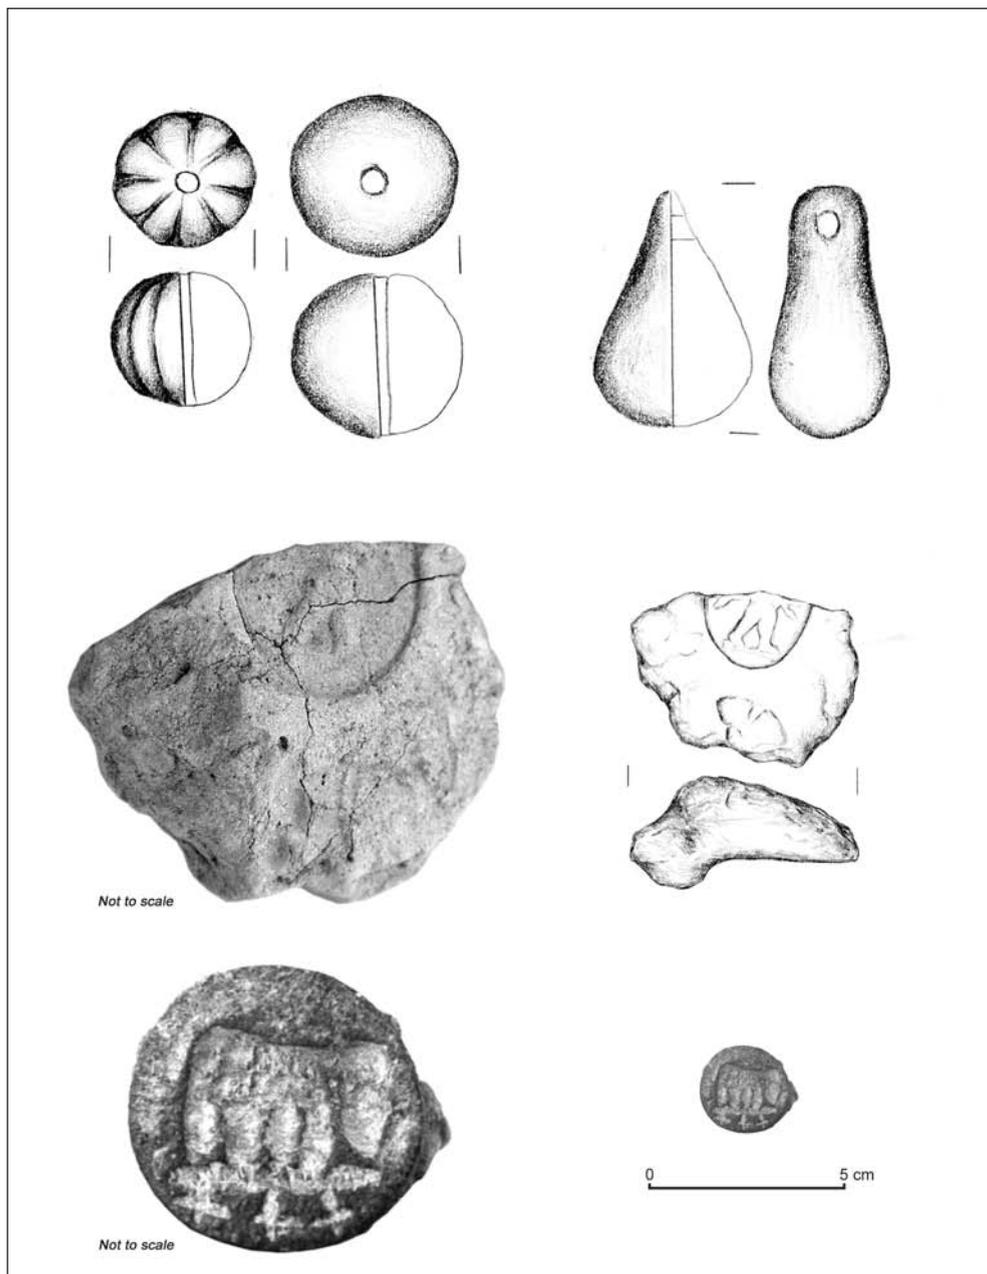
Fig. 15. Faience and quartz beads (top); fragment of mud stopper or sealing with a stamped image of a walking man (center); bronze seal ring with image of an elephant(?) in sunken relief (Drawing A. Cedro, R. Hajduga; photo K. Molga)

Faience beads of globular shape with fluted body were one of the types of beads represented in the assemblages. The so-called arched beads, slightly spherical, with a hole drilled through a long appendage, were the most common. A single example of a quartz bead was located in room 16 [Fig. 15, top]. A significant number of

Stone finds included also a significant number of stone grinders, pounders and smaller querns. Among other artifacts of metal one should mention a bronze seal ring with sunken stamp image, probably of an elephant, found by a resident of Selib [Fig. 15, bottom].
