**Kohone-ye Div: Preliminary Report
on the Second and Third Seasons of
Irano-Polish Excavations (2009 and
2010)**

Polish Archaeology in the Mediterranean 22, 543-551

Abstract: The report covers the second and third seasons (2009 and 2010) of excavation and restoration conducted at Khone-ye Div by an Irano–Polish (PCMA UW) archaeological mission. The ruins of a stone building were located on a rock spur in the Revand River gorge, in mountains about 40 km northwest of the city of Sabzewar. Building construction phases were reconstructed based on the results. The peculiar location and the substantial effort put in its construction suggest the exceptional function of the structure.

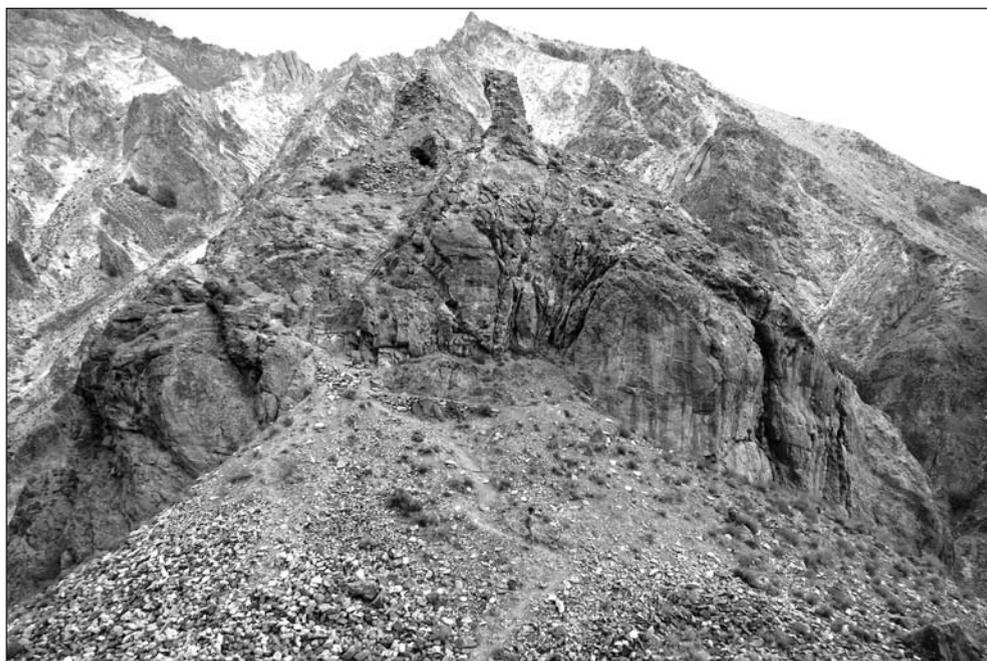
*Fig. 1. Ruins of Khone-ye Div, view from the west
(All photos B. Kaim)*

Some stone steps were discovered in the northern part of a narrow corridor [Figs 1, 4], adjoining the northeastern wall of the *chahār tāq*. It is not clear to which phase they should be assigned. The corridor ends blindly just before the sharp edge of the hill, hence the steps should be seen rather as shelves of sorts.

In the next phase a room of the *ayvān* type (4.40 x 3.00 m) was built adjoining the northern part of the northeast wall of the *chahār tāq* and the fragment of wall parallel to the eastern part of the same wall. The west wall of the *ayvān*, constructed to the right of the entrance [see Fig. 1], hugged the exterior face of the *chahār tāq*, the north wall was set directly against the rock face. Both were built of mud bricks (46 x 46 x 10 cm). The lower part of the east wall was built of irregular stone rubble. A brick barrel vault may have covered the *ayvān*. Three high, L-shaped steps or benches were constructed inside the *ayvān* [Fig. 5, top], the top of the lowest one being level (1663.23 m a.s.l.) with the top of the third of the stone steps described above. The highest bench stood about 0.66 m above floor level. Just as the stairs,

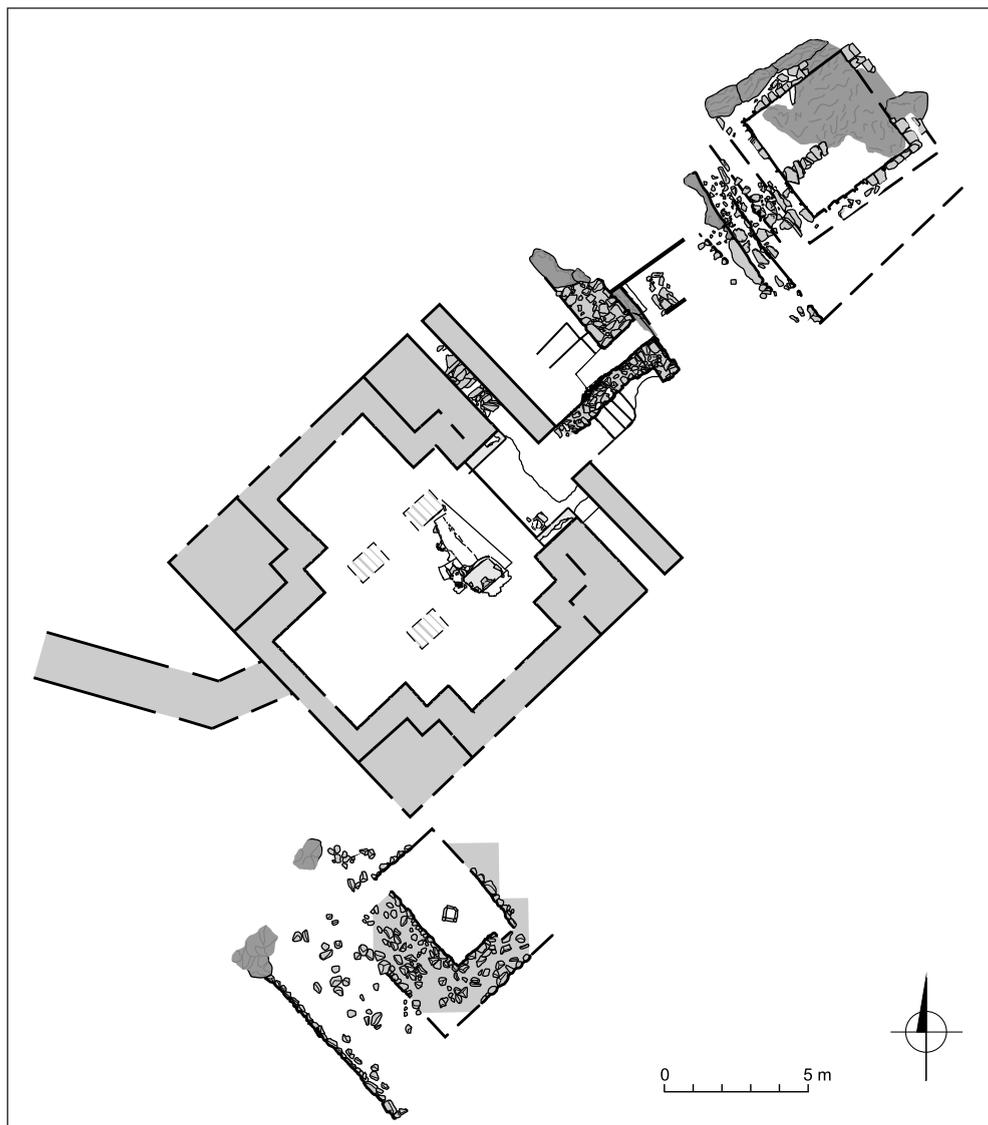
*Fig. 2. Plan of the area excavated in the 2009–2010 seasons
(Drawing and digitizing M. Grabowski)*

The building turned out to be a *chahār tāq* (meaning “four arches” in New Persian) considered the most characteristic form of Sasanian architecture. The central part consisted of four corner piers once supporting a dome [*Fig. 2*] and was closed by relatively thin walls. Short barrel vaults

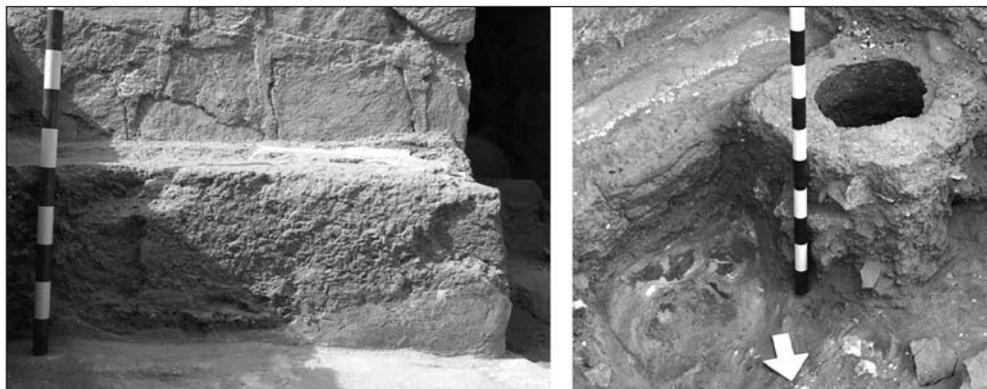
Fig. 3. Clay bench along the northeastern side of the entrance to the *chahār tāq* (left) and oven leaning against the southeastern bench

A small T-shaped trench, designated as number 2, was located in the area encompassing an entrance bay and two narrow corridors running to the northeast. A floor covered by a thick layer of gypsum plaster was found at approximately 0.70 m depth. Mud-brick benches [Fig. 3, left] ran along the side walls of the entrance bay: the southeastern bench was 0.42 m wide and 0.48 m high, and the northeastern one 0.42 m and 0.56 m respectively. The bricks used were square (39 x 39 x 10 cm) and the surface of the benches was rendered with polished gypsum plaster. Traces of a red-painted wavy pattern were noted

The second building phase encompassed a small clay oven filled with ashes leaning against the southeastern bench [Fig. 3, right]. A layer of mud-brick fragments scattered on the floor seemingly represented the remnants of a collapsed vault. It was overlaid by a thick layer of mud-brick fragments mixed with stones which were occasionally coated with gypsum mortar and fragments of gypsum plaster.

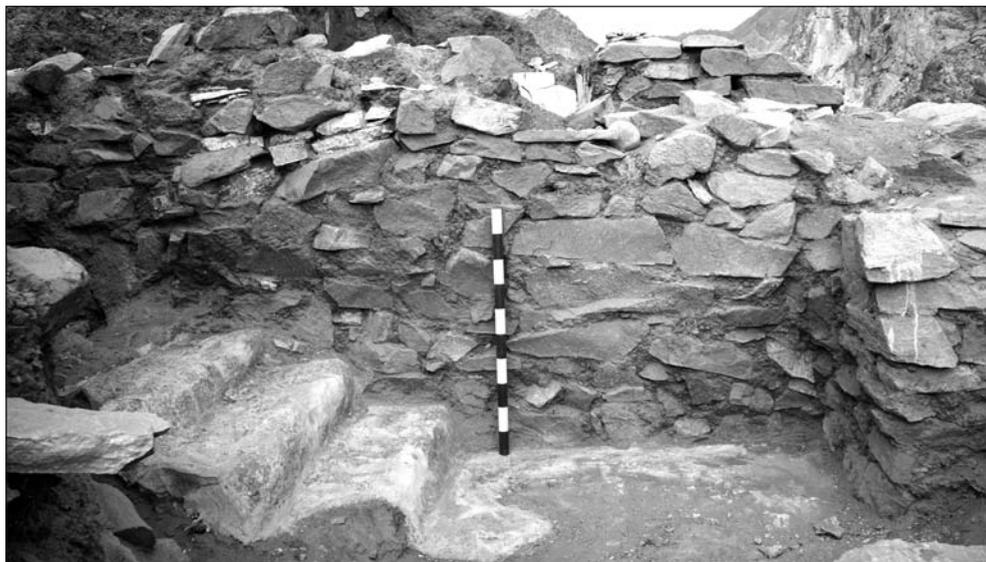
Fig. 4. Stone steps leading to the chahār tāq

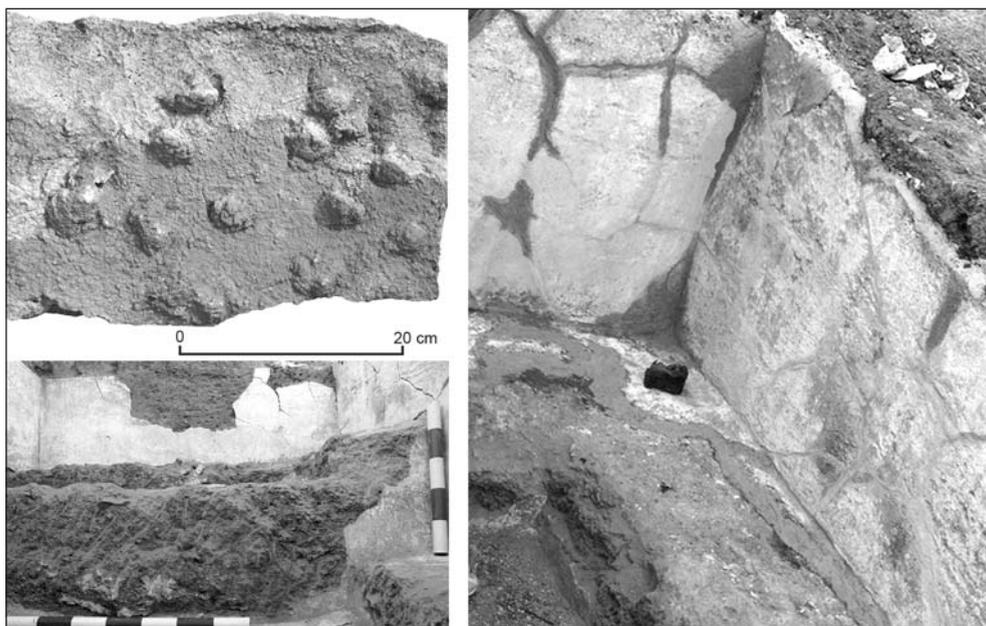
Fig. 5. Gypsum plastered steps in the ayvān (bottom left), and the wall plastering in the ayvān during conservation (right); back of a fragment of gypsum plaster showing the pock-marking of the bricks (top left)

the benches inside the *ayvān*, as well as the walls and floor, were covered with a thick layer of gypsum. The bricks were pock-marked in order to increase the adhesion of the plaster [Fig. 5, bottom left]. In the case of the stone wall, the gypsum when wet could have penetrated into the cracks between the stones.

A conservation program was carried out on the gypsum plaster of the walls of the water reservoir and the steps of *ayvān* [Fig. 5, bottom right] and a proposal was submitted to the Iranian Center for Archaeological Research on how to preserve the walls of the *chahār tāq* (drawn up by engineer M. Michiewicz).

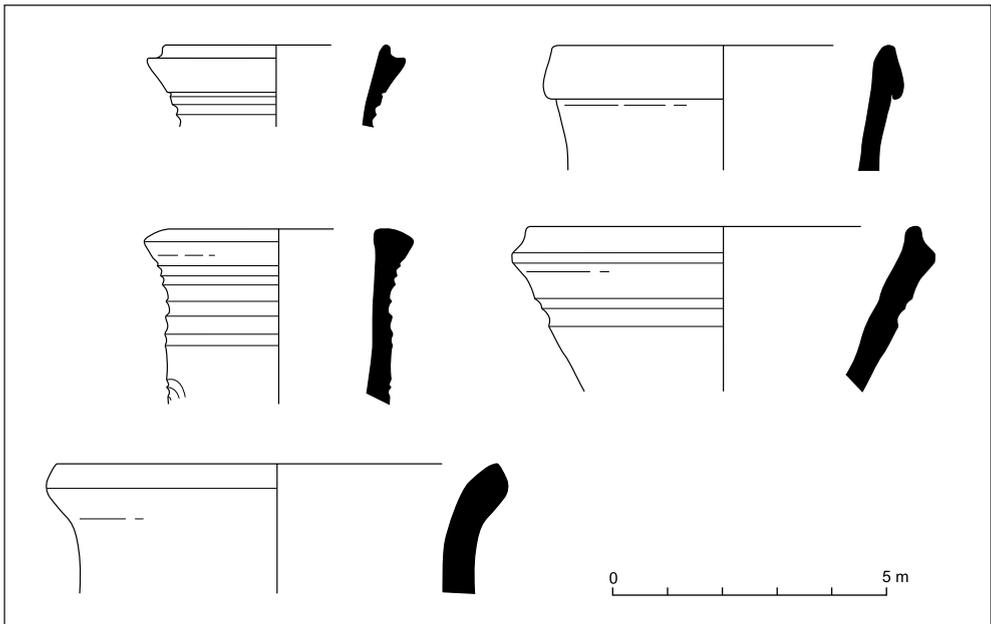
Fig. 6. Sasanian/early Islamic pottery
(Drawing and digitizing M. Wagner)

the walls of the second and third phases. The area south of the entrance to the *chahār tāq*, enclosed by a stone wall, was probably unroofed. Prior to the construction of the wall perpendicular to the *chahār tāq* entrance, its function must have been connected with activities that took place in the *ayvān*. Unfortunately, in the absence of any parallels, the nature of these activities remains unknown. The pottery finds from the season included, early Islamic wares as well as some Sasanian vessels [Fig. 6].

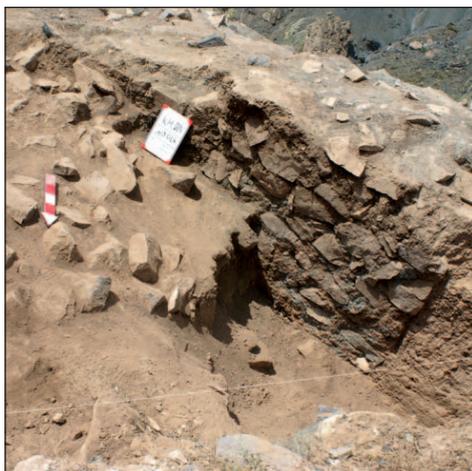
Fig. 8. Excavation in Trench 7

Excavations in this area revealed walls in dry-stone masonry, set in a brown, earthy mortar [Fig. 8]. They formed a room (3.30 x 2.00 m). The first floor inside the room was composed of a 0.20 m thick layer of pressed clayish earth lying directly on bedrock, which had been leveled prior to wall construction.

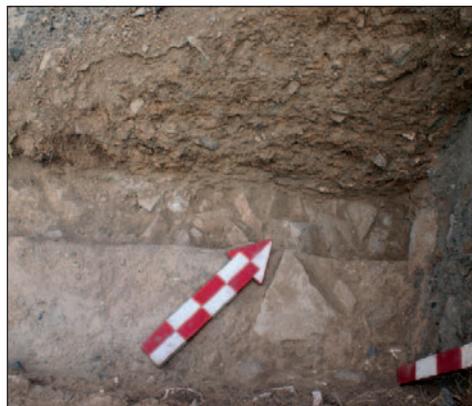
Fig. 9. South side of the wall surrounding the area southeast of the chahār tāq; note leveled bedrock surface

excavation along this side of the *chahār tāq* could weaken its structure. The assumption that the bedrock in the entire area southeast of the building had been leveled is supported by the founding of the surrounding stone wall [Fig. 9] almost on the same level (1658.50 m a.s.l.) as the

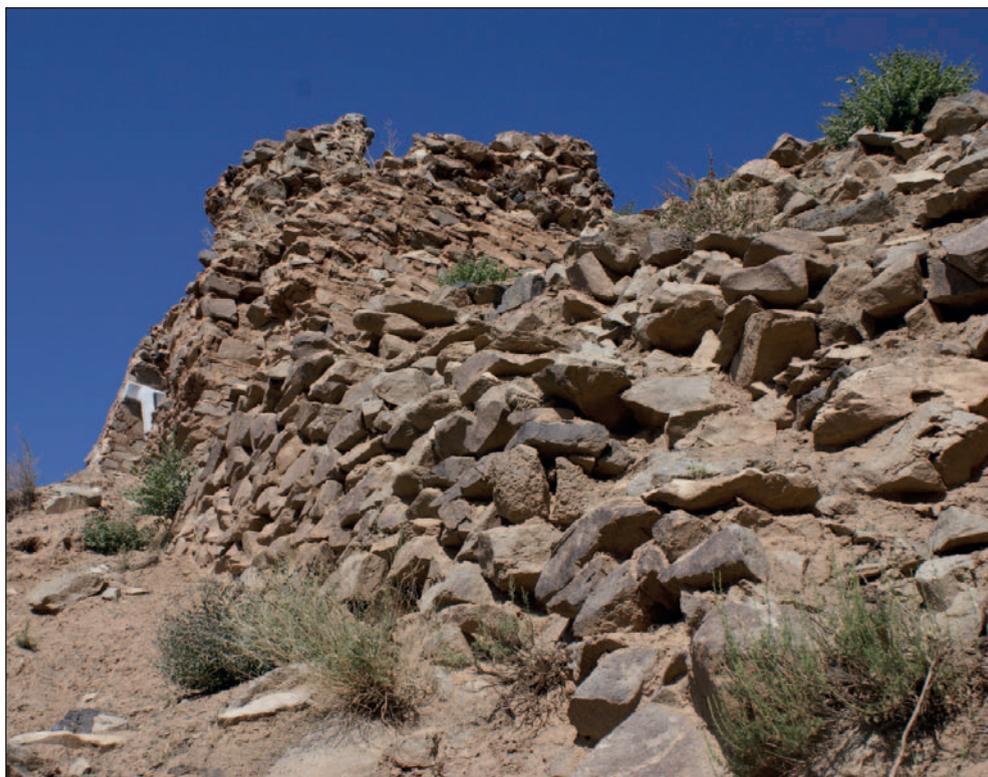
Fig. 7. Southeastern side of the stone platform

A small trench (Trench 6), 3.50 m by 1.50 m, was opened behind the stone wall enclosing the area to the left of the entrance to the *chahār tāq*. A stone platform was discovered, extending from the highest of a series of steps leading from the reservoir unearthed in 2007 and the wall parallel to the eastern part of the northeast wall of the *chahār tāq*. Not only the wall to the left of the entrance to the *chahār tāq*, but also presumably the southeastern part of the *chahār tāq* were built on this leveling platform. The southeastern side of the platform [Fig. 7] may have been higher and formed an enclosing barrier.
