**Alexandria: Excavation and
Preservation Work on Kom El-Dikka :
Season 2011**

Polish Archaeology in the Mediterranean 23/1, 23-44

ALEXANDRIA EXCAVATIONS AND PRESERVATION WORK ON KOM EL-DIKKA SEASON 2011

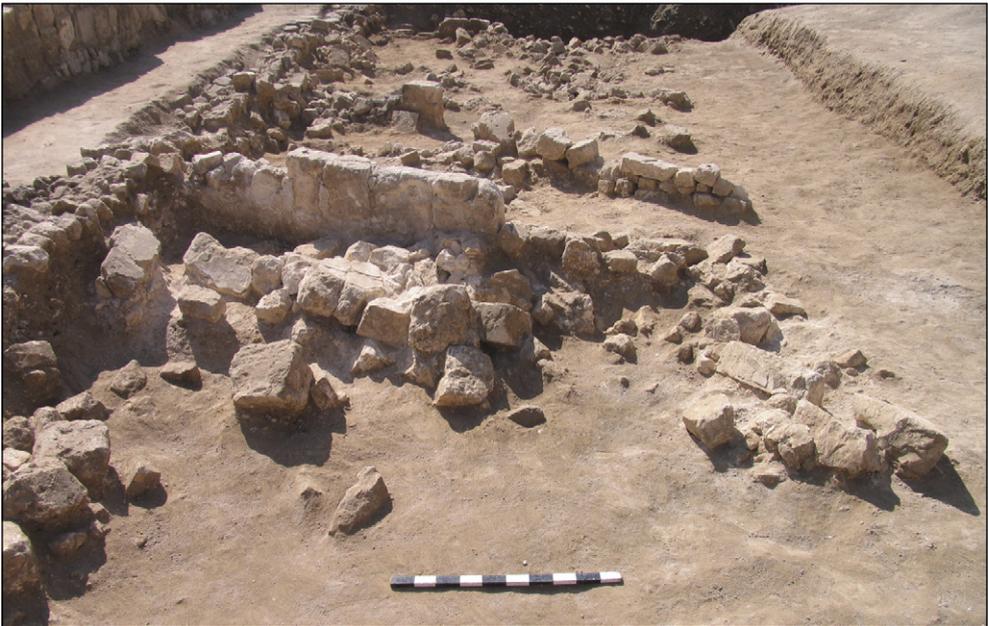
Fig. 1. The stone collapse in area US, viewed looking south
(Photo G. Majcherek)

was surveyed and mapped. A substantial stone collapse was cleared directly under the present ground surface [Fig. 1]. It turned out to cover almost the entire surface of the trench with the concentration being particularly thick in the eastern part where it exceeded 1 m. The collapse bordered on a drainage channel running alongside the huge stylobate of the Theater Portico. Both the channel and foundations of the stylobate were apparently built later than the collapse, and obviously some of the stone debris was cleared during the process or recycled into the fabric of the new structures. The stylobate itself suffered heavily from seismic-related devastation and large-scale stone robbing, causing both horizontal and vertical distortion [Fig. 2]. Large sections of its fabric were removed, as were the portico columns.

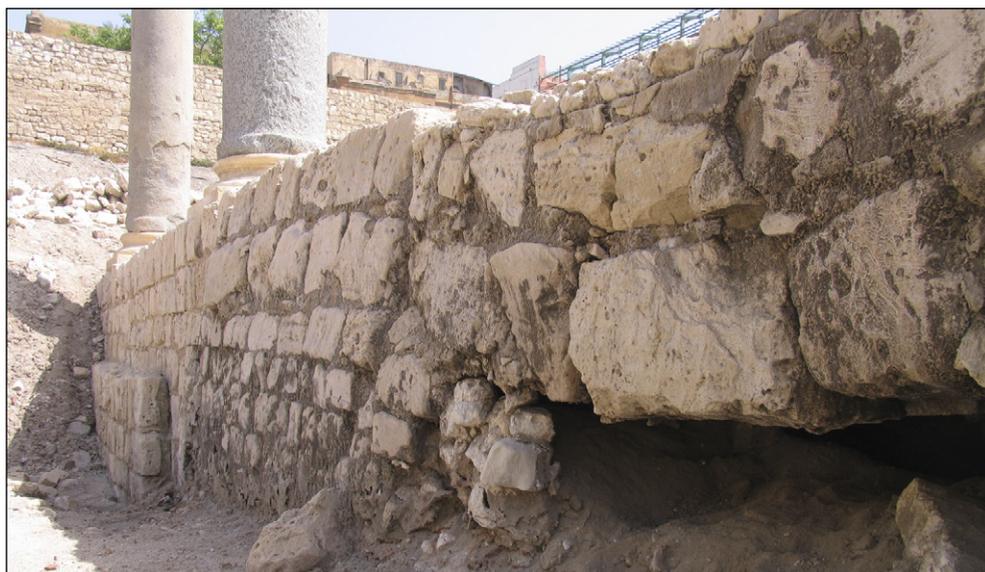
Fig. 2. Stylobate of the Theater Portico looking north; robbed out section in the right foreground (Photo G. Majcherek)

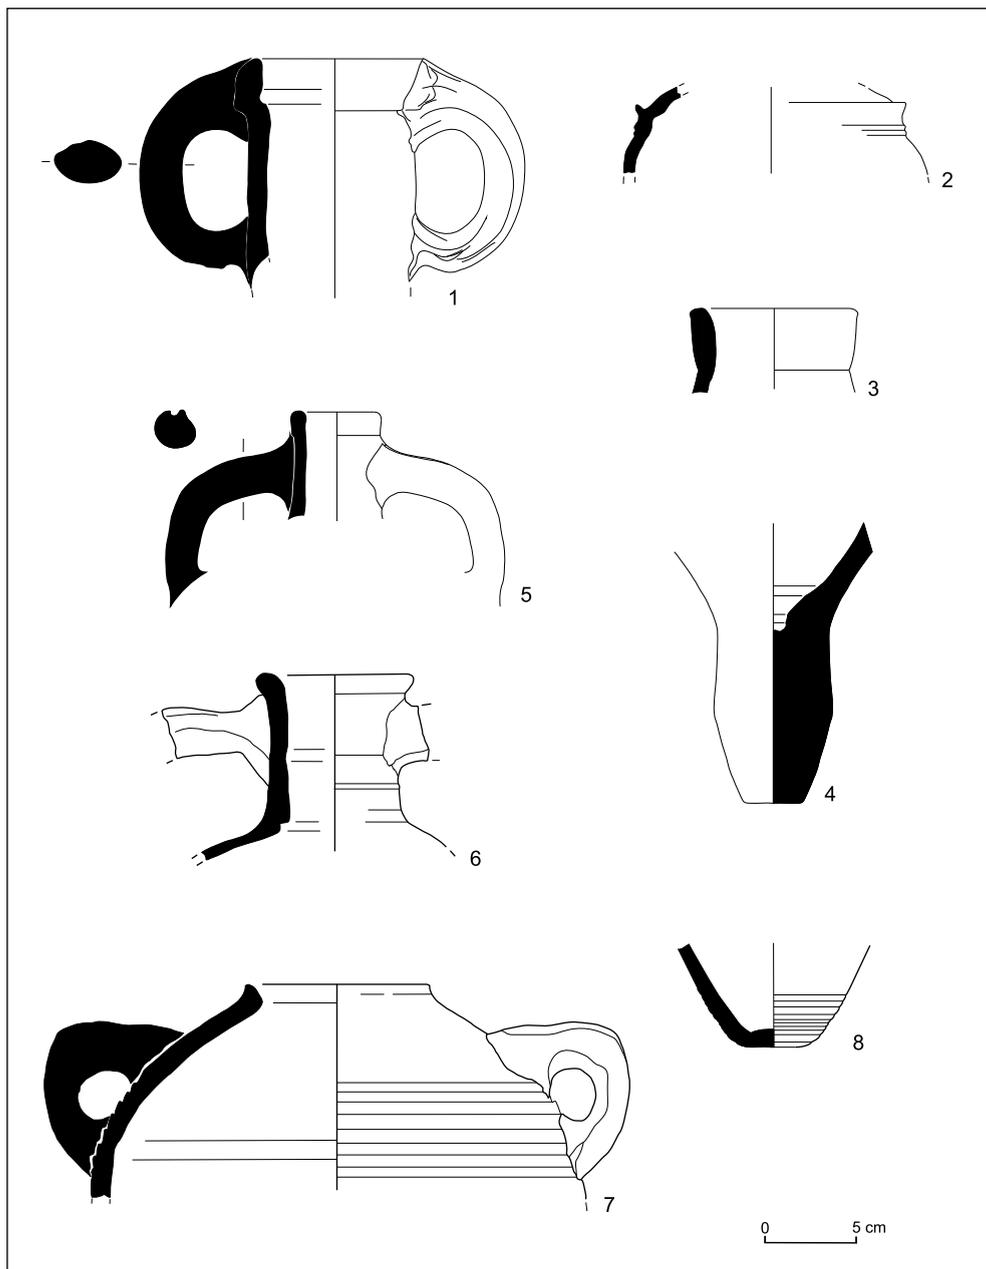
Fig. 3. Selection of Late Antique pottery: 1 – Egloff's 172 Nile silt amphora; 2 – LRA 7; 3, 4 – African II amphoras; 5, 6 – LRA 1; 7, 8 – Gazan (LRA 4)
(Drawing E. Czyżewska, A. Dzwonek)

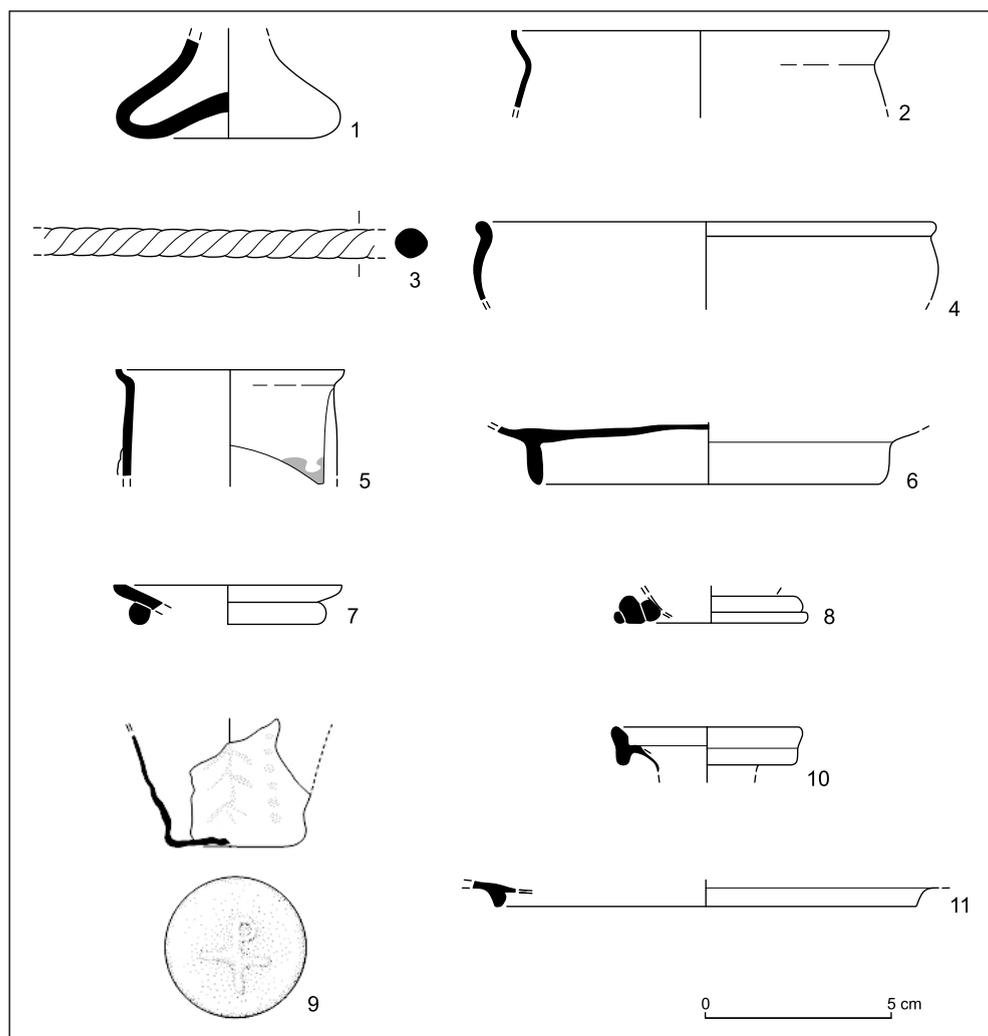
Fig. 4. Glass finds from the US area: 1 – candlestick-type bottle; 2 – globular bowl with cracked-off rim; 3 – stirring rod; 4 – bowl with thickened rim; 5 – lamp or beaker with cracked-off rim and applied blue decoration; 6 – high ring base of plate or bowl; 7 – jug rim with applied trail; 8 – trail-wound base; 9 – basket-handled jar with chrysmos; 10 – toilet bottle rim; 11 – cast low-ring base (Drawing M. Momot, E. Kulicka)

distorted probably by high temperatures were observed. Most of the fragments represented a variety of bottles, flasks and unguentaria. The latter, including a candlestick-type with triangular-sectioned body and concave bottom, merits particular attention as such cosmetic containers are still very rare in the glass assemblage from Kom el-Dikka [Fig. 4:1].

Other forms to be noted include a very thin-walled bowl with cracked-off rim and globular body [Fig. 4:2] and a fragment of beaker-shaped vessel with cylindrical body and thickened, rounded flaring rim, apparently with a thick, solid disk-base. Glasses other than vessels include a small mosaic ball with a pattern imitating *serpentino verde* and two segments of twisted glass rods used probably as medical or cosmetic instruments [Fig. 4:3]. Several fragments of nearly colorless flat windowpanes were also observed.

A noticeable number of vessels was made by the cracking-off method. The S-shaped profile of cups, beakers and lamps is typical, the surfaces occasionally decorated with applied blobs, dark blue in color [Fig. 4:5]. The excavation has

very low quality, often covered with milky-white weathering, silver and peacock iridescence. A few of the shards were severely deformed by high temperatures. In some areas the glass had been melted. Most of the assemblage represents domestic glassware, such as bottles, flasks, beakers and bowls. Fragments of two vessels, both representing toiletry specimens, can be singled out. One is a large, very thick-walled long necked bottle with a spout. The second, probably belonging to a bottle or jug with cylindrical neck and pear-shaped body, is represented by a thick, neatly worked, flaring rim forming a horizontal exterior rib [Fig. 4:10].

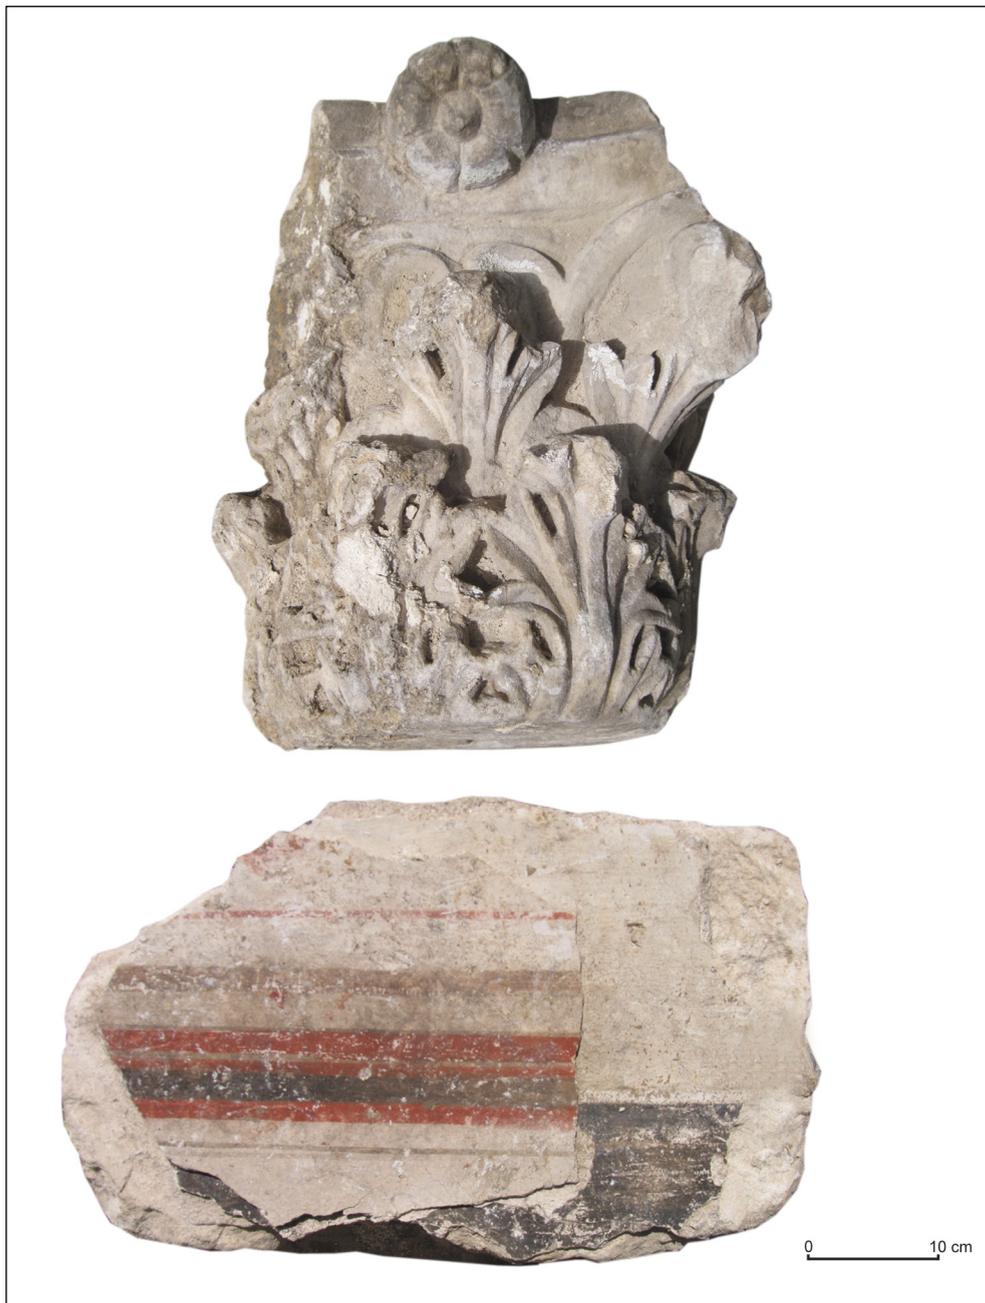
*Fig. 5. Fragment of marble capital, top, and early Roman plasterwork
(Photos G. Majcherek)*

framed with red bands enclosed by thin black lines. Some loose remains of figural representations were also recorded. Similar ornamentation was recorded previously from an Early Roman House MB located next to the theatre (Majcherek 2002). The collapse yielded also several elements of architectural embellishment: fragments of engaged columns, cornices and a small marble capital [Fig. 5, top].

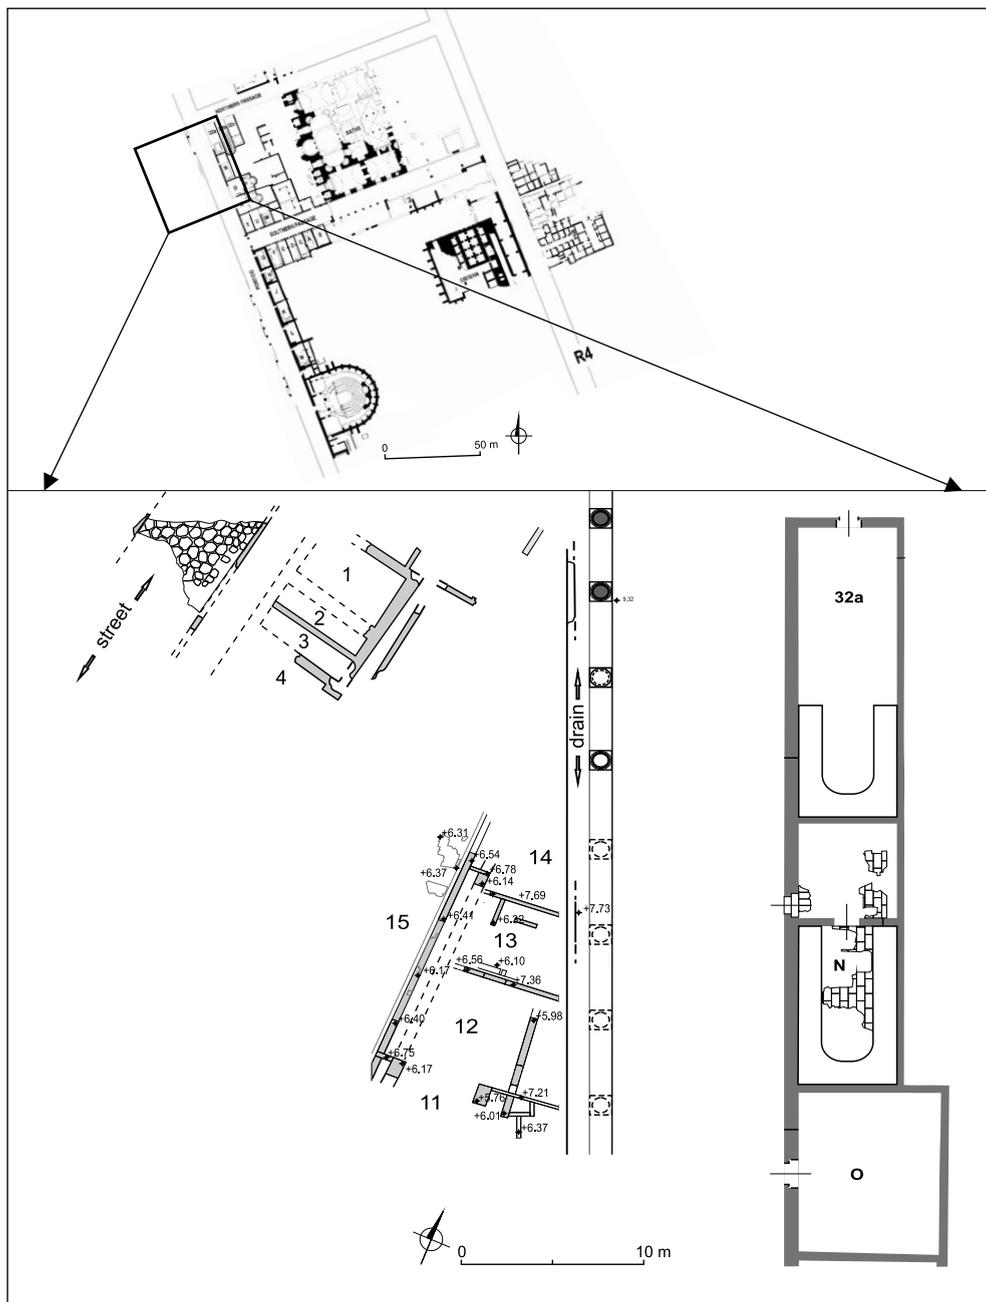
Fig. 6. Area US. Plan of early Roman structures; top, location of sector on a plan of the Kom el-Dikka site (Drawing M. Polak, A. Piszczewski, G. Majcherek)

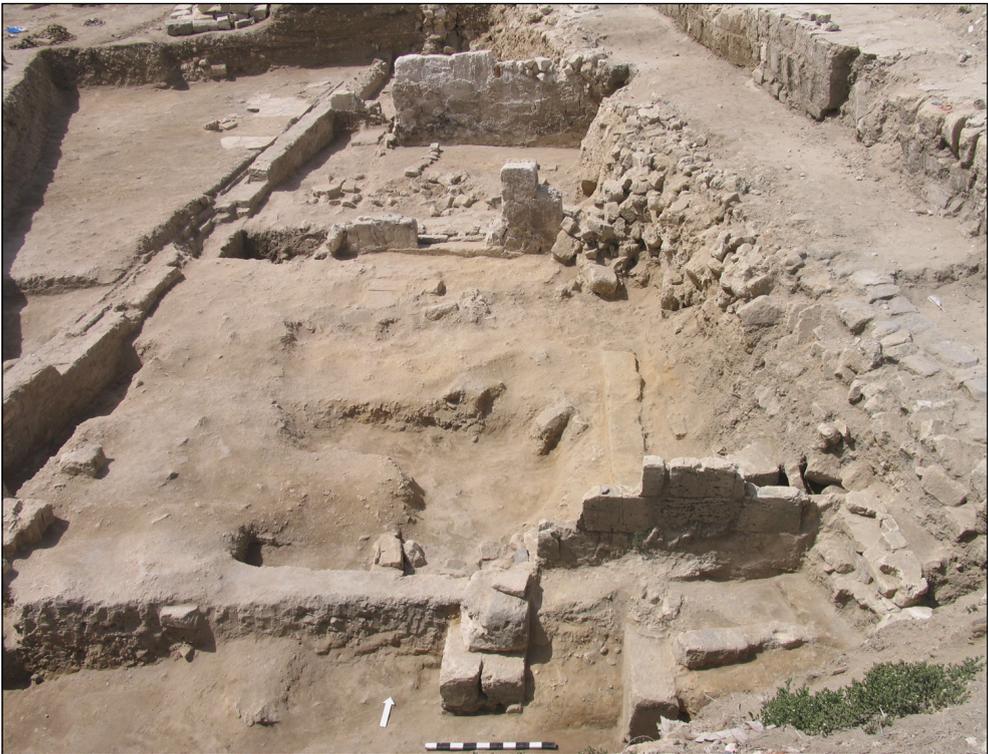
Fig. 7. Early Roman structures in area US, view looking north
(Photo G. Majcherek)

Some still standing walls were exposed directly below [Fig. 7]. They were structured in the rather unusual technique of vertically set slabs, some 22–25 cm thick. Such technically unstable structuring implied a single-storey building. Three sections of such walls were uncovered, forming four units of varying width [Fig. 6]. The largest of them (No. 12) was 5.50 m wide. The length was not established as neither the western nor the eastern limits of the structure could be traced. The eastern end was destroyed most probably during the later construction of the portico, making it impossible to determine the full dimensions of particular rooms. In consequence, the general layout of the uncovered structures is mostly conjectural. The function of the structures is also unclear. Some decorative elements and artifacts would point to domestic use. In all of the newly explored area, a destruction layer was discovered directly superimposed on the Early Roman ruins. The nature of this layer, when considered together with the evidence provided by numerous elongated vertical cracks in the walls, leaves no doubt that the destruction of the building had been cataclysmic. Evidence of this disaster is also to be observed in the countless bulges caused by thermal expansion of limestone subjected to high temperatures.

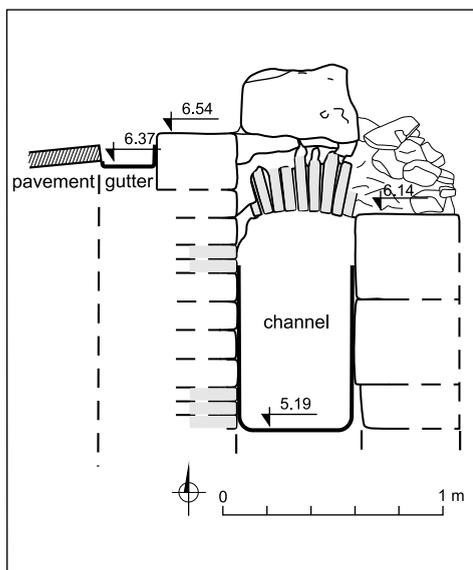
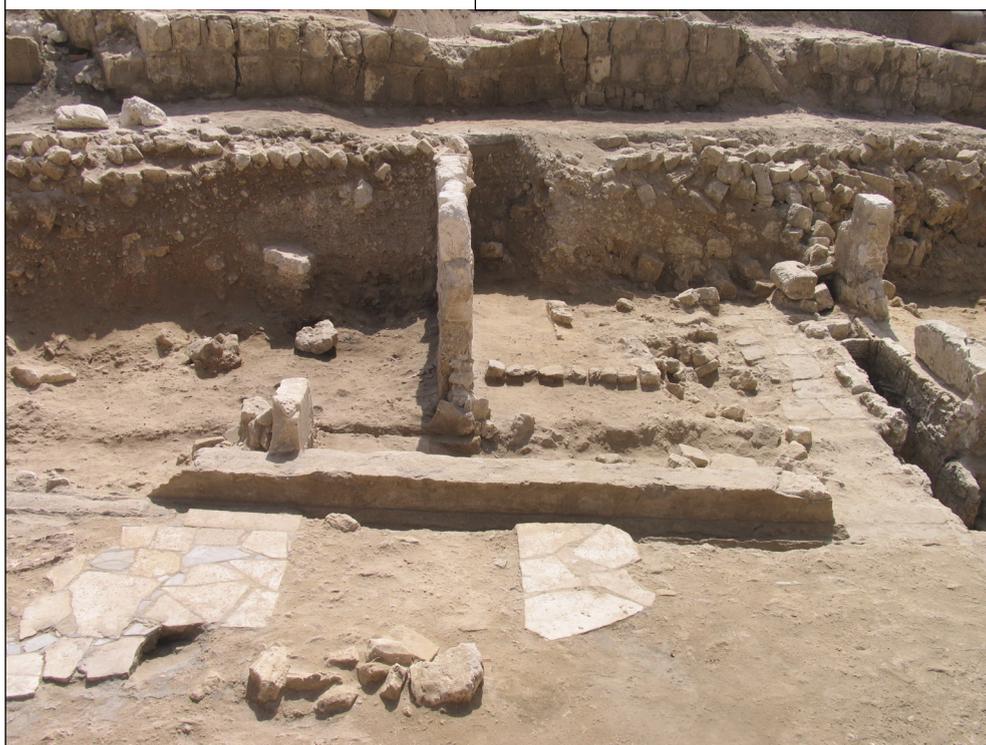
Fig. 8. Small latrine, view looking east and, top left, section through the latrine channel in Unit 13 (Photo G. Majcherek; drawing K. Juszczyk)

In unit 13 (3.85 m wide), a small paved area edged with a low stone barrier showed an abundant concentration of ashes. In units 12 and 14, hearths were found, accompanied by a thick ash deposit. There, a number of broken and burnt vessels, stone mortaria and other utensils were unearthed. Nevertheless, at this stage of research, it is still unclear whether both the ashes and the hearths should relate to the original occupation period or rather to the secondary occupation following the abandonment of the building. In unit 13, a small latrine channel (2.40 m by 0.35 m) was found alongside the wall [Fig. 8]. It emptied into a large sewage

some 3.50 m apart (two were found still in place) [Fig. 8, top]. They were typical radial arches made of large flat brick-tiles, usually encountered in structures from the early Roman period. These arches appear to have supported the seats, which were probably wooden, of what appears to have been a public latrine (Hobson 2009). This apparently large multiseat *forica* featured a rather unusual design. The marble floored area would have formed the main hall of the building. Instead of the typical rectangular layout with a channel running along the walls, we have here a single long channel (a stretch at least 12 m long has been cleared), accessed from the floored area cleared to the west of it (Unit 15).

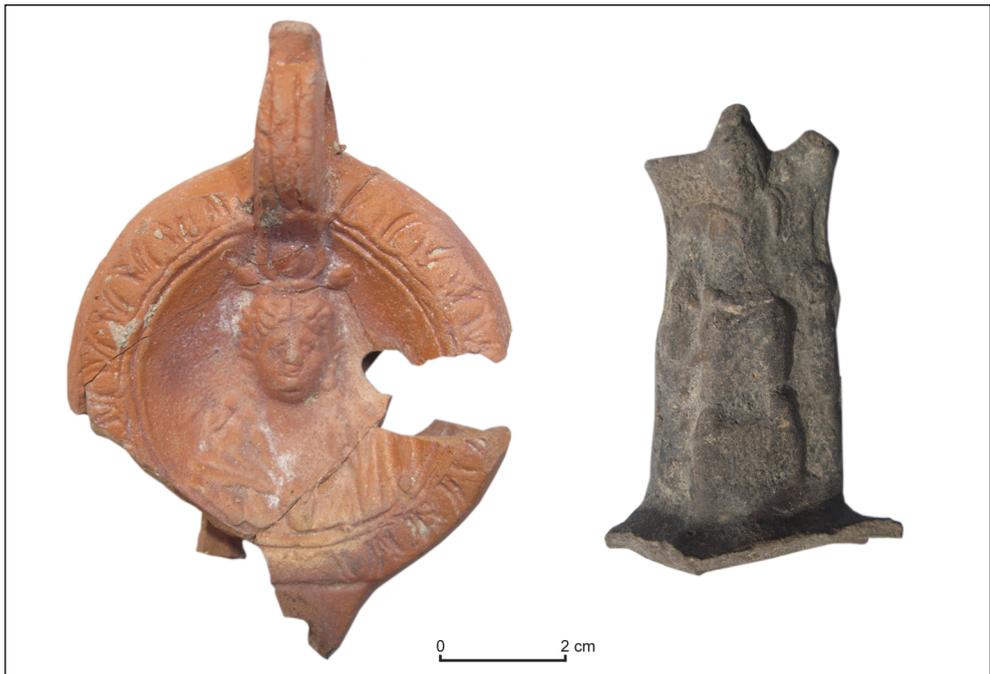
Fig. 9. Clay oil lamps with representations of Isis and Serapis found in area US: left, Field Inv. No. 137.08.11; right, Reg. No. 5327 (Photos E. Kulicka)

Contexts related to the occupation and destruction of all revealed structures produced quite a number of 1st–3rd century AD finds. A number of lamps and their fragments, as well as terracotta figurines were recovered. Among the lamps some of undoubtedly Alexandrian manufacture bore representations of Isis or Serapis on the discus or attached figural handle [Fig. 9].

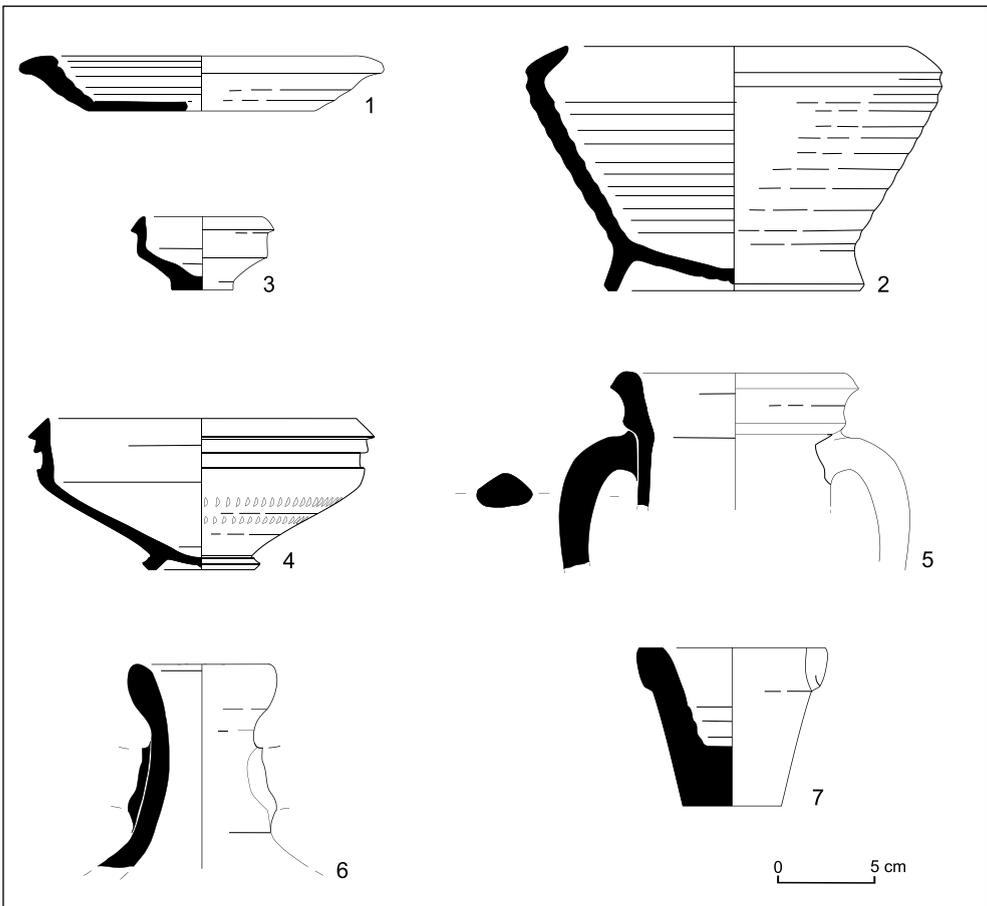
Fig. 10. Selection of Early Roman pottery from area US: 1, 2 – domestic wares; 3, 4 – Egyptian vessels imitating Cypriot sigillata forms; 5 – Tripolitanian III amphora; 6 – Cretan amphora; 7 – travertine mortarium (Drawing M. Więch, A. Jurgielewicz)

Ceramic material was plentiful. Apart from domestic wares [Fig. 10:1] and toilet

vessels [Fig. 10:2], a surprisingly large number of vessels of Egyptian manufacture closely imitating some Cypriot Sigillata forms was noted [Fig. 10:3,4]. Most of them imitated common Cypriot bowls and craters (P40 and P42). Amphoras of diverse origin were prolific as always. Apart from vessels produced in the Mareotis (mostly of AE3 and AE4 types), some forms originating from centers located in the Nile Valley and manufactured in conspicuous Nile silt were identified. These included AE3 *similis* forms and early versions of the notorious LR 7 amphoras (Egloff 177). North African containers (Africana I and Tripolitanian I and II, Fig. 10:5) came first, quantitatively speaking, among the imported vessels. Eastern amphoras, although surprisingly less prolific, formed quite a numerous group representing various regions. Products from Crete (AC1-2) [Fig. 10:6], "pinched-handle" amphoras from Cilicia and Cyprus, as well as early forms of Gazan/Askalonite amphoras were recognized.

Small stone mortaria, made of granodiorite and Egyptian alabaster (travertine) were also present [Fig. 10:7].

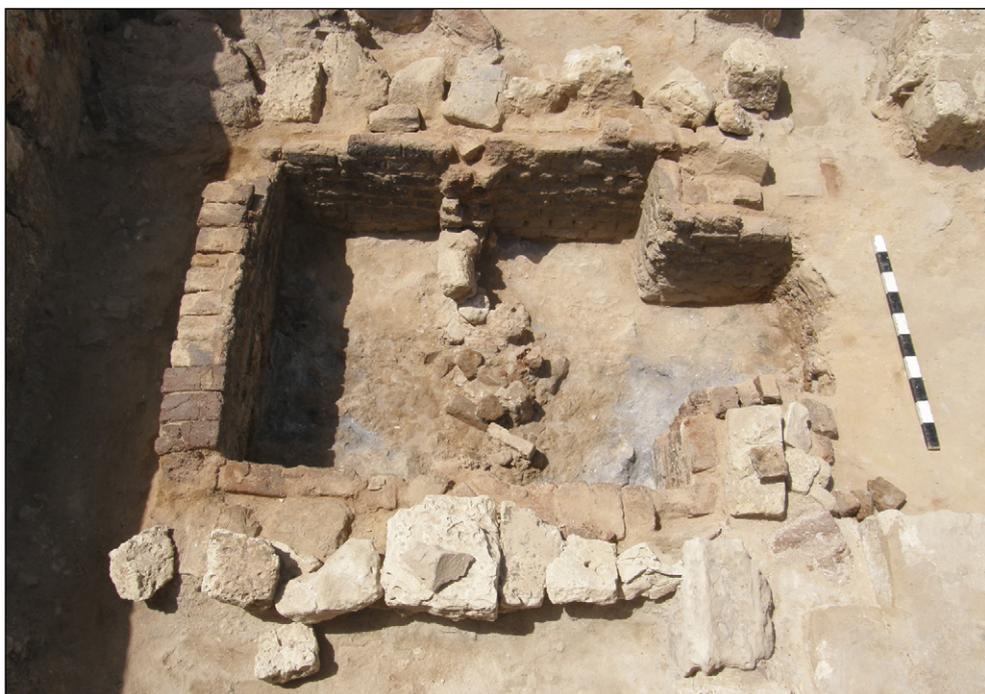
*Fig. 11. Oven in layer predating auditorium E
(Photo K. Kapiec)*

In auditorium E (area G; trench supervisor K. Kapiec), exploration of underfloor layers added substantially to data on the architectural history of the area in periods preceding the building of the academic complex. A large rectangular oven was cleared in the southern part of the room [Fig. 11]. It was built of large fired bricks, used mostly in structures dated to the Late Antique period. The oven featured an almost square chamber (2.00 m by 1.80 m, internal dimensions). Remains of two pillars preserved on the longer sides indicated the presence of a vault

supporting the floor. The oven was used most probably for cooking purposes; in similarity to yet another such structure discovered previously in the adjacent section of the passage leading to the bath (Rodziewicz 1984: 285, Pl. I,10). Exploration of ash deposits inside and around the oven did not produce any substantial chronological evidence. It is obvious though that it postdated a large *forica* discovered there the previous year, and could in all probability belong to the late 5th century AD phase. A small section of the latrine channel was discovered along the south wall of auditorium F, confirming the proposed hypothetical general layout of the *forica* (Majcherek 2013: 43).

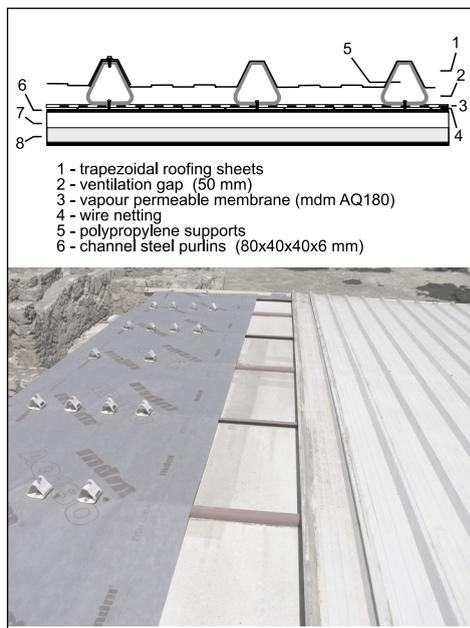
Fig. 12. *Installing roof underlaying in the mosaic shelter; top, section through the roof underlaying (Photo and drawing G. Majcherek)*

The principal task this year was to reduce humidity inside the shelter. In order to achieve the desired effect, a breather membrane was introduced as underlaying (mdm^R AQ 180). The whole operation, carried out expertly by Zygmunt Nawrot, was time consuming. In order to install the underlaying, the trapezoidal roofing sheets had to be removed piece by piece. Strips of underlaying 1.50 m wide were laid perpendicularly over a supporting wire net [Fig. 12] and fastened to the channel steel purlins using galvanized clout nails, leaving airspace between the underlaying and roofing sheets for drainage and ventilation. Overlaps 15 cm wide were fixed with caoutchouc contact glue. Additional polypropylene supports, triangular in shape (8 cm high), were installed for better ventilation and improved stability of the roofing sheets [Fig. 12, top]. This season

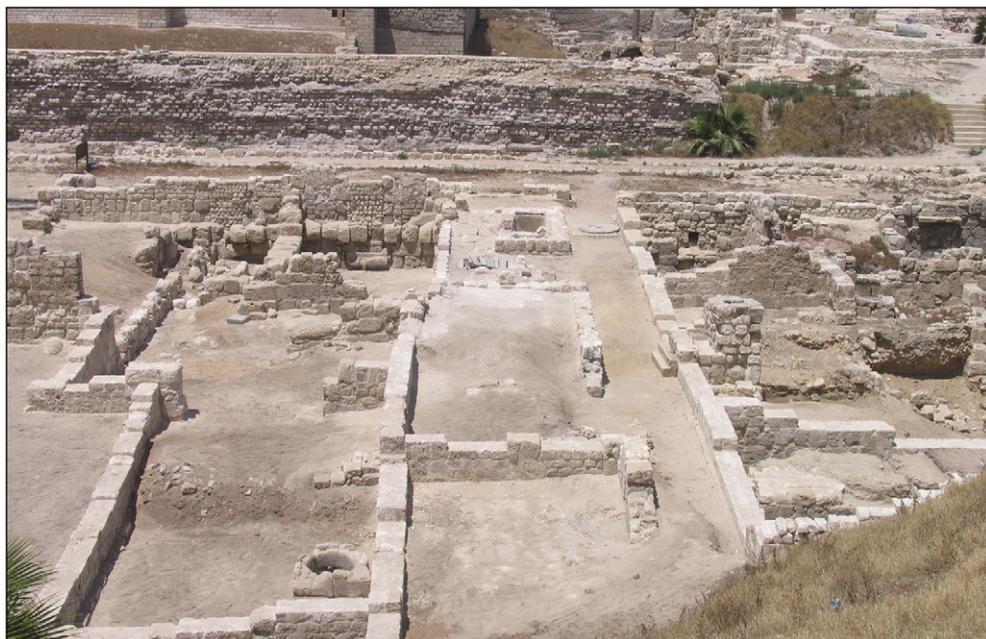
Fig. 13. *Area W_1N following conservation work in 2011, view looking west (Photo G. Majcherek)*

Conservation measures were taken also in a large fragment of the Late Roman domestic quarter (area W_1N) (supervised by Aureliusz Pisarzewski and Marcin Polak) [Fig. 13]. This year's activities should be seen as a continuation of the procedures applied last season. More sections of the walls, already damaged or dismantled in antiquity, were again either consolidated or rebuilt. In building G, a large part of the wall dividing rooms G9 and G14–G15 was completed with

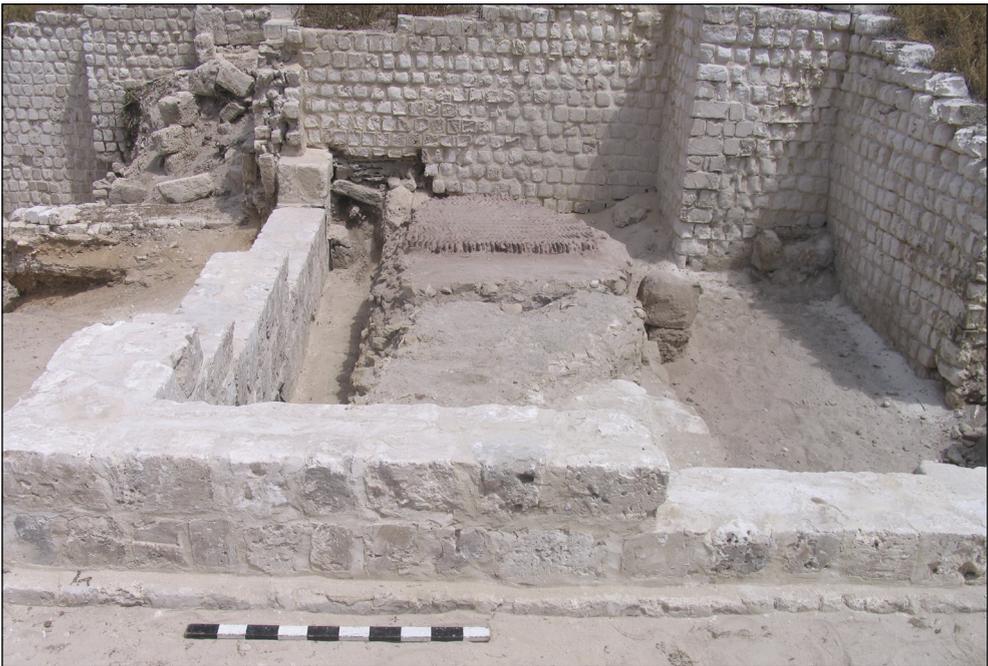
Fig. 14. Latrine H-11, following the 2011 restoration, view looking north (Photo G. Majcherek)

Restoration in building H focused on rebuilding the walls of a public lavatory occupying room H-11 (Majcherek 1992). It was a sizeable latrine, measuring 6 m by 3 m. The floor of the latrine, a large fragment of which was found in the northern section of the room, was made of small bricks set on end in a herringbone pattern (*opus spicatum*). A channel (0.50 m wide), built along the walls, emptied into the main sewer in the alley, running parallel to the southern facade of the house. The latrine was obviously accessible from the street as indicated by the position of two large slabs covering the channel on this side. The south wall (some 7 m long) and the west wall (6 m long) were both restored to a height of approximately 1.50 m [Fig. 14]. Some elements of the

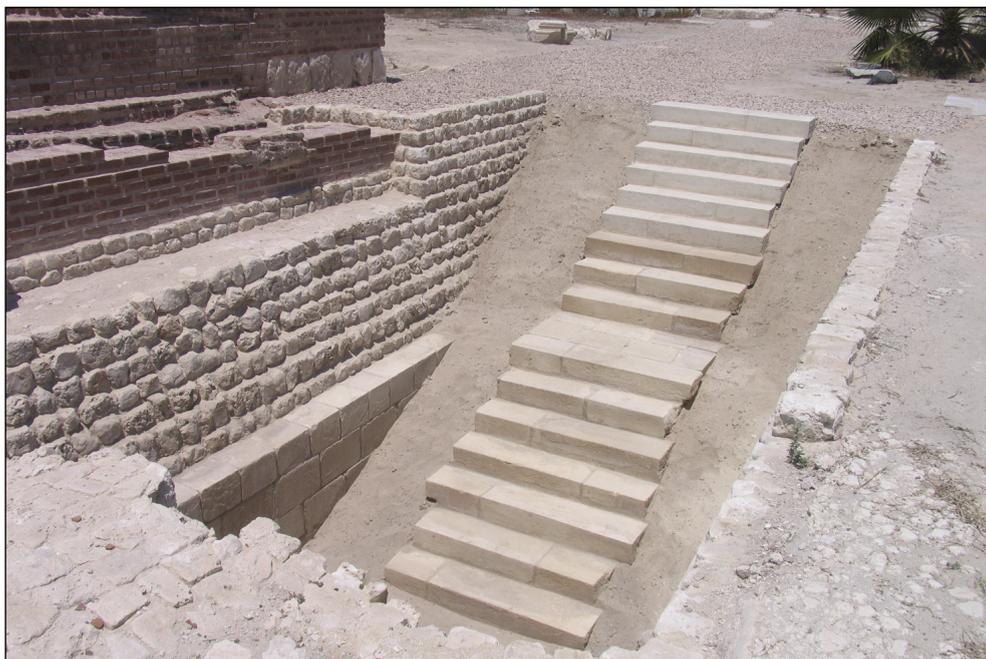
*Fig. 15. New steps leading to the cellar in the bath complex
(Photo G. Majcherek)*

Work in the bath area encompassed a set of modern steps leading down to the cellar level, designed and built by Aureliusz Pisarzewski. Altogether 17 steps negotiated some 3 m difference of levels between the frigidarium floor and the cellar floor [Fig. 15]. An adjacent part of the frigidarium was also rearranged. The area between the brick-made *thermae* proper and the eastern entrance to the bath complex was leveled and covered with gravel as part of the final site development project.

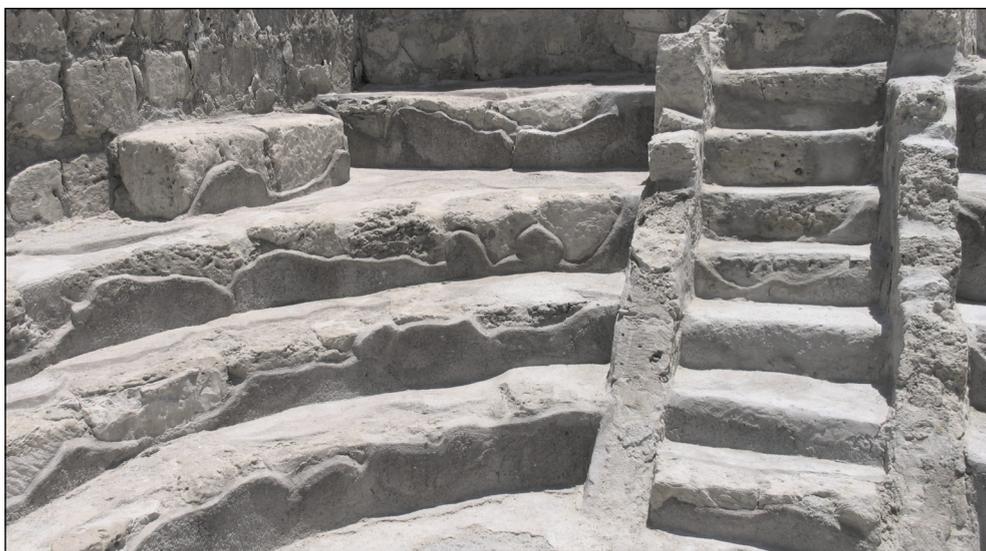
*Fig. 16. Protected plastering in auditorium K
(Photo G. Majcherek)*

The conservation of auditoria discovered during previous seasons (Majcherek 2006) was also continued. In auditorium F, the stone benches were treated, their structure being reintegrated, joints filled with new mortar and plaster extant on the seats protected. Mortar based on an ancient formula was used (1:3:0.5 of lime, sand and crushed bricks). Similar treatment was undertaken in adjacent auditoria G and K. The seriously damaged and partially dismantled southern run of benches, including the honorary seat, was now restored. Original blocks were fixed in new mortar, while some missing fragments were restored with new blocks. The edges of extant plasterwork were also secured with a protective mortar band [Fig. 16]. The huge wall dividing auditoria F and G was treated as well. One course of masonry was added on the existing top of the wall. This operation was undertaken not only in order to protect the existing ancient substance, but also as an attempt to recreate the original layout of the auditoria.
