# MARINA EL-ALAMEIN: CONSERVATION OF ARCHITECTURAL DECORATION AND GEOLOGICAL STUDY IN AID OF CONSERVATION

**Keywords:** Marina el-Alamein, Tomb T17, Southern Baths, stone conservation, architectural decoration, geology

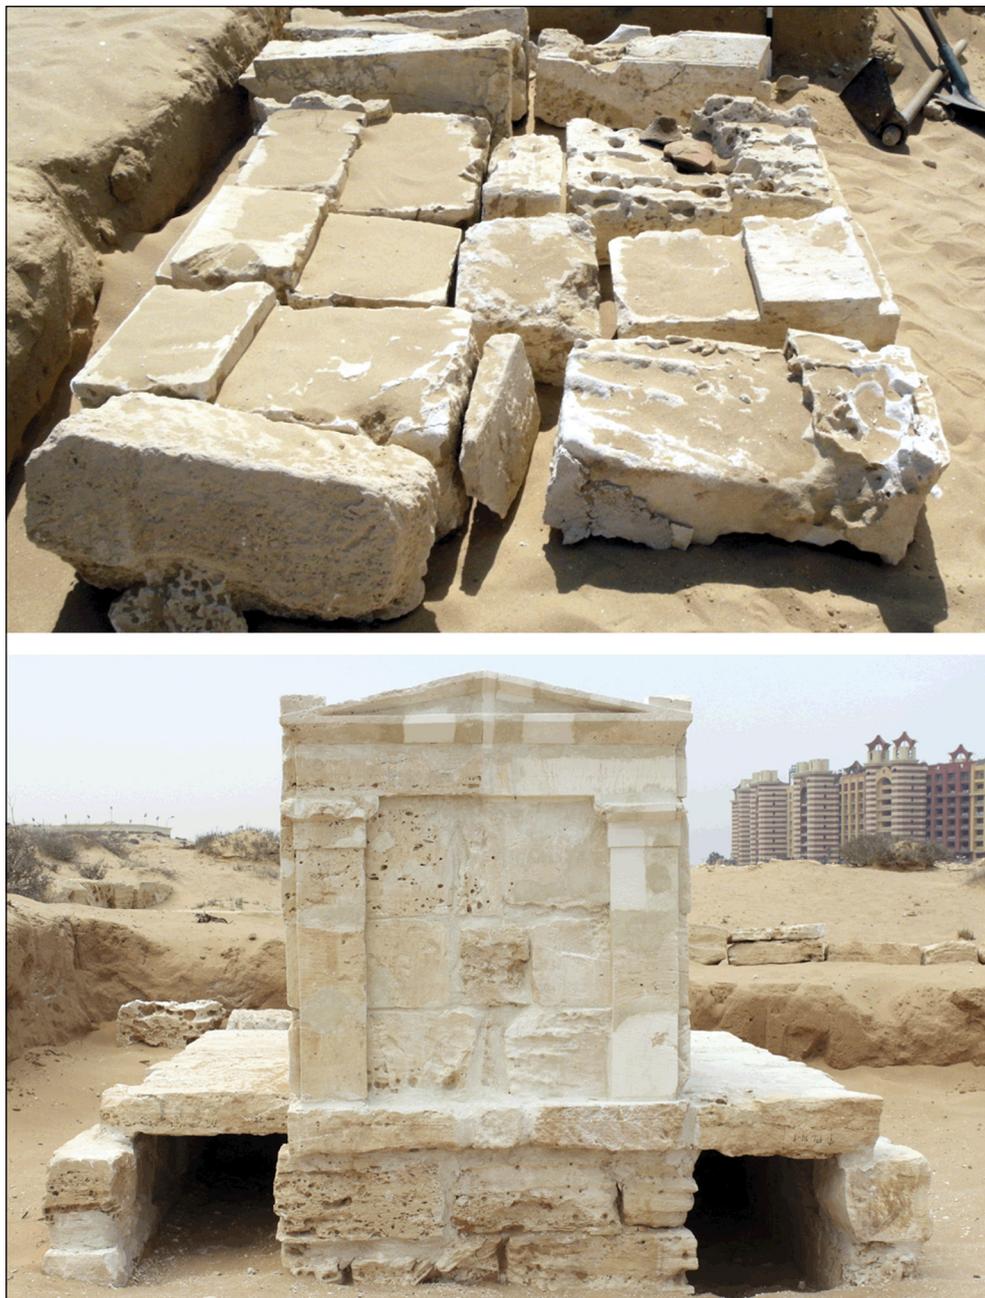
The planned work was part of the anastylosis project for this tomb [Fig. 2]. Elements of the tomb facade (discovered in 1997, see Daszewski 1998: 69–70) were in an extremely poor condition, the stone having eroded to the point that holes appeared in the masonry burial box structure. Elements like pilasters and cornices had become difficult to distinguish. The original elements had to be reconstructed in their original form (without losing their historical expression) in order to be reattached.

*Fig. 2. Elements of the facade of tomb T17, before (top) and after conservation in 2011  
(Photo G. Bąkowska-Czerner)*

Description of work: Documentation was completed of the condition before conservation of particular elements. Sockets were prepared to be fitted with stone patches. Big losses were filled in with stone patches of a material with properties matching the original. An epoxy resin-based binder (KEMAPOXY 150 produced by CMB) with lime filler was used to fit the patches. Small losses were filled in with lime–cement mortar with sand filler (6 parts sand to 3 parts lime to 1 part white cement). Post-conservation documentation was prepared.

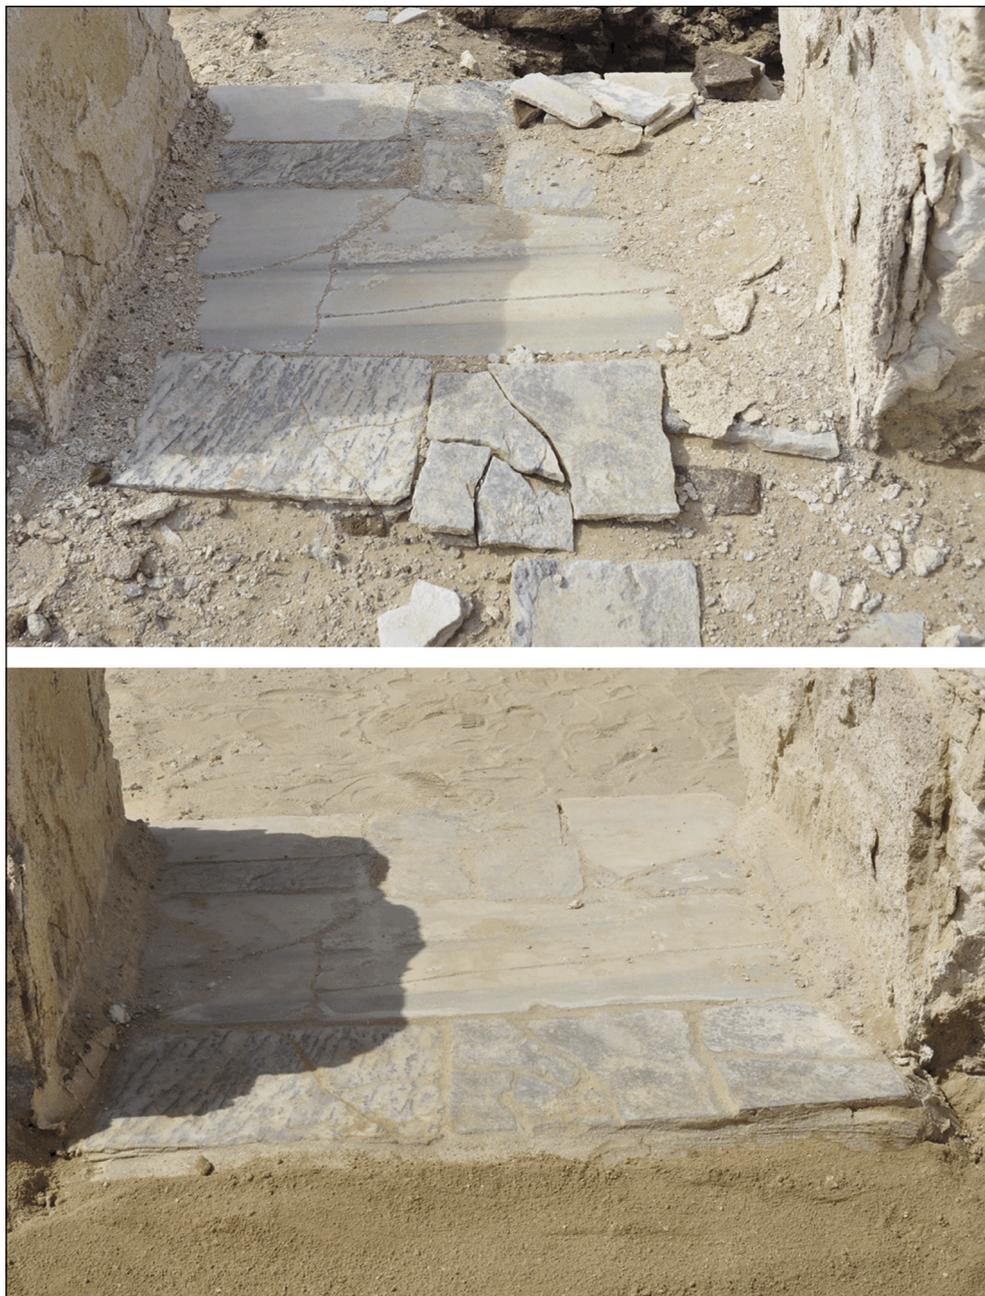
Conservation was essential in this case of the preserved relics of marble floors in the passage between rooms 6 and 7, to avoid the expected damage resulting from the use of the passage, as exemplified by already detached edge slabs [*Fig. 3*]. The weakened bedding had to be reinforced and the stone slabs returned to their original position.

*Fig. 3. Floor in the passage between rooms 6 and 7, before (top) and after conservation (Photo P. Zambrzycki)*

Description of work: The current state of preservation of the marble tile flooring was documented (G. Bąkowska-Czerner, P. Zambrzycki) and programs were prepared for protecting the hypocaust cellar remains and preserving the marble floor (R. Czerner, G. Bąkowska-Czerner, P. Zambrzycki). Geotextiles were used to cover the relics before backfilling the area with sand up to the level of the reconstructed part of the floor. The membranous fabric also served as a marker between the ancient substance and backfill. Cracked and detached fragments of the floor in the passages were removed in order to prepare a new

substructure. The bedding consisted of limestone bonded with lime-cement mortar with sand filler (6 parts sand to 3 parts lime to 1 part white cement). Dismantled floor slabs were cleaned and replaced using mortar as above (P. Zambrzycki). Final documentation was prepared.

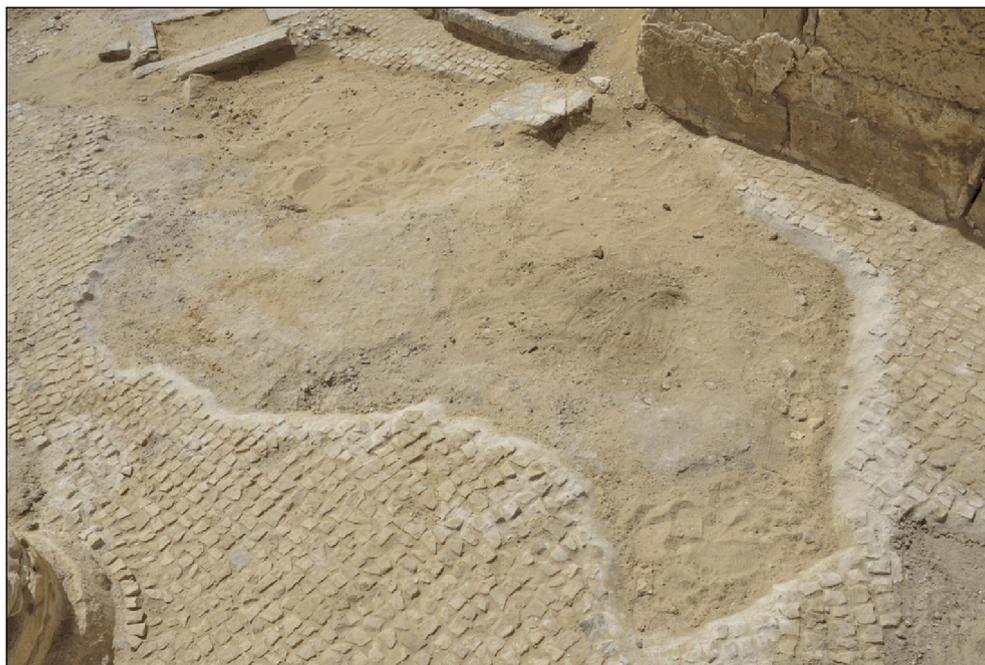
The planned two-year program of emergency preservation work includes on-site exposition of the decoration. Taken together, building structure, technique and preservation condition determined the extensive nature of future conservation works, which will include a transfer of the mosaic decoration to a new setting. A reconstruction of the whole floor will not only enable effective rainwater draining of the surface, but also ensure renewed use of the passage in its original function. At present, activities were limited to reinforcing the weakened parts with bands stabilizing the edges of the decoration and to fixing detached tesserae in place [*Fig. 4*].

Fig. 4. Southern Baths, southern portico of courtyard 4 after conservation of the floor mosaic (Photo P. Zambrzycki)

Description of work: The state of preservation was assessed (P. Zambrzycki). The mosaic was cleared of loose dirt lying on it and fragments that should undergo conservation work were selected. Cement mortar with lime filler (1:3) with added plasticiser (5% solution of PRIMAL AC33 in water) and natural pigment (vine black) was used. Wherever the original mortar was lost, a lime–cement mortar (3:1) with filler (coarse gravel) was used as a stabilizing base put under a band. Post-conservation documentation was completed.
