Possibility of the Evaluation of Injuries of an Unbelted Passenger in a Vehicle and the Need for Special Procedures while Inspecting the Site of the Accident

Security Dimensions. International & National Studies nr 4 (20), 132-164

2016

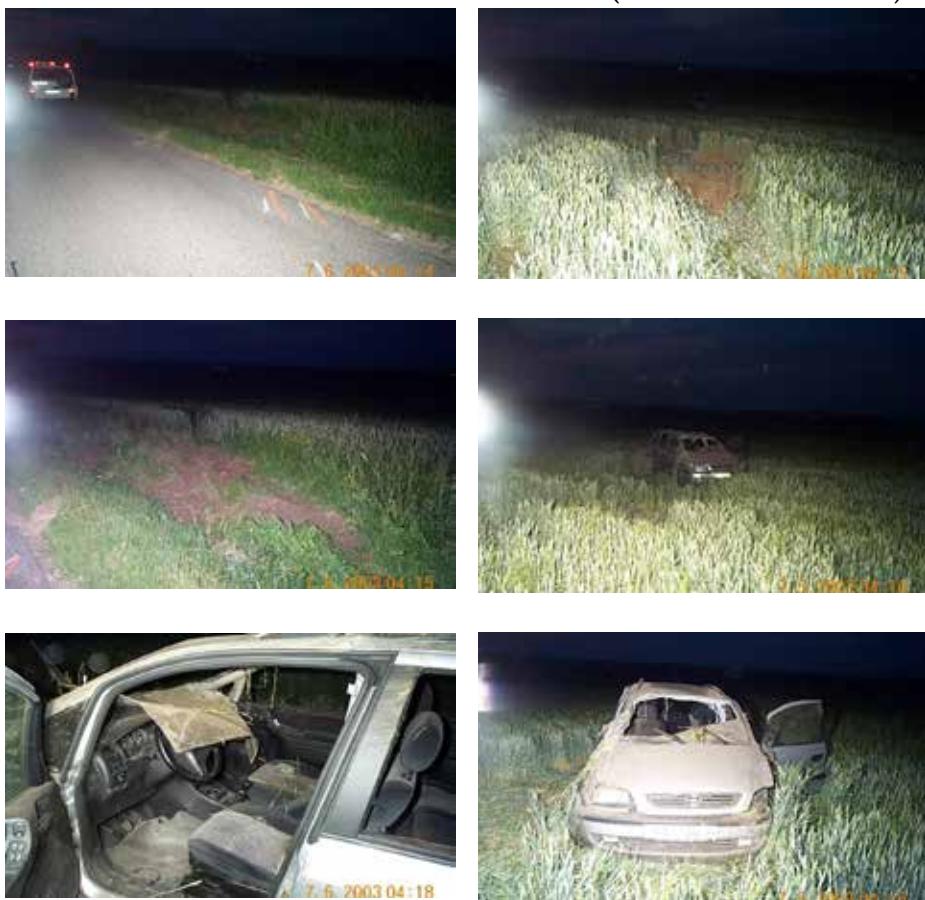
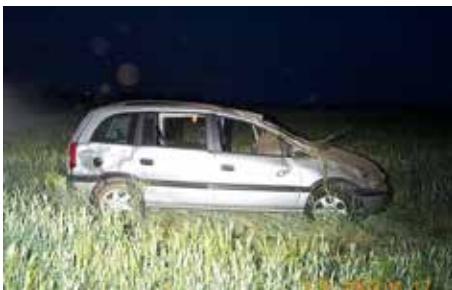
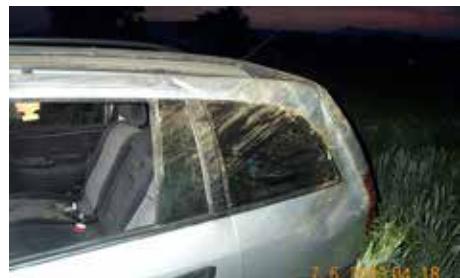
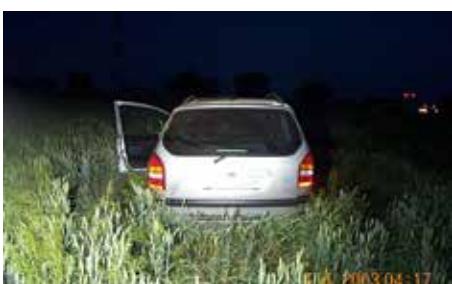
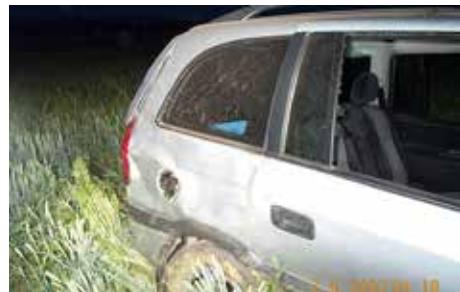
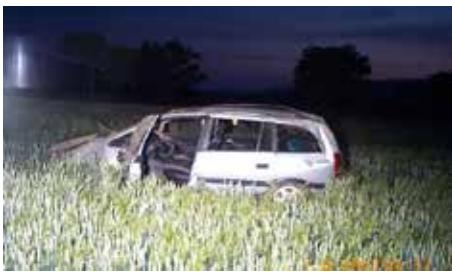
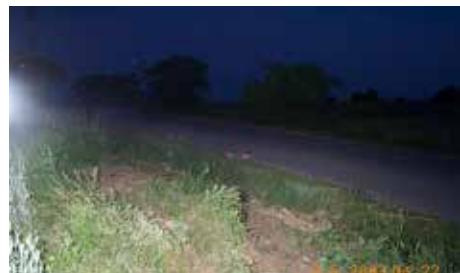
Photo documentation from the accident site (informative selection):

It is obvious from the file documentation as well as from the photo documentation of the accident site that it was performed after the accident at night under unfavourable light conditions (using the artificial light too).

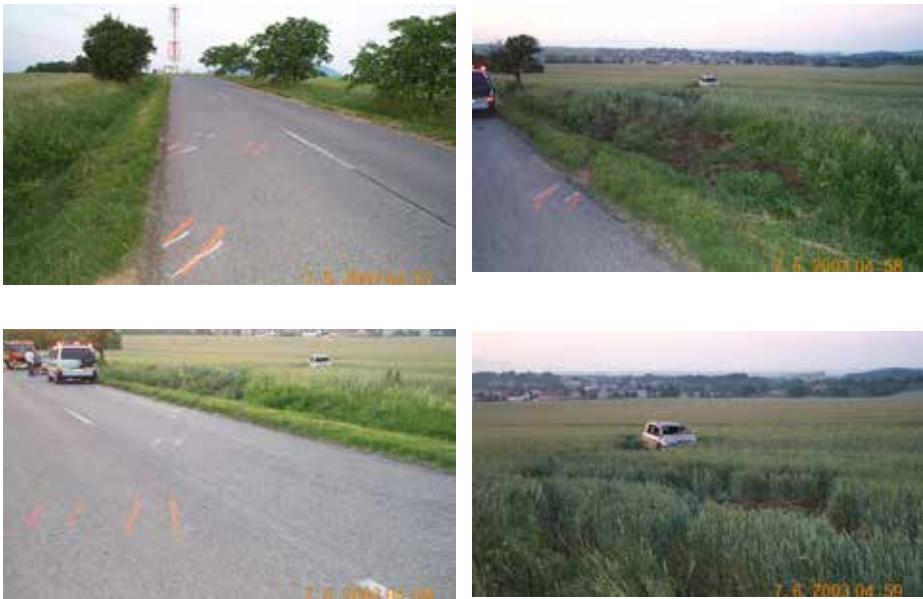
Due to the fact that the first inspection was performed at night, additional inspection of the accident site was performed on the following day during which the photo documentation was prepared (see the selection):

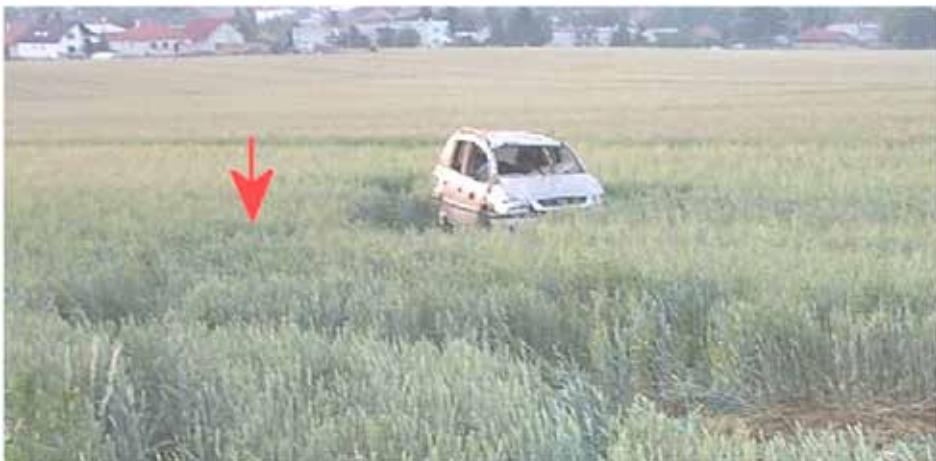
the injured body after the accident was lying on the ground approx. 3 m far from the vehicle (not less than 3 and not more than 5 m) on the back, i.e. facing the sky, more or less straight, as if it got from the passenger's seated position to the lying position – in the same direction as a seated passenger – only straightened to a lying position.

The statement was accompanied with a photograph with a marked additionally indicated approximate final position of the passenger.

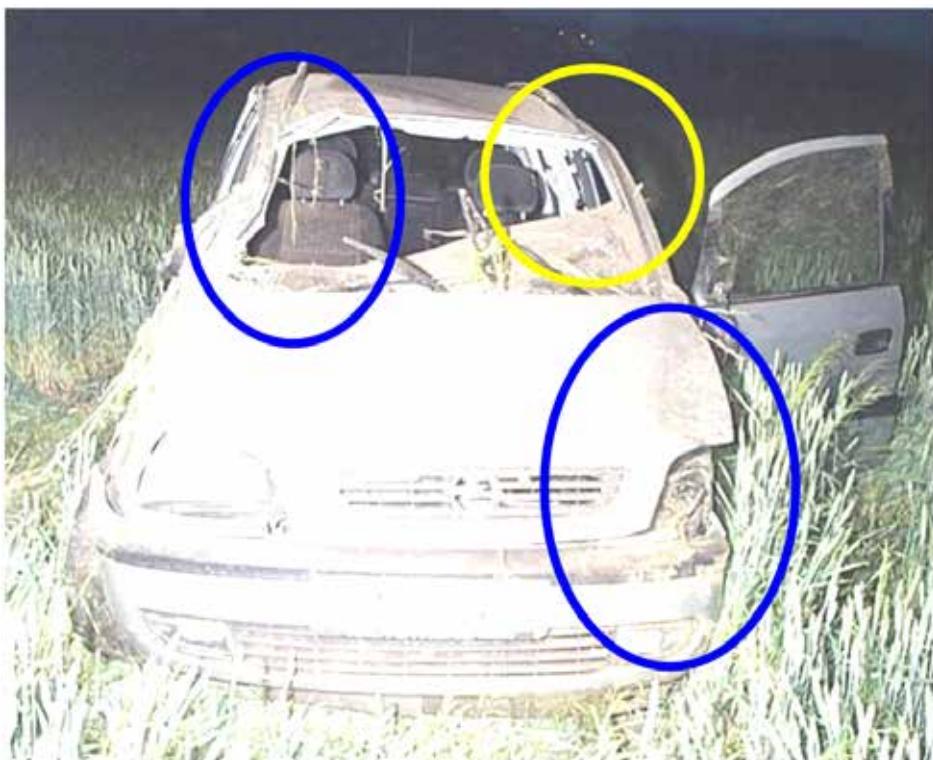
RF fender – pressed, RR fender – pressed, RF door – broken glass, RR door – broken glass

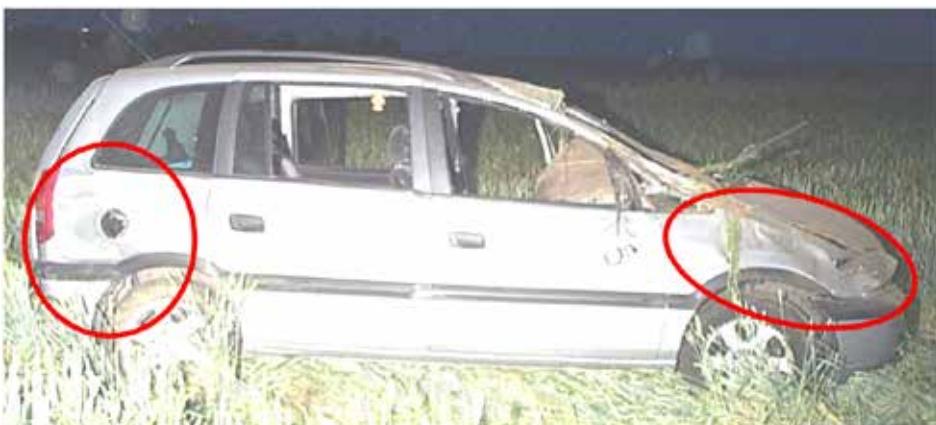
The front part of the vehicle

- the front part undamaged
- a deformation of the LF fender and headlamp
- R bumper shifted to the L side
- the R hood flattened on the R side

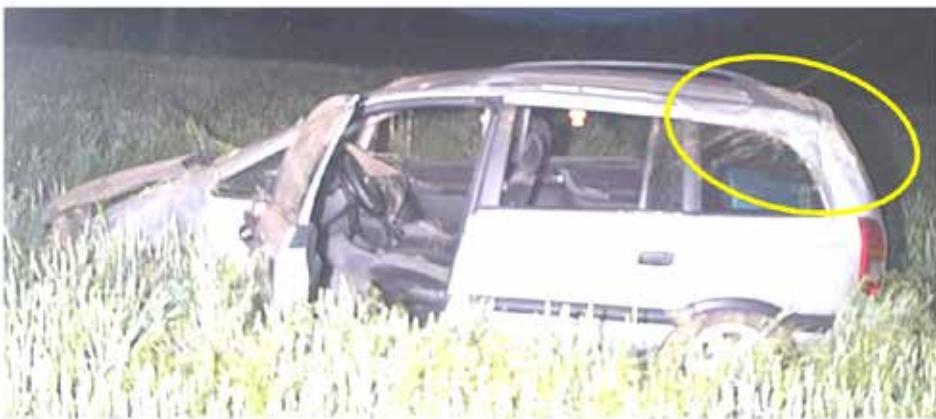
the left A pillar undefomed

the right A pillar – a deformation by a collision
with the windshield pressed inwards

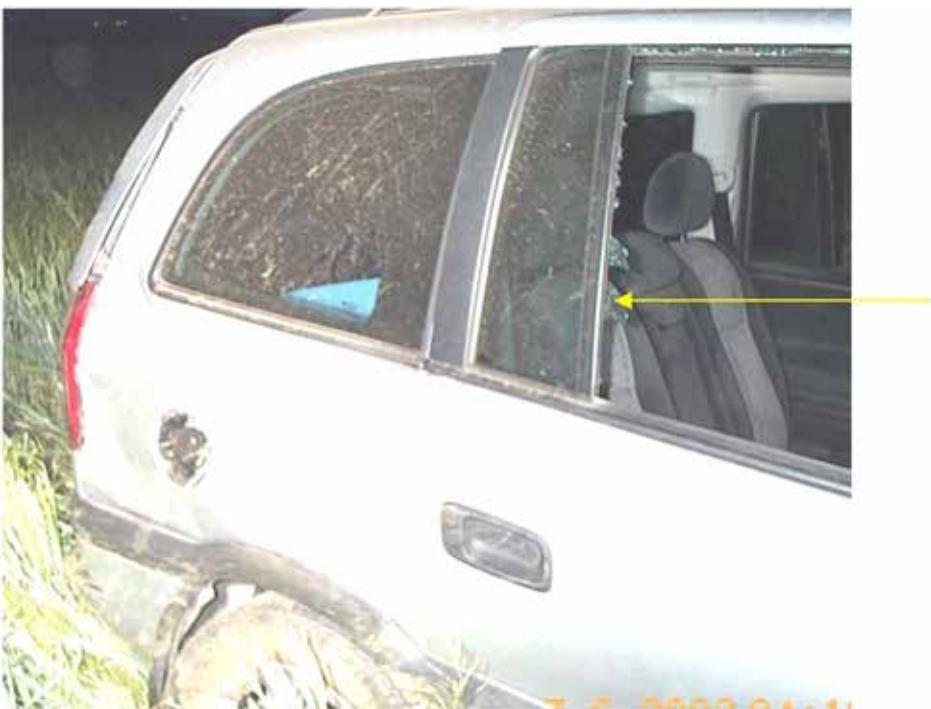
The glass remains trapped in the guide seal of the RF door

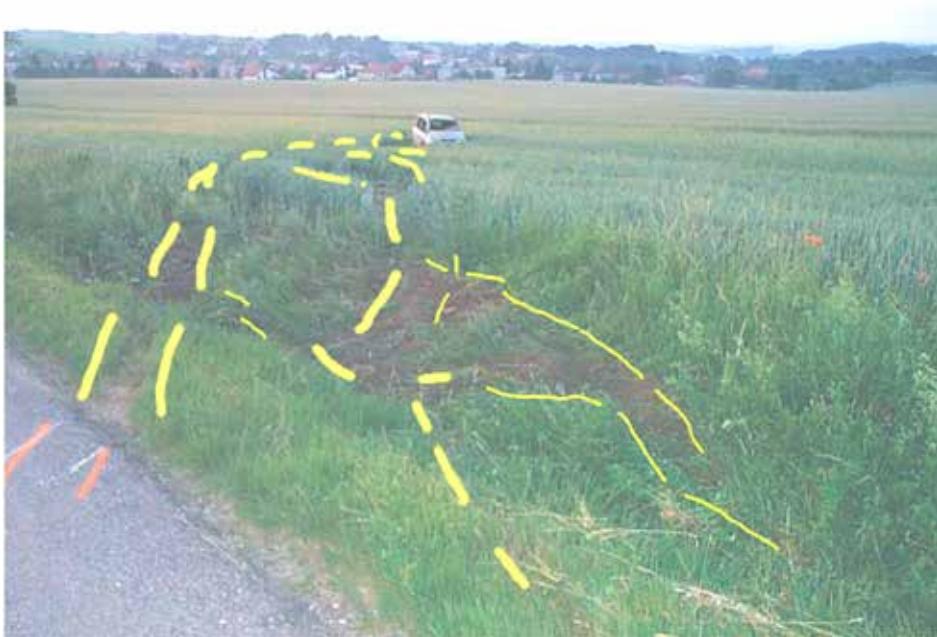
Tracks detected in the terrain

The glass remains trapped in the guide seal of the RR door

The tracks of the vehicle movement in the terrain (the ditch and crop) (it is not possible to rule out the additional tracks in the crop – caused by the movement of people during the realization of TA (traffic accident))

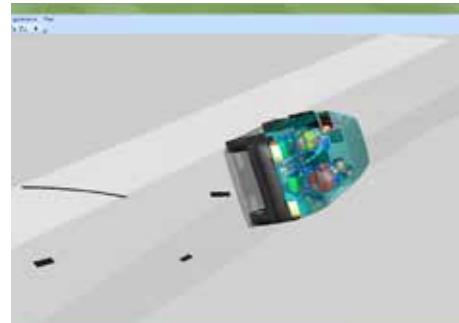
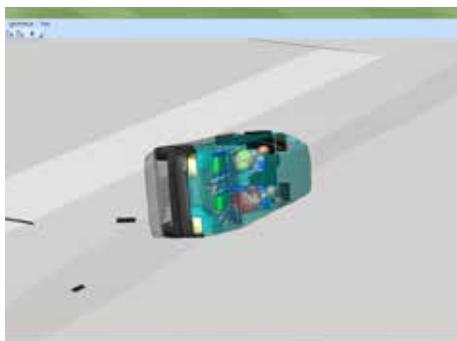
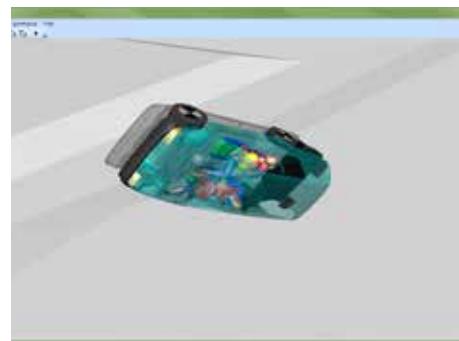
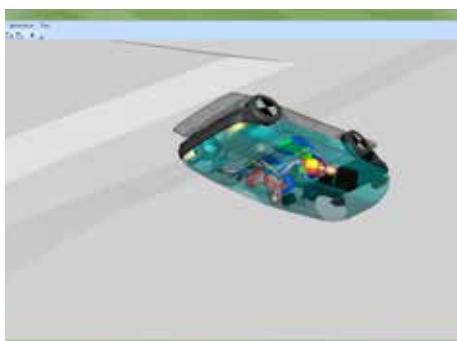
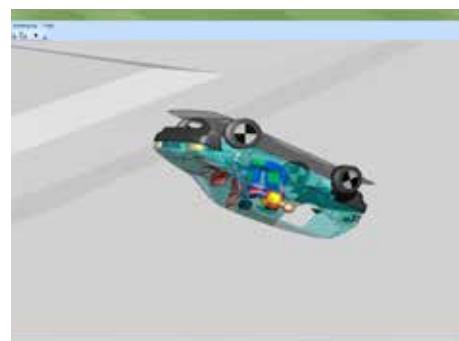
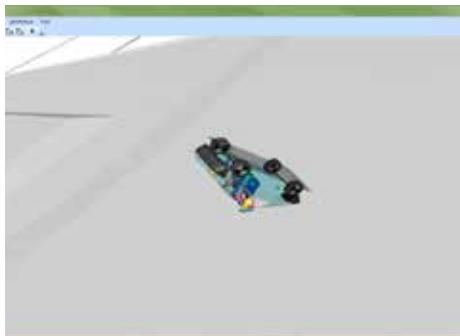
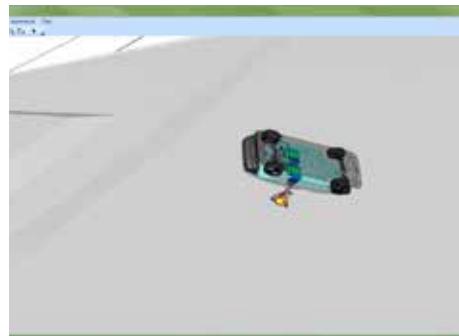
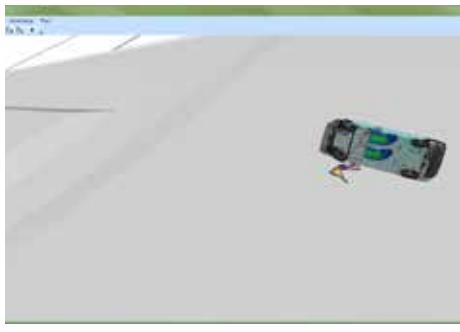
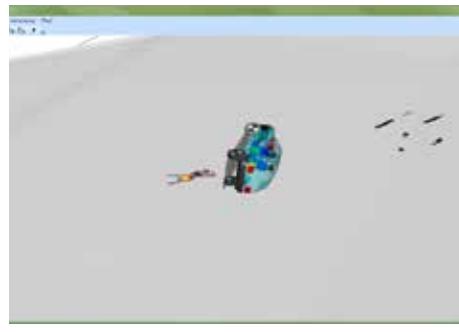
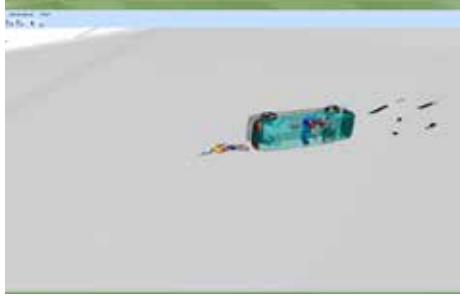
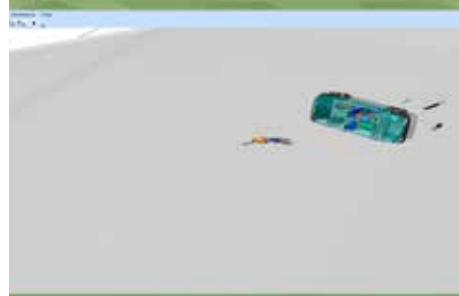
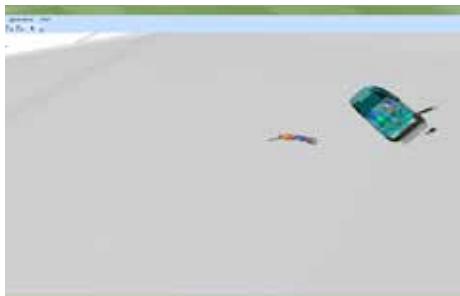
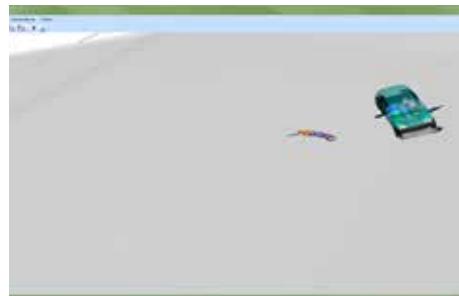
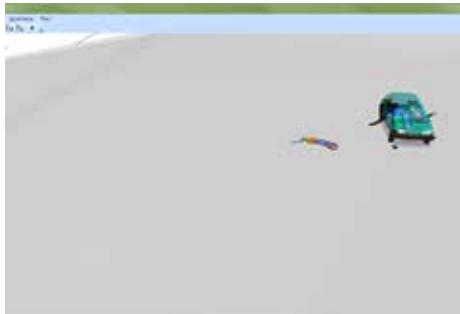
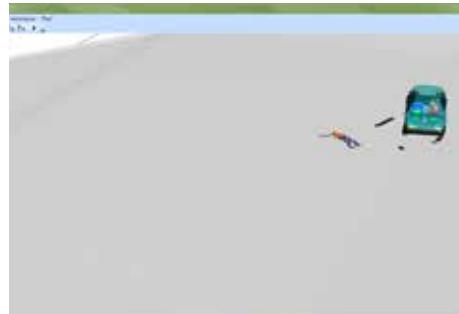
The movement of the vehicle crew and the passenger on the RF seat (the yellow figure) according to the calculation:
