## Maucallacta, Peru : Information about the work carried out in the 2012 season

## MAUCALLACTA, PERU: INFORMATION ABOUT THE WORK CARRIED OUT IN THE 2012 SEASON

The Maucallacta archaeological site is located at the foot of the Coropuna volcano's southern slopes, in the Pampacolca District, the Castilla Province, the Arequipa Department.

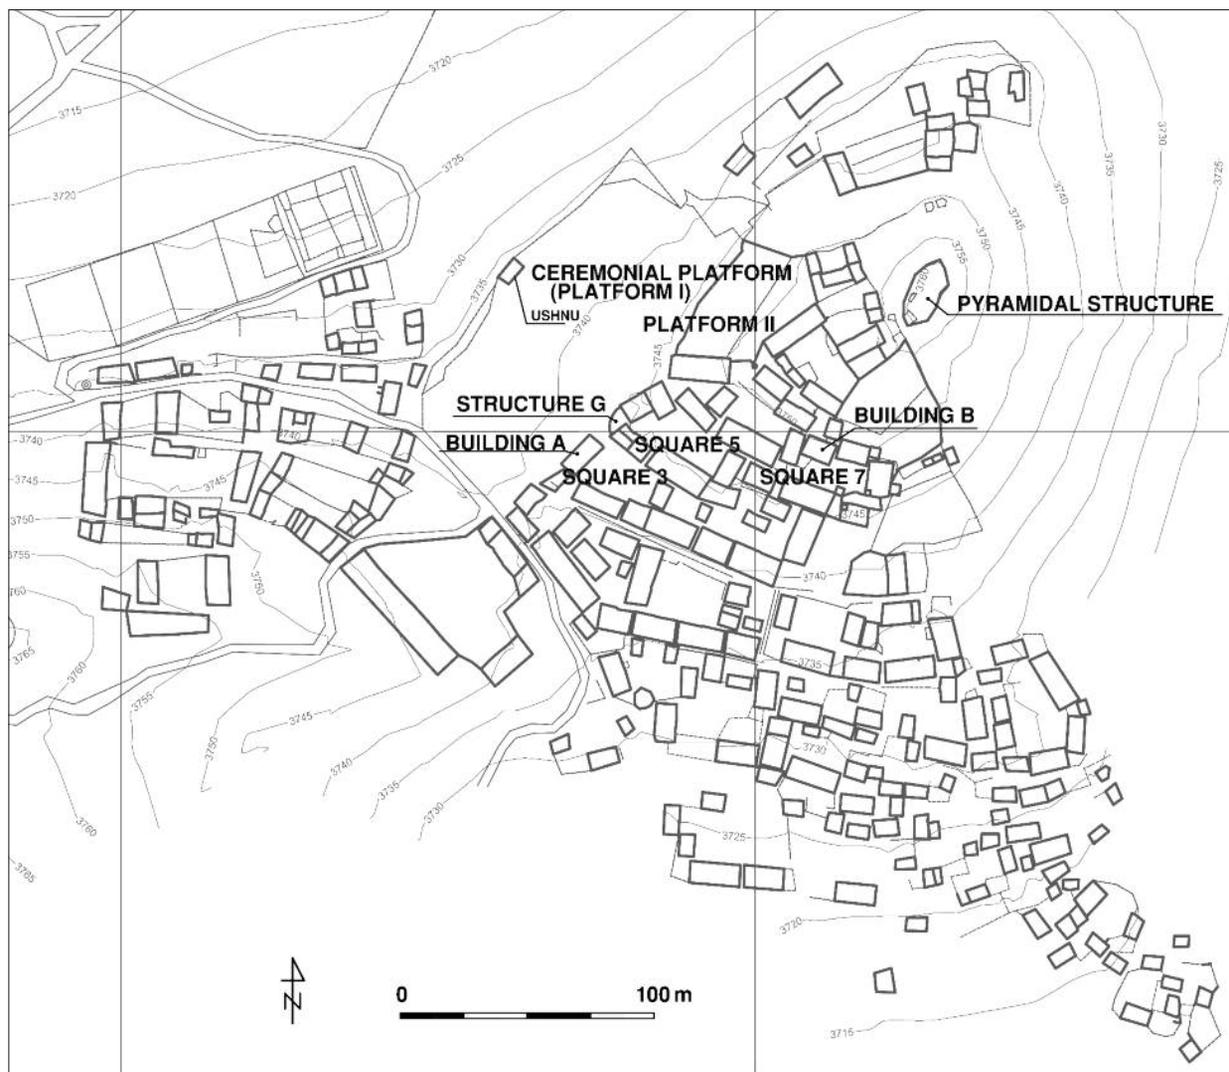
Fig. 1. Plan of the Maucallacta site, showing the location of the structures described (Drawing E. Żuławska-Sobczyk).

A team of 44 people participated in the study, including four archaeologists, two topographers and seven archaeology students from Poland, as well as two Peruvian archaeologists and about 30-strong group of workers. Archaeological work consisted of clearing the interiors and carrying out surveys of the buildings: A at Square 3 and B at Square 7 (Fig. 1).

Restoration work concentrated on Building A, the lower part of the wall between Platforms I and II (the so-called banquette), the outer wall of Structure G at Square 5 (Fig. 1). As part of regular activities, clearing the complex off vegetation and maintenance work was also carried out.

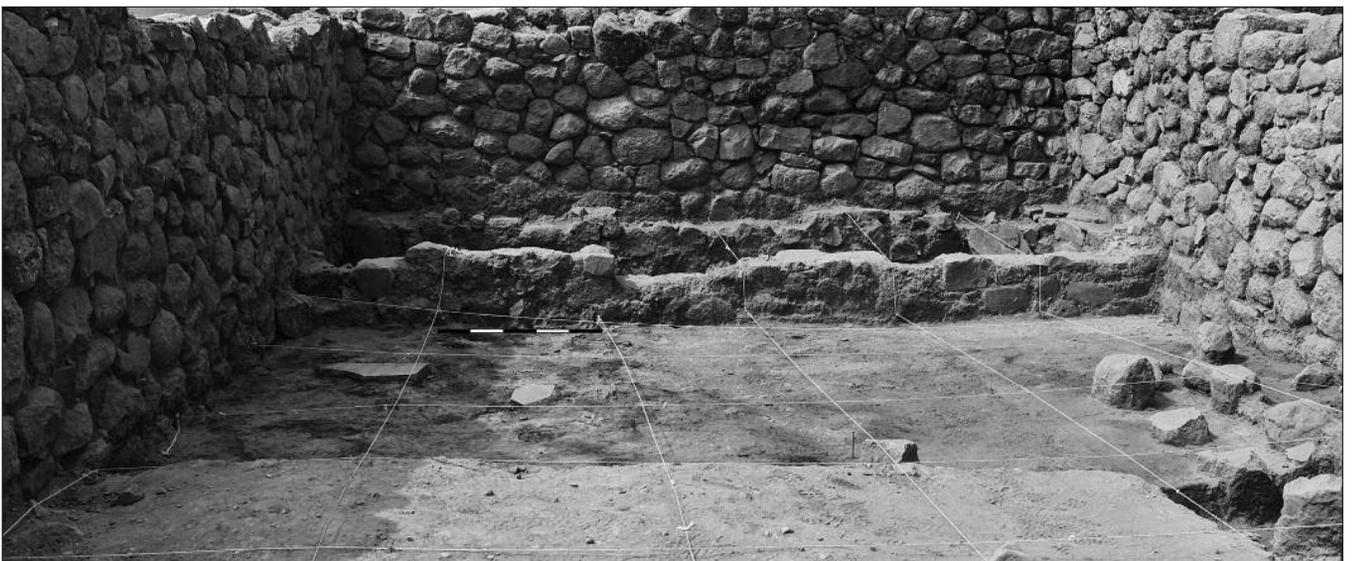
Fig. 3. Square 3, Building A, the inside of the discovered “storage” (photo M. Sobczyk).

The second element consisted of surveys placed on the eastern half of the building. In the process, a structure taking up the entire space at the foot of the eastern wall and

measuring  $5.80 \times 1.90$  m, was uncovered (Fig. 3). According to preliminary studies, it may have served as handy storage. Numerous traces of burning, with fragments of fabric among them, were found on the floor level of the “storehouse.”

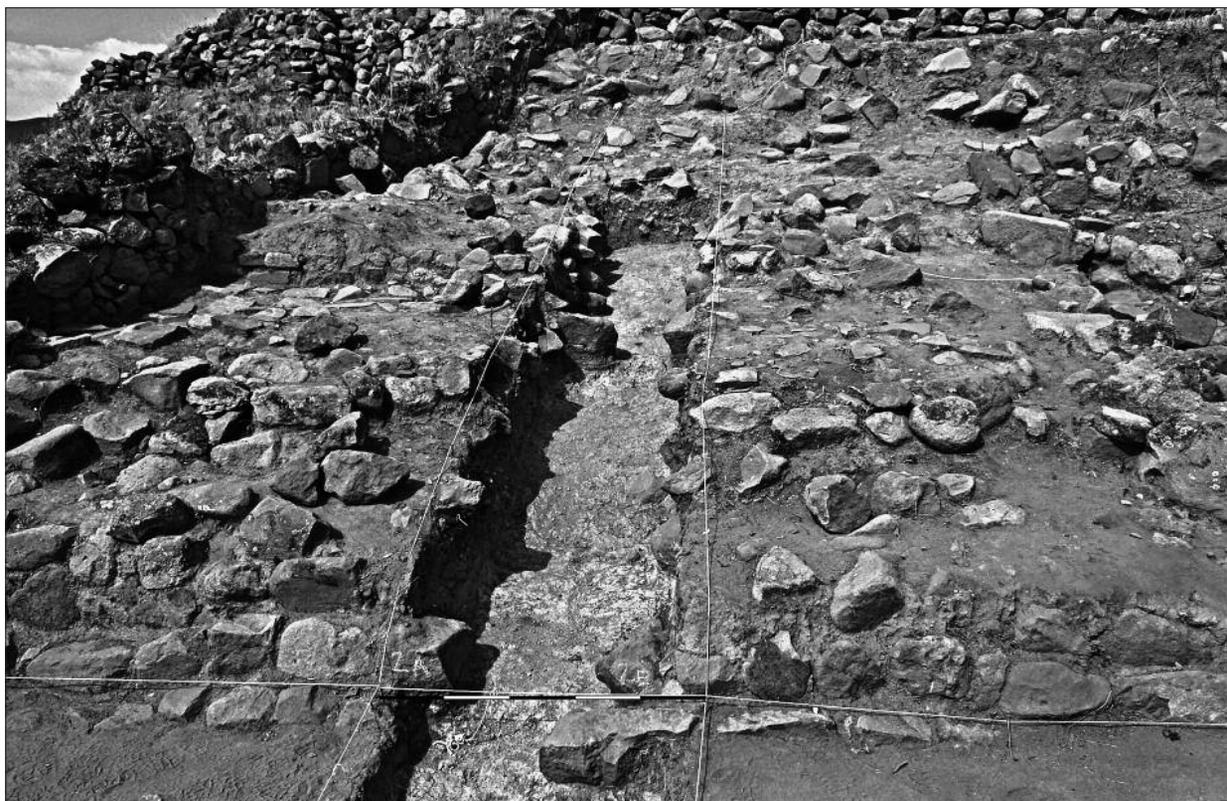
Fig. 4. Pyramid, a group of small platforms (stairs), for the entrance to the top of the pyramid (Photo M. Sobczyk).  
Ryc. 4. Piramida, niewielkie platformy (schody), służące jako wejście na szczyt piramidy.

a wall of layered stone, an oval feature was created, towering over the entire central part of the complex, its shape echoing slightly the Coropuna volcano in the background. During the work in previous years, a group of small platforms was uncovered on the west side that was clearly one of the elements of the entrance to the top of the pyramid. A trial pit (1×5 m) was placed in the stairs to identify the internal structure of the feature (Fig. 4), and ceramic fragments as well as human bones were found in layers of the fill. Material for radiocarbon analysis was also collected.

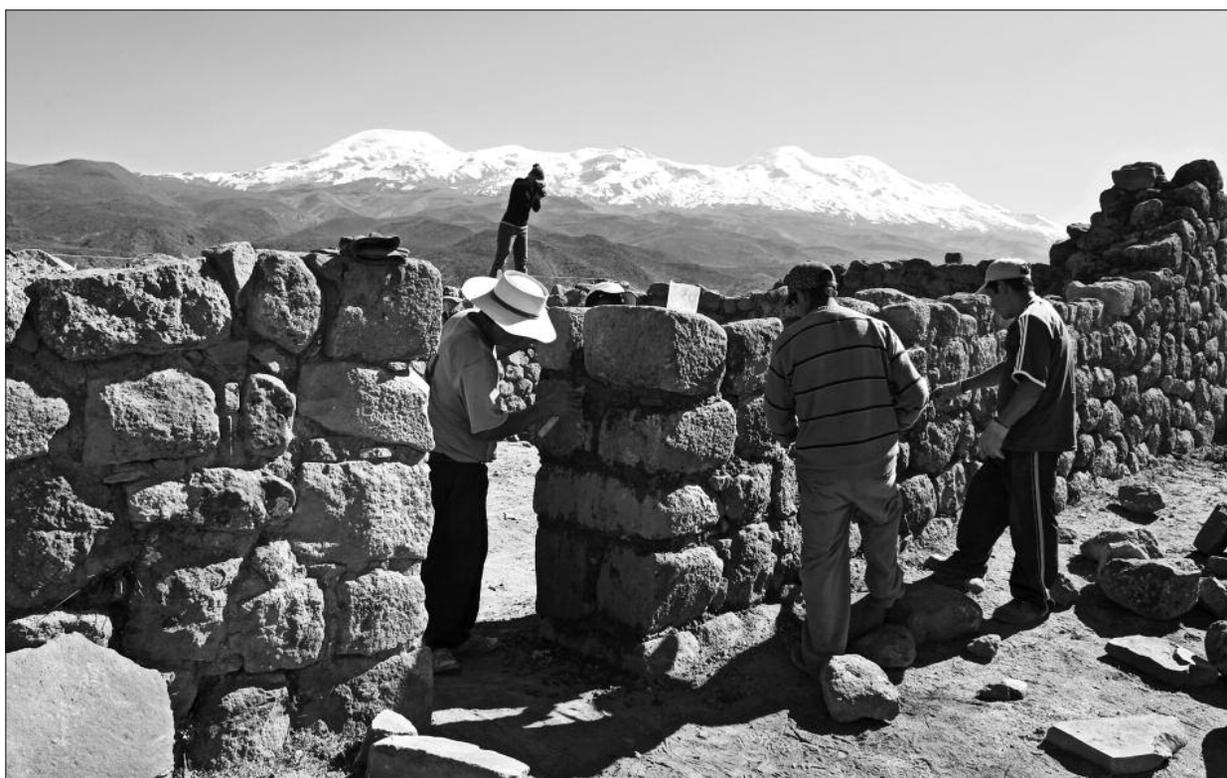
Fig. 5. Reconstructed front wall of Building A, Square 3 (Photo M. Sobczyk).  
Ryc. 5. Rekonstrukcja frontowej ściany budynku A przy placu 3.

Work carried out in the 2012 season dealt mainly with Building A at Square 3; after clearing had been completed, work on stabilising the remaining walls began by filling gaps in the clay mortar, then completing the walls with stone fragments taken from the rubble, so that it formed a building block (Fig. 5). In accordance with the Venice Charter, walls above the level of preserved original fragments are not restored.

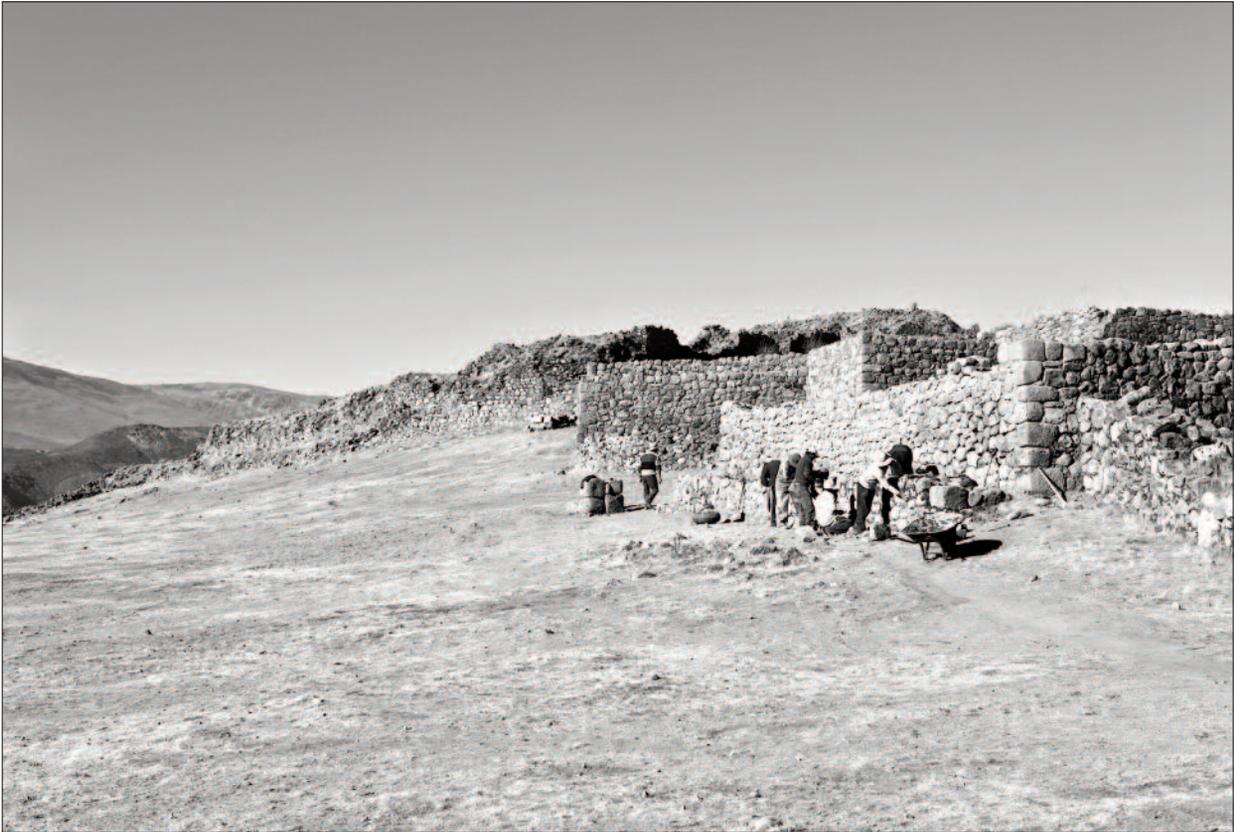
Fig. 6. North wall of Building A, Square 3. Work consolidating the structure of the face of the wall, within the banquette (Photo M. Sobczyk).

Also, work consolidating the structure of the face of the wall was done at the time of restoration of the banquette (earth and stone bench), adjacent from the north along the entire length of the walls of the building (Fig. 6).
