**Marina El-Alamein: Polish-Egyptian
Restoration Mission : Conservation
Work in 2008**

MARINA EL-ALAMEIN POLISH-EGYPTIAN RESTORATION MISSION: CONSERVATION WORK IN 2008

RESEARCH, BUILDING, CONSERVATION AND RECONSTRUCTION IN THE 2008 SEASON

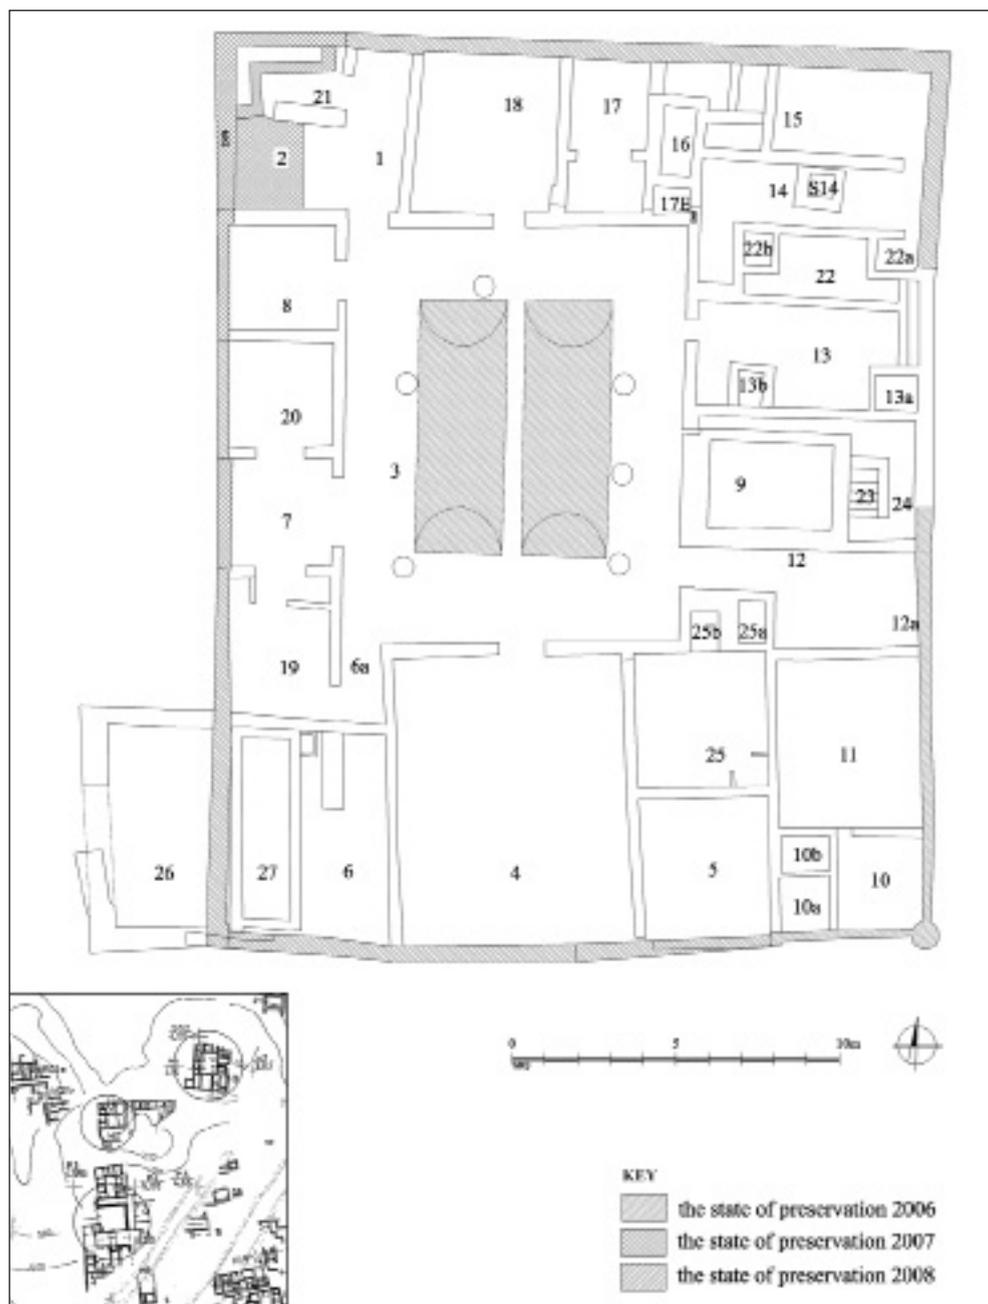
Fig. 1. Plan of house H1 showing stages of preservation works; inset, localization of the house on the town plan (Drawing M. Krawczyk-Szczerbińska; updated plan PCMA archives)

The southwestern part of the enclosure wall, encompassing the south and west walls of Room 27, which are at the same time the outer walls of the house [*Fig. 1*], continued to be reconstructed, building up now on the foundations and lower courses laid already in 2006 and 2007 — three courses in the south and five in the west (using blocks 0.30 m wide). By the same, the corner of the house has finally been raised high enough to become visible in the surrounding area [*Fig. 2*].

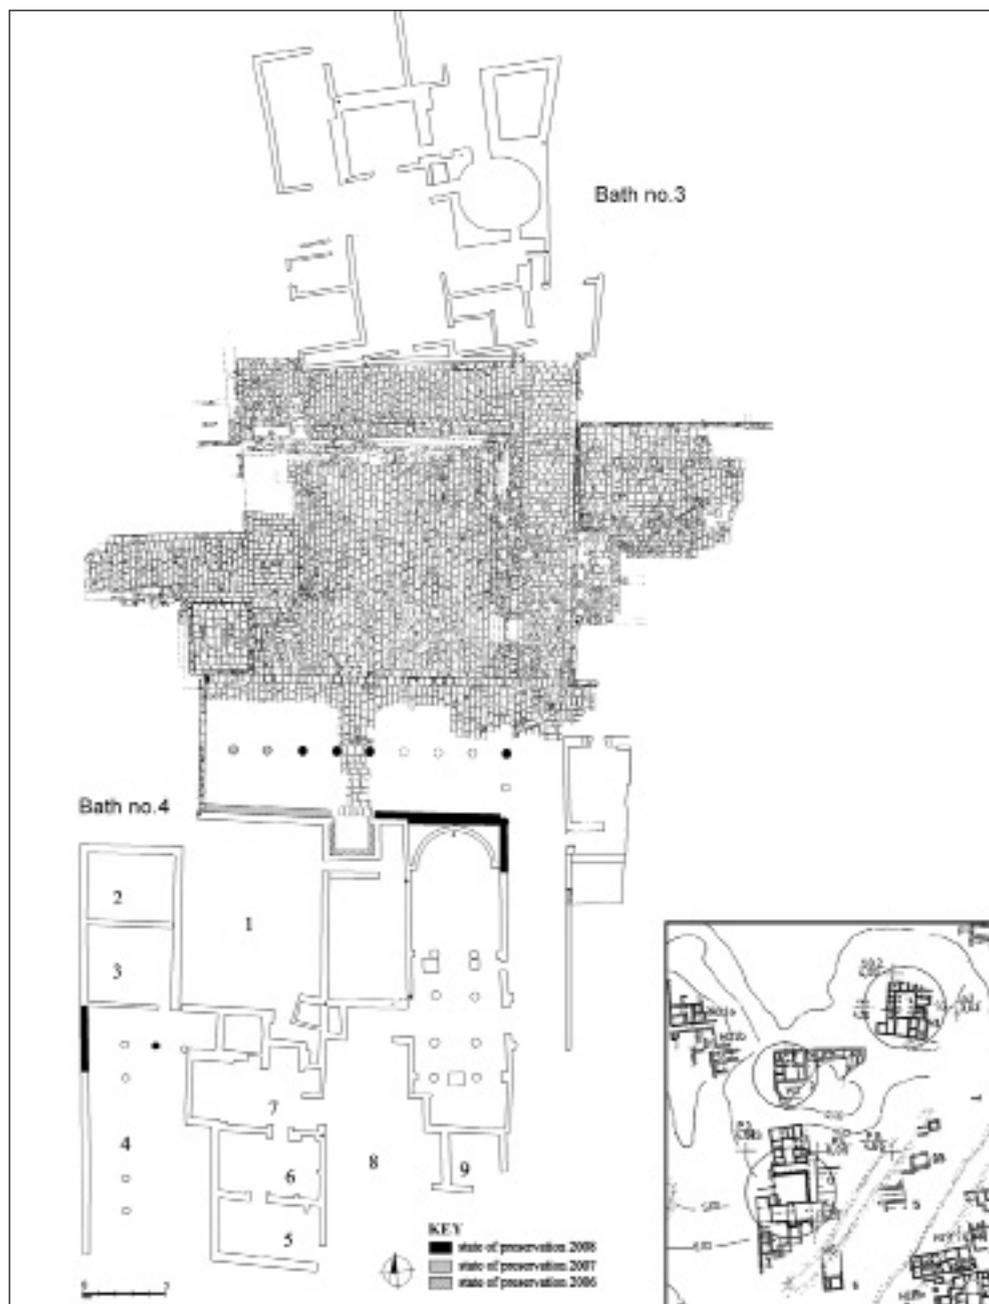
Fig. 5. Plan of the main town square and bath complexes: no. 3 to the north and no. 4 to the south (Plan M. Krawczyk-Szczerbińska, after J. Dobrowolski, A. Błaszczuk, updated, PCMA archives)

The architecture of the southern portico of the main town square (forum) started being conserved in 2006 and was continued on a broader scale in 2007 [Fig. 5].² The work included the stone benches, beginning with the section in the portico exedra in the center of the south wall and encompassing the part by the south wall to the west of this exedra. Three columns of the southern row of the portico, located at the extreme west, were raised, two to full height and the third to mid-height. The engaged column at the extreme west end of the northern row of columns in the portico facade was also reconstructed in its lower part (Medeksza 2010: 88–91, Fig. 7).

The present work started with an anastylosis of the original elements from the collapsed back wall of the portico east of the exedra in the center. The reconstruction proceeded concurrently with the conservation of the broken stone bench by the wall, which had to be dismantled for the purpose.³ The raising of the third column of the southern row, which commenced in the previous season, was now completed and the corner southeastern column of the portico ending the south wall on the east was also erected. The bottom parts of a few other columns in this row of the portico were also restored partly with new elements, the process being regulated by availability of preserved shaft drums. Once the conservation of bench elements was completed, the benches were put back in place.⁴ The surviving parts of the exedra reveals and the wall of the portico next to them were completed and preserved in place.

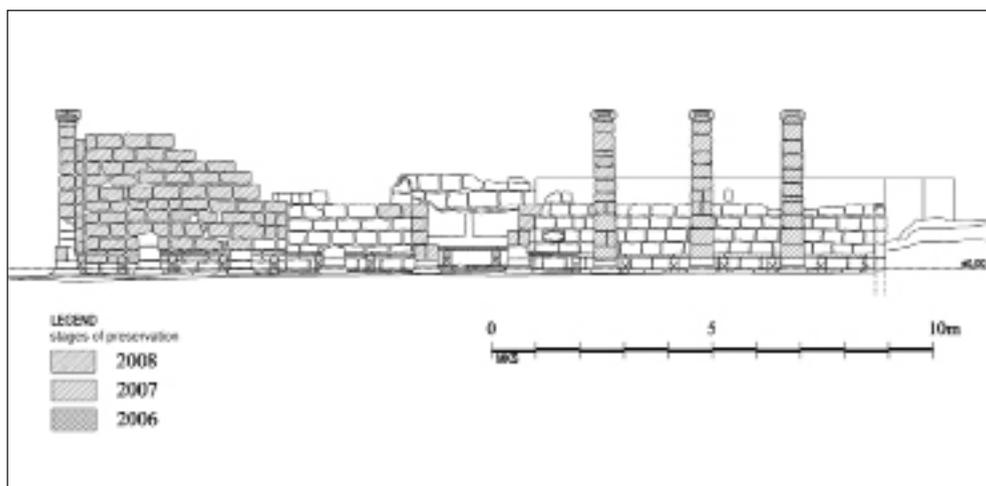
Fig. 9. Anastylosis of the columns and back wall in the south portico of the main town square (Drawing M. Krawczyk-Szczerbińska)

in the pseudo-Ionian order common in the Marina el-Alamein region [Figs 9, 10]. Column height, according to a study by the discoverer Wiktor A. Daszewski, was about 3.60 m (Daszewski 2005: 86; 2007: 88–90), composed as a rule of a base, eight to nine drums from 0.28 m to 0.35 m high, and a capital in a style resembling the Ionian order. A soft limestone was used for these pieces of the architectural order. The bottom drums were usually made up of two half-drums joined vertically. The bottom drums were 0.50 m in diameter, the upper ones 0.43 m. The columns were all coated with lime mortar render and plaster with relief fluting.

ancient procedure for the lower parts of column shafts. Usually only one half of the lowermost drums needed replacement. The bases were all original, preserved in good condition and requiring only consolidation and strengthening of the substructure. Four drums (about a third of the height, that is, 1.51 m) of the easternmost column in the middle row were thus put together to await anastylosis, as were two drums (0.78 m in height) of the easternmost column in the northern front row (fifth counting from the corner).
