Nea Paphos: Season 2009

NEA PAPHOS SEASON 2009

Abstract: Three seasons of excavations (winter, spring and autumn) were conducted by the Department of Antiquities and on behalf of the Department under Polish supervision, implementing a program of salvage testing under the planned shelter (the design of which underwent successive modifications in the course of the work). The only larger planned trench was excavated in the southeastern part of the House of Aion, uncovering rooms 40–43. A regular excavation campaign was held by the Polish Mission in September. It focused on clearing the western part of the so-called Hellenistic House, uncovering rooms 13, 28, 31–33, aiding in the preservation of the cistern and restitution the colonnade of the portico.

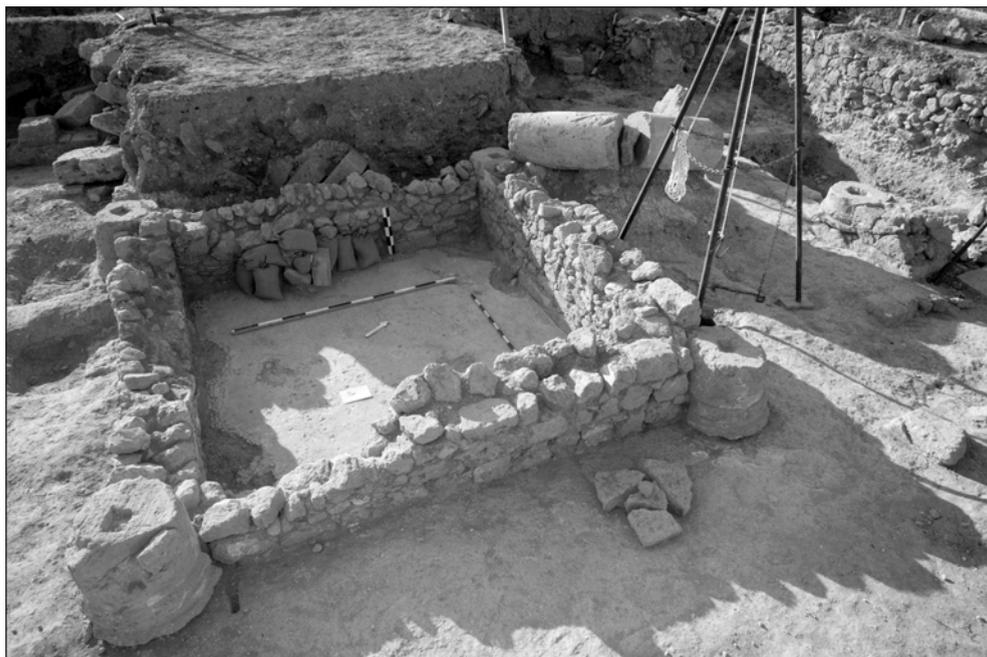
Fig. 5. The tetrastyle with impluvium remodelled into a basin in courtyard 13 of the so-called Hellenistic House, seen from the east; note the pipe outlet in the western edge of the impluvium (Photo H. Meyza)

Uncovering most of courtyard 13 has shown that its central part was occupied by an open tetrastyle with rough walls connecting the columns, standing on a single row of large masonry blocks [Figs 4, 5]. The walls seem to have been built in a late phase, apparently necessitating the

recutting of the corner columns (drum diameter at base 0.58 m, base itself 0.67 m). The good quality hydraulic plaster on the floor and a pipe outlet in the western side of the masonry socle indicate the presence of a shallow impluvium. All the column bases, monolithic with a low drum, were preserved in place, and the northwestern column also had two drums collapsed northward and a capital lying approximately 1 m to the west of them. One drum of this column appears to be missing. The capital is of the so-called Nabatean type in the pseudo-Ionian variant from Petra (McKenzie 1990: 117, Diagr.14k, Pl. 149a) [Fig. 6]. This form has no immediate relation to the pseudo-Ionian capitals of Marina el-Alamein (Czerner 2009: 22–26, Fig. 39).

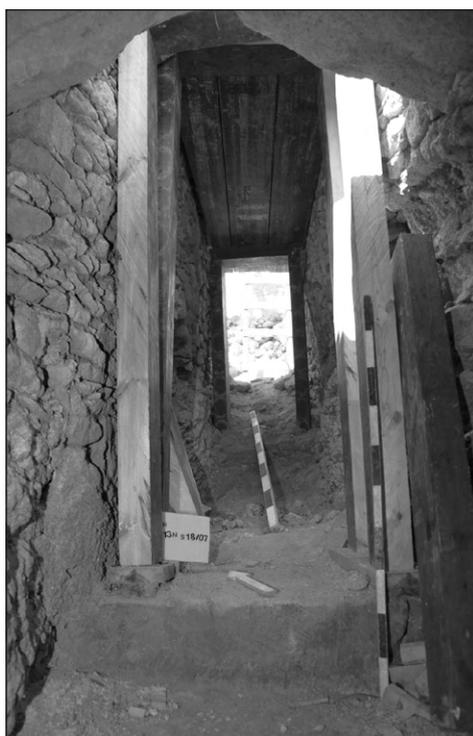
Fig. 7. Supported access corridor to the cistern under courtyard 13 (Photo H. Meyza)

Conservation work in the cistern underlying the northern and central part of courtyard 13 [Fig. 7] was preceded by leveling of the strata filling the cistern. Stairs leading to it at the end of the access corridor were cleared at their lower end. The bronze butt of a spear was found there, differing from the standard *sauroter* by having a rounded knob instead of a spike at its end. The butt was decorated and retained inside remnants of a wooden shaft [Fig. 8]. The cistern roof was supported by filling its sides with openwork cribs made of wood and filled with local clay (*khonnos*) and slid rock fragments as well as lining the roof with planks. This

permitted safe restoration of the column at the northwestern corner of the tetrastyle.

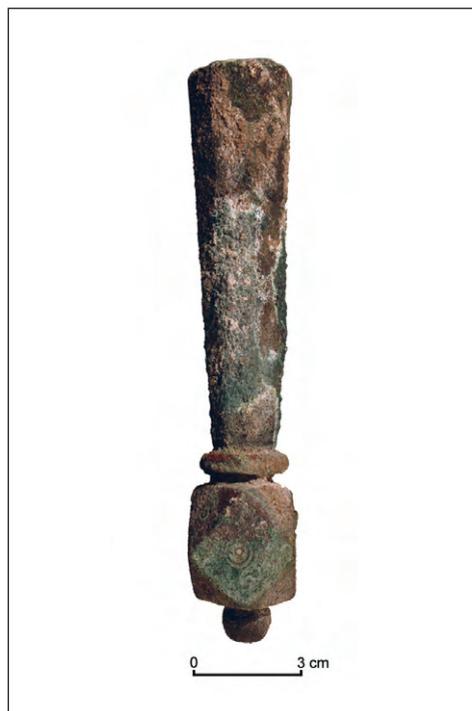
Fig. 8. Bronze spear butt (*sauroter*) found in the cistern under courtyard 13 (Photo H. Meyza)

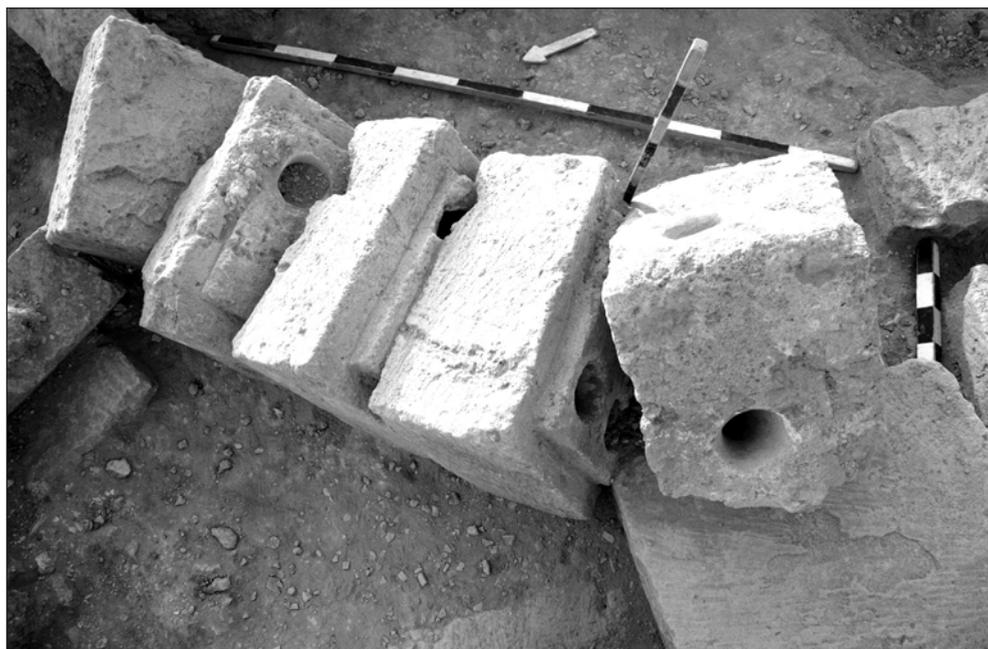
Fig. 9. Collapsed pillar with drilled triple pipes from the area west of the Hellenistic House tetrastyle (Photo H. Meyza)

A set of blocks, parts of a stone siphon triple pipe, reused as a pillar, was found in

place, collapsed northward on the eastern side of this cistern mouth, in the same direction as the only preserved column of the tetrastyle. The presumed purpose of this pillar was related to the rectangular shaft cistern. Between the siphon blocks there is one which suggests that they may have belonged to a *castellum aquae*, as its three pipes diverge in three directions [Fig. 9]. Between the rectangular head of the second cistern and the *impluvium* the courtyard floor was covered with a layer 5 cm thick in places, consisting of Plain Ware mugs/jugs crushed into small sherds. The anticipated use of these vessels was for pouring water over bathing persons in a bath.

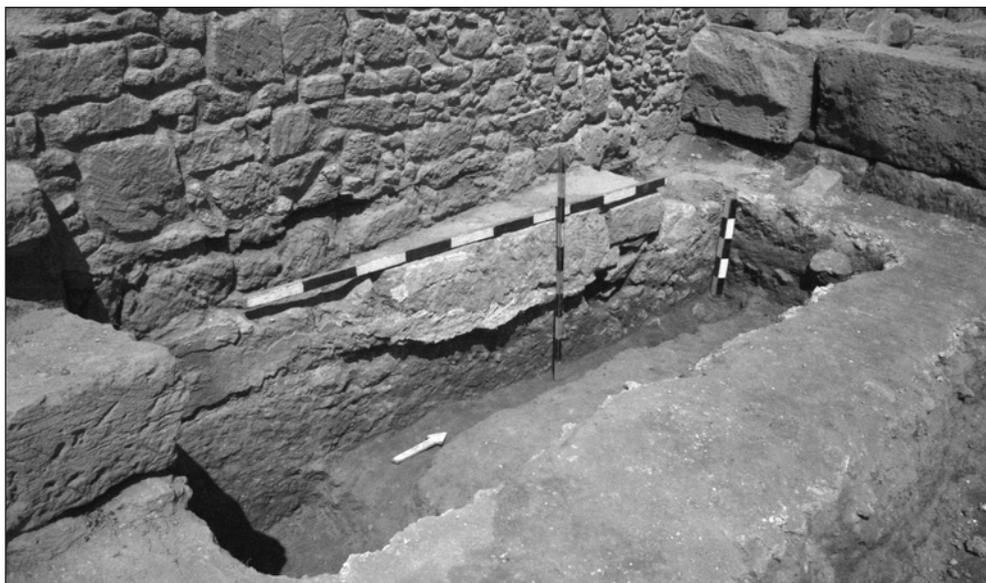
Fig. 11. Walls plastered below latest floors in room (courtyard?) 30 of the so-called Hellenistic House; Late Roman wall on top and south wall of the Villa of Theseus at right (Photo J. Michalska)

Excavations on the southern side of the southern elevation of the Villa of Theseus, under the floor of courtyard 30 of the so-called Hellenistic House, have shown that the walls of that house were plastered below the level of that floor, but there is no clear floor corresponding to the lower edge of that plaster [Fig. 11]. Before that floor there existed also an earlier wall dividing courtyard 30, plastered deeper to approximately 1 m below the floor surface.

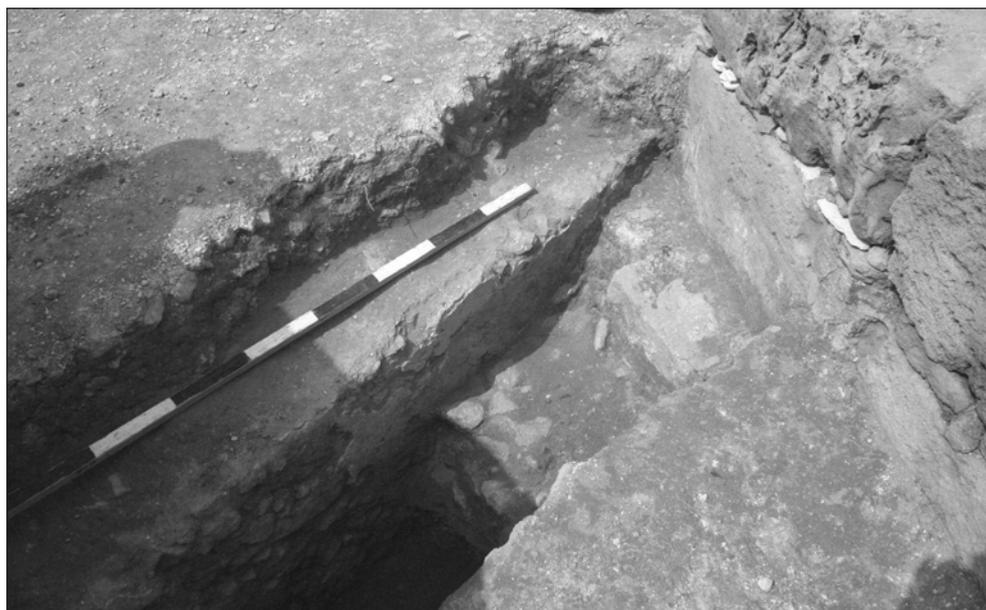
Fig. 12. Wall preceding the floor of Hellenistic House room 30 with superimposed southern elevation of the Villa of Theseus (Photo J. Michalska)

The southern elevation of the Villa of Theseus running against and superimposed over that wall had cut through the floor of courtyard 30 [Fig. 12]. All layers preceding the floor and its bedding contained solely Hellenistic material. Unfortunately, the early walls on both sides of the southern elevation of the Villa of Theseus do not run in the same line despite retaining a generally N–S orientation, as is the case of a wall found in the adjacent room 5 in trench Λ6 of 2003 (Daszewski *et alii* 2004: 290).
